St. Catherine of Alexandria Church  
107 North Main St.  
Westford, MA 01886  
Prepared for Reverend Peter F. Quinn, Reverend Joseph M. Rossi

Prepared by Office of Property Management  
Archdiocese of Boston  
66 Brooks Rd., Braintree, MA 02184

## **St. Catherine of Alexandria Church/Offices Facilities Assessment**

### **EXECUTIVE SUMMARY**

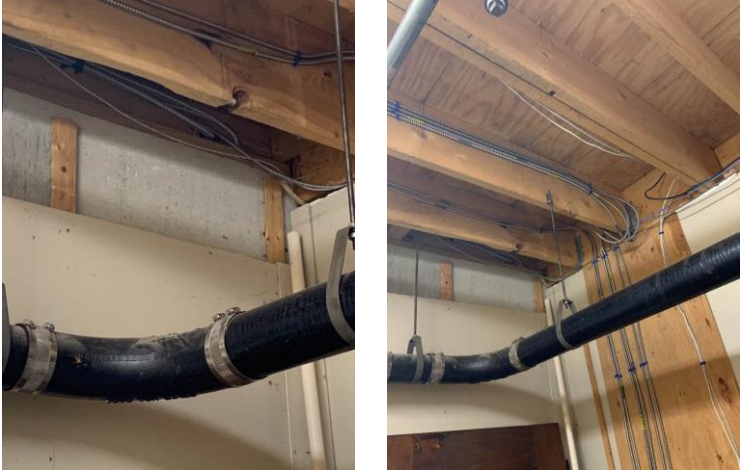
<b>Foundation Description</b>	<p>Foundation is poured concrete and appears to be acceptable in areas that are visible. No visible indications of bulging, cracking or other deformities or concerns.</p> <p>Note photos below of first floor, truss framing, bottom section of trusses on either end are unsupported. Examples are noted in the red circles. While this has been the situation since it was built it is strongly recommended assessment by structural engineer.</p> <p>These trusses are in an area approximately 20 x 40 where the sprinkler pump system and electrical panels are in the basement. It should be confirmed the trusses in the remaining sections of the building are securely seated and supported from below. Typically, they would be sitting on the sill or some other type of perpendicular structural support from below.</p>
<b>Foundation Type</b>	Concrete
<b>Foundation Floor</b>	Slab on Grade

Budget for structural assessment of basement truss framing members, noted in photos, 1 to 18 months, \$9,200

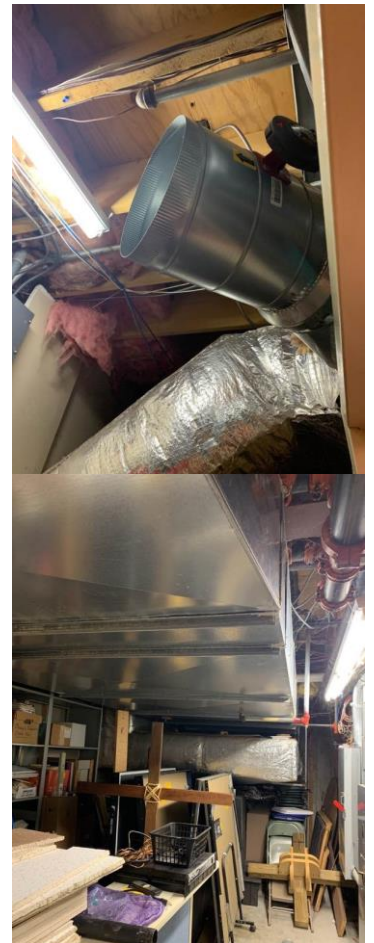
HVAC system seems to be in working order. There's been no indications from staff as to any problems.

Based on age of units, parish should start budgeting for replacement potentially at the five-year to ten-year mark.

Units are combination heating/cooling by Carrier. No boiler in the building.

Budget for replacement of heating/cooling units, 1-5 years, 6-10 years, \$90,000/unit

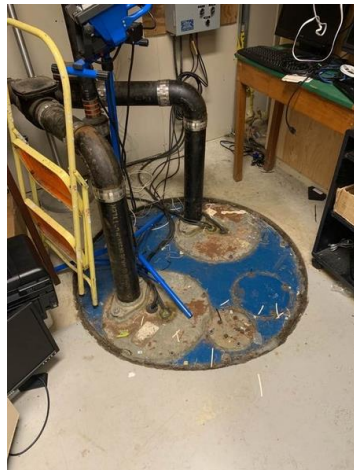
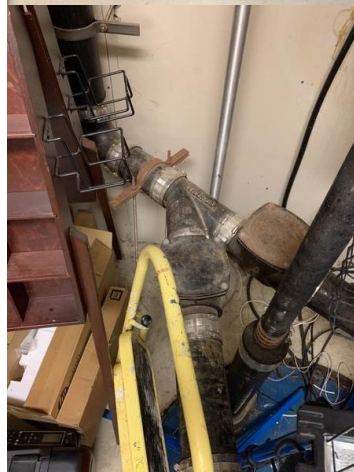
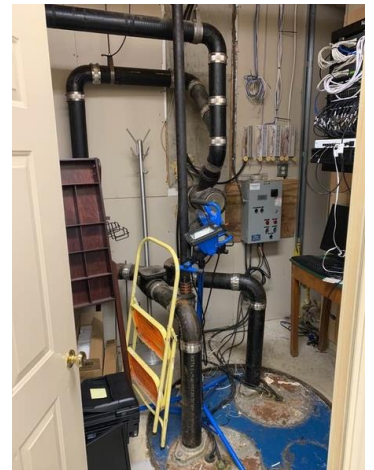
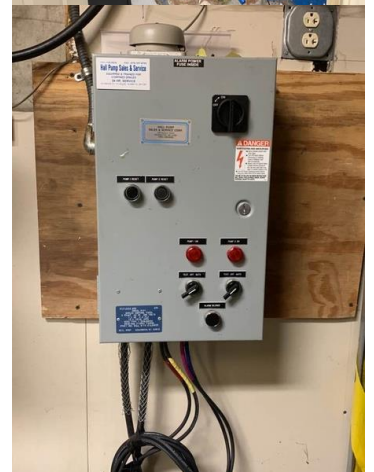
Plumbing systems appear to be operating as intended. There's no indication of issues with its performance.

All lines drain to an ejector pump in the basement which pumps out to a septic system and leaching field. System is on a regularly scheduled pump out.

Recommend pump inspection and assessment of remaining useful life.

Budget for replacement of sewer ejector pump, 6-10 years, \$11,500

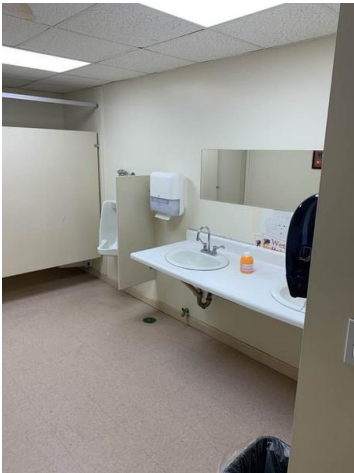
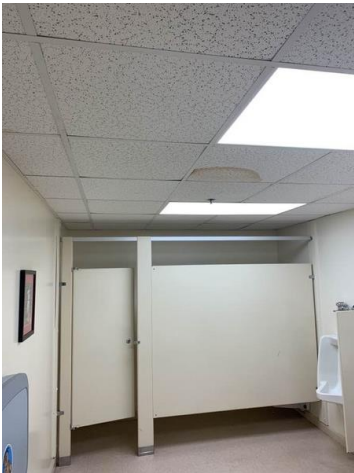
<b>Bathroom Assessment</b>	<p>Bathrooms in the building appear to be acceptable. Minimal maintenance required noted in the photos below.</p> <p>The main level bathrooms appear to be acceptable. Note photos below.</p>
<b>Bathroom Photos</b>

Budget for bathroom repairs as noted in photos, 1-5 years, \$4,200

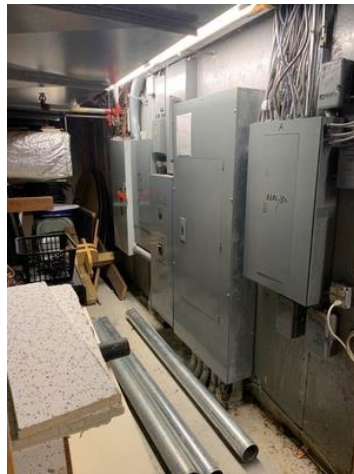
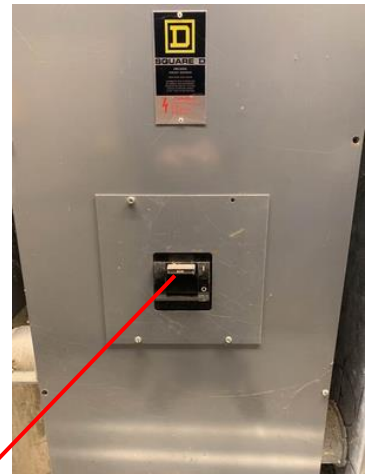
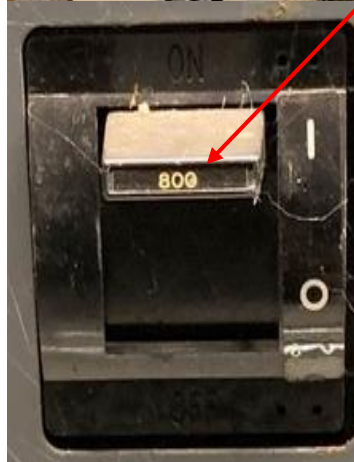
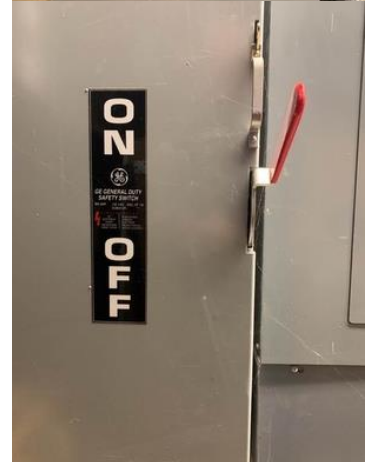
800 Amp electrical service appears to be adequate for the building. There's been no indication from staff as to performance issues or concerns.

Panels appear to be acceptable with no evidence of moisture or rusting.

Fire code requires all safety detector heads be replaced every 10 years.

Budget to replace smoke detector heads, 6-10 years, \$10,200

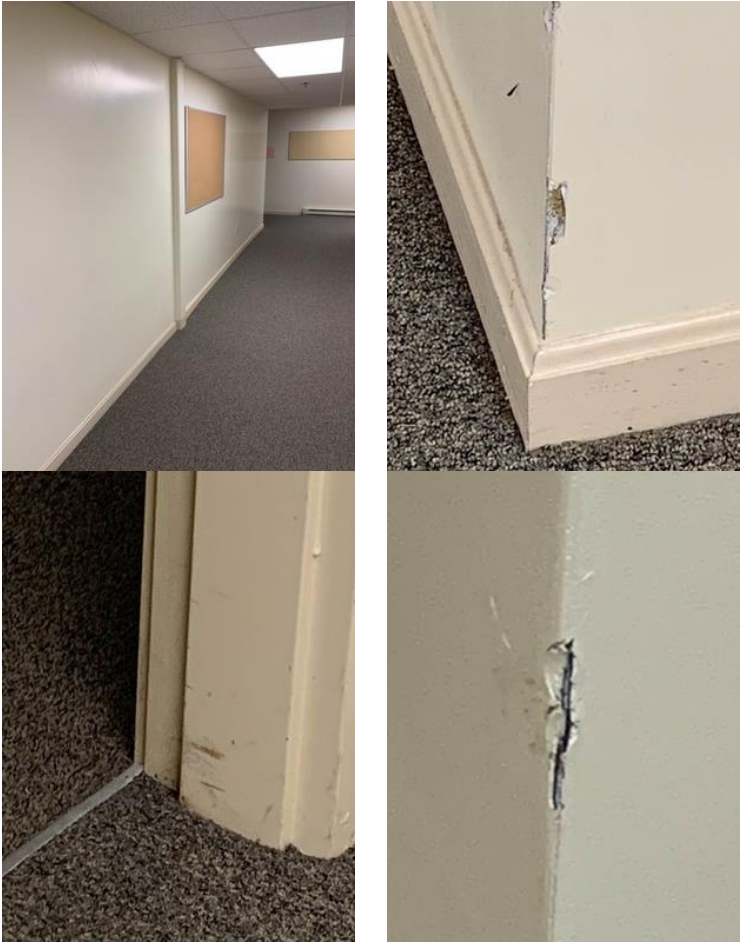
Walls appear to be acceptable, painted sheet rock.

Minor repairs required as noted in photos below.

Main level walls are combination of painted sheet rock and brick. Some areas have flat wood panel with trim accents, wainscoting as noted in photos below. All wall surfaces appear to be acceptable.

Upper room walls appear to be acceptable. Combination of wood, paneling, wainscoting, and painted sheet rock.

Church walls are acceptable with repair needed as noted in the photos below.

Wall behind door on the way to the basement needs repair last photo in the section.

Budget for minor wall and door repair, 1-5 years, \$4,800

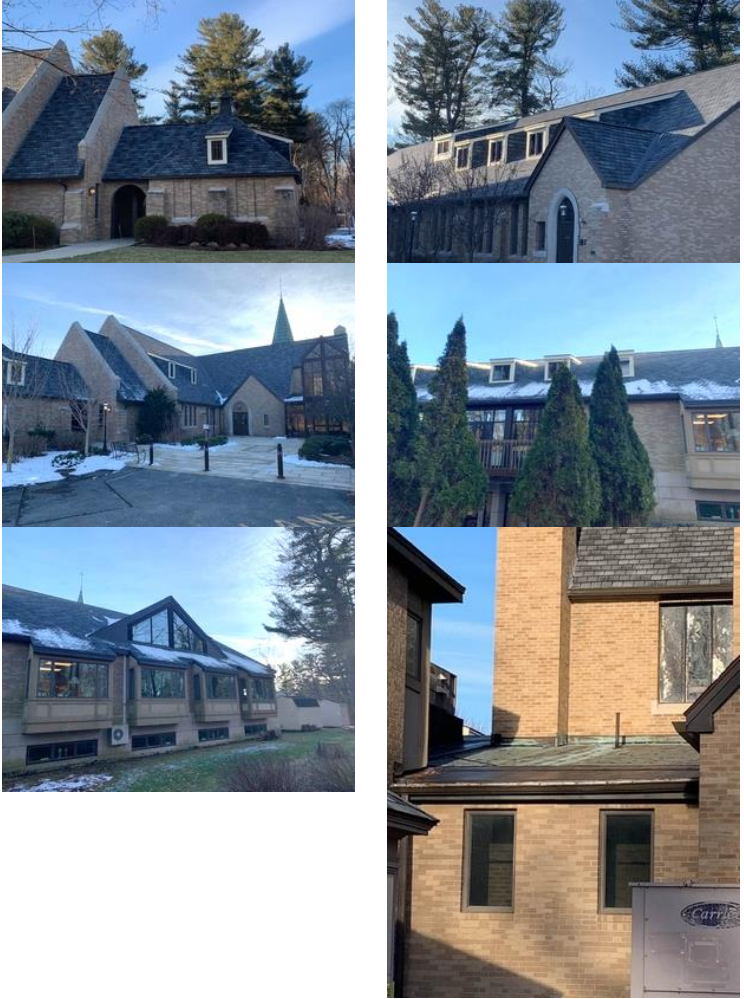
New roof was installed fall of 2022. Asphalt three tab.

Copper and rubber roof at rear should be inspected annually.

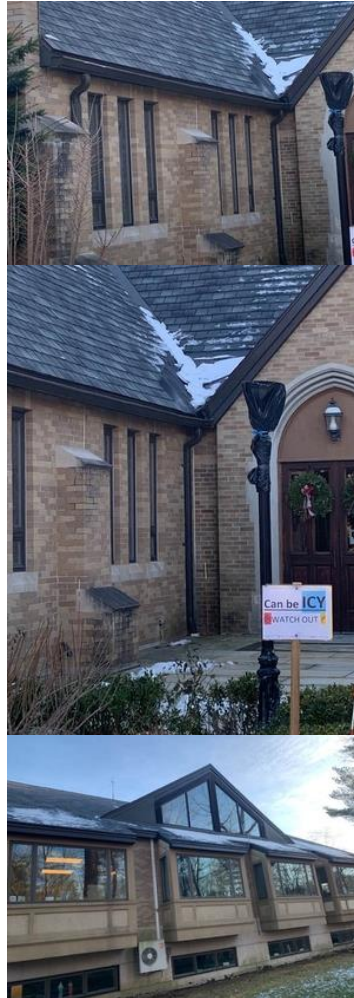
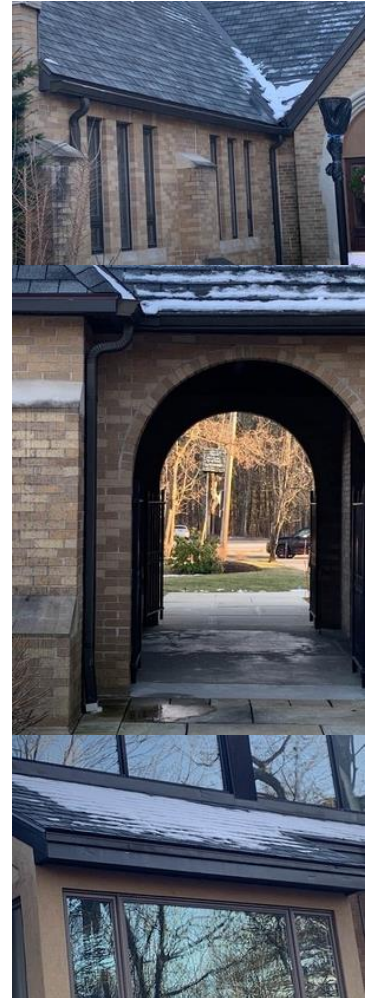
<b>Drainage Assessment</b>	<p>It appears that the roofing company had made some minor repairs resealing rolling gutters.</p> <p>Gutters should be maintained annually.</p>
<b>Drainage</b>	Gutters Aluminum
<b>Drainage Downspouts</b>	Aluminum

Budget for repair and maintenance of gutters, 1-5 years, \$3,500; 6-10 years, \$3,500

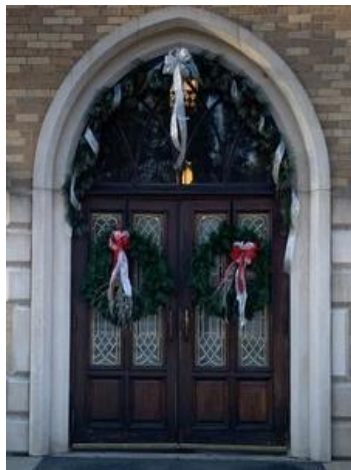
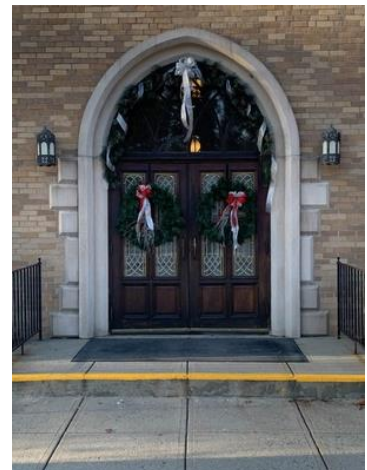
There is minor masonry repair required on all elevations of the building. These will be noted in sections and photos below.

Budget for masonry repointing/repair and precast restoration, all elevations, 1-5 years, \$80,000

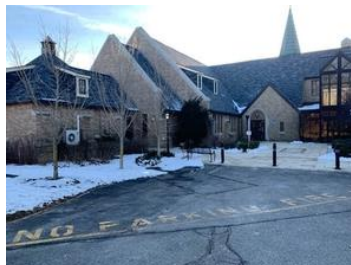
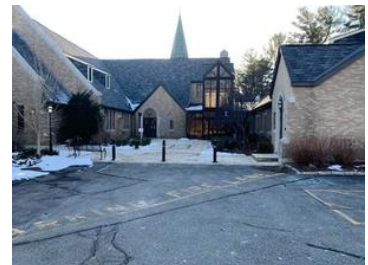
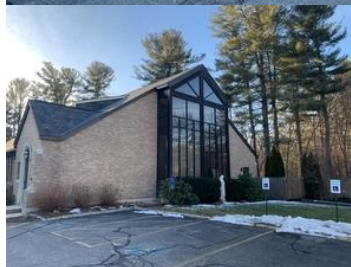
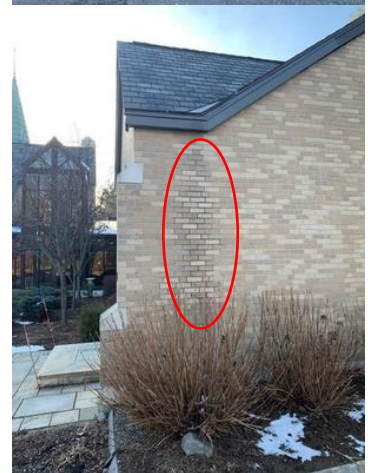
Exterior right wall appears to be acceptable with minor repair required.

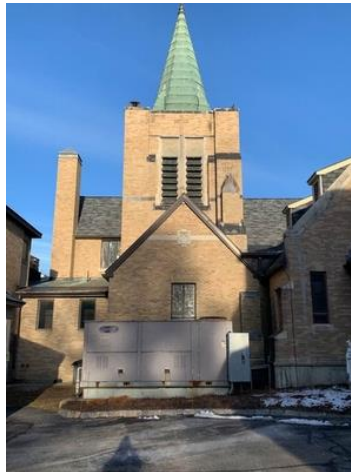
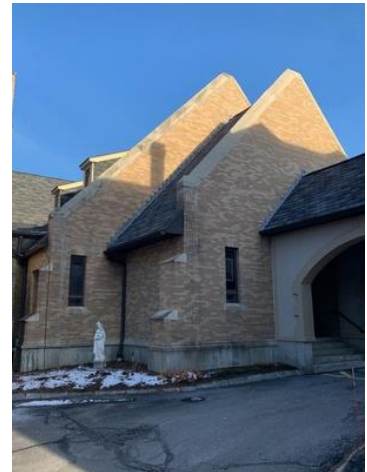
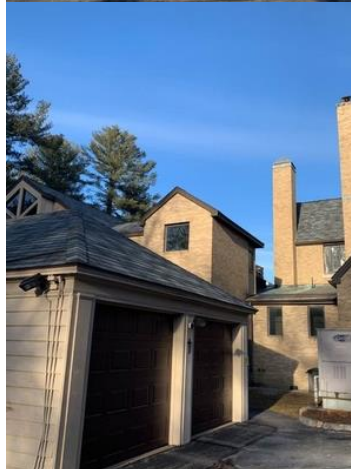
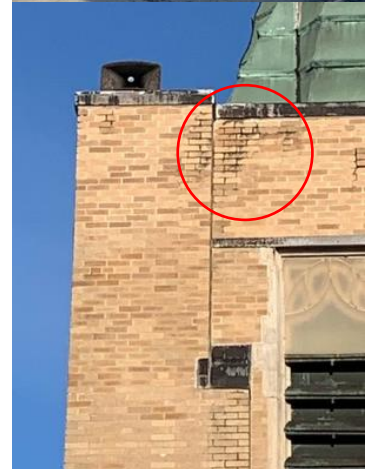
Exterior left side appears to be acceptable with some repointing required as noted in the photos below.

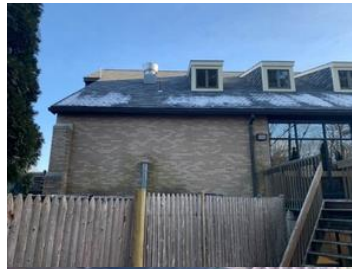
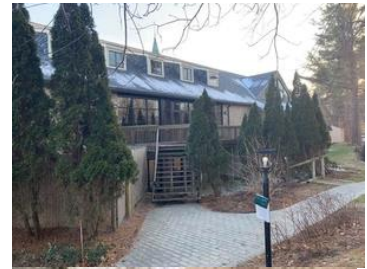
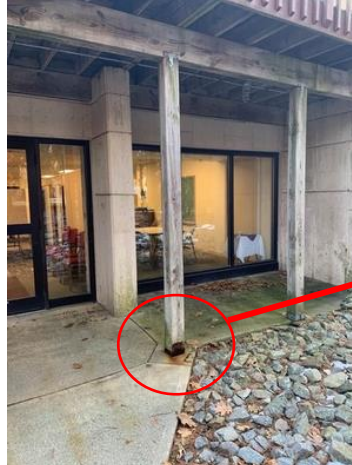
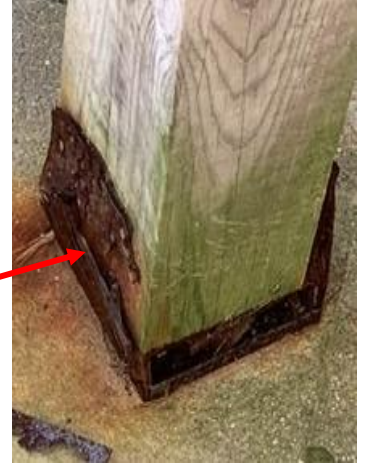
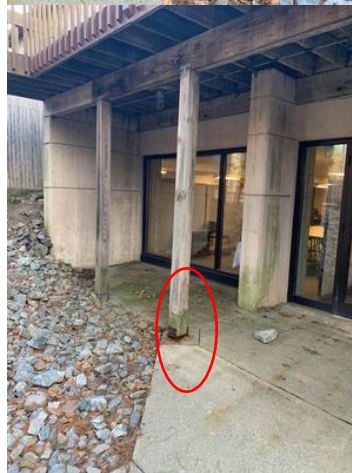
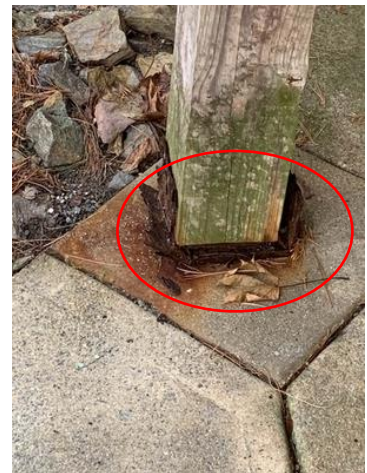
Replace post bases of rear deck is noted in photos below.

Rear elevation appears to be acceptable in terms of masonry condition.

Budget for replacement of deck post bases at rear elevation, 1-18 months, \$1,800

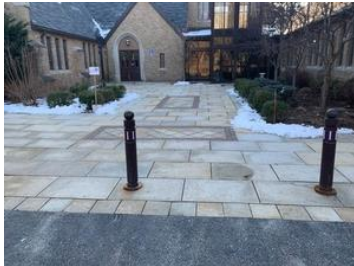
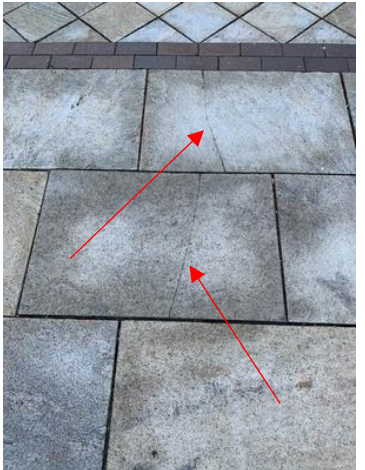
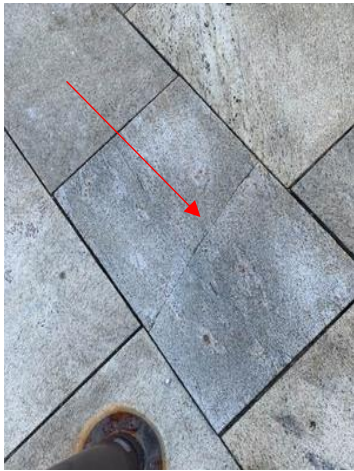
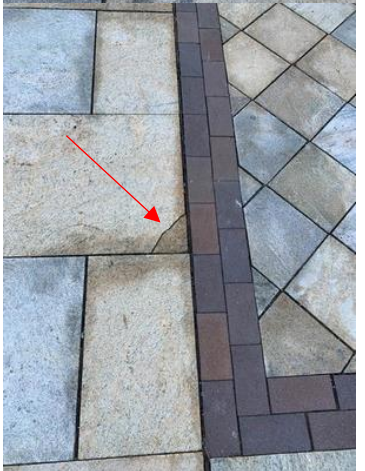
<b>Walkways</b>	Flat, slight incline, stairs, stamped concrete, other, in field repair needed
<b>Walkway Photos</b>

Budget for concrete walkway repair, 1-18 months, \$1,800
