St. Catherine of Alexandria Rectory
109 North Main St.
Westford, MA 01886
Winter 2023
Prepared for Reverend Peter F. Quinn, Reverend Joseph M. Rossi

Prepared by Office of Property Management
Archdiocese of Boston
66 Brooks Rd., Braintree, MA 02184

St. Catherine of Alexandria Rectory, Facilities Assessment

EXECUTIVE SUMMARY

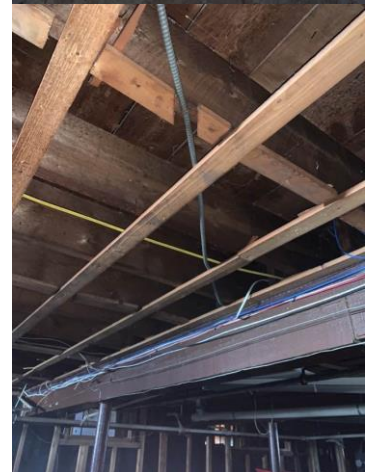
Lolly columns and timber support dimensional lumber deck.

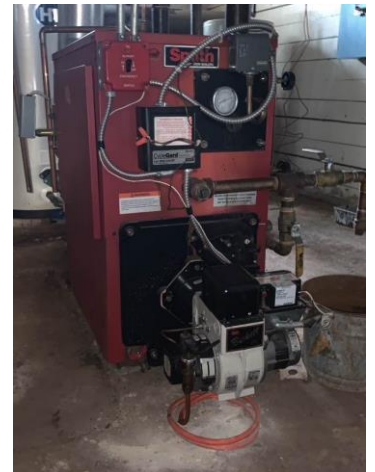
Heat is provided by oil fired boiler

Recommend sealing seams of smoke pipe.

Boiler should be maintained annually.

Budget for sealing of smoke pipe, 1-18months, \$225

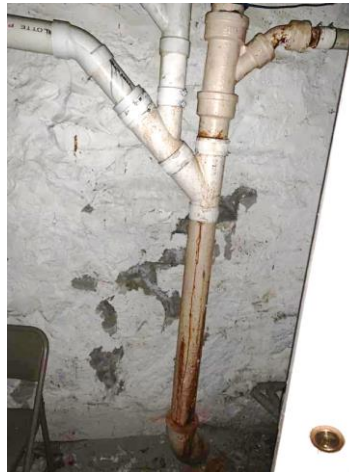
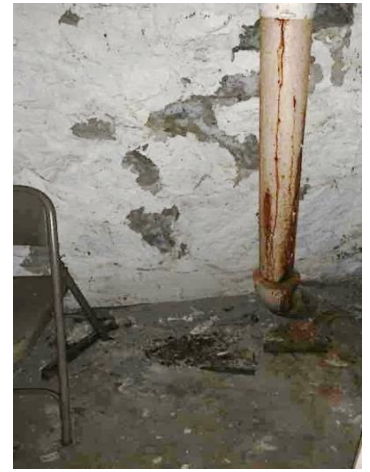
Cast iron drains in the basement have begun to stain/weep. Cast iron will deteriorate/corrode, from the inside out. Recommend a plumbing contractor assess current condition. And establish a timeline for replacement. A budget number will be provided in the six-to-10-year time frame.

Cast iron is beginning to stain/weep.

Budget for replacement of cast iron drains with PVC, 6-10 years, \$3,800

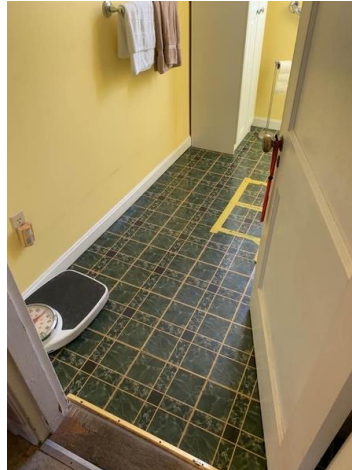
First floor bathroom needs repair as noted in photos below. Color of the walls are yellow.

Replace flooring

Budget for replacement of first floor bathroom floor, 1-18 months, \$1,200

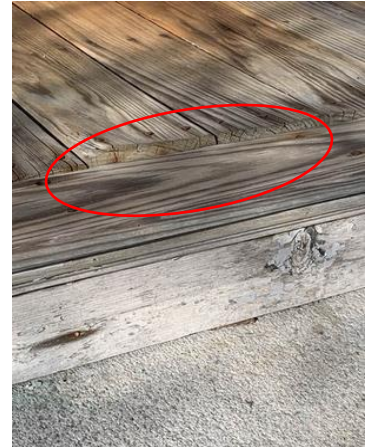
Trip hazard.

Budget for resetting pavers as needed in front walk, 1-18months, \$6,200

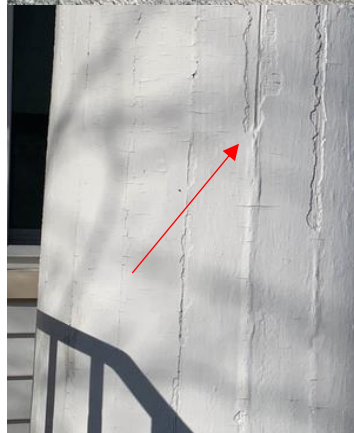
Multiple layers should be ground down.

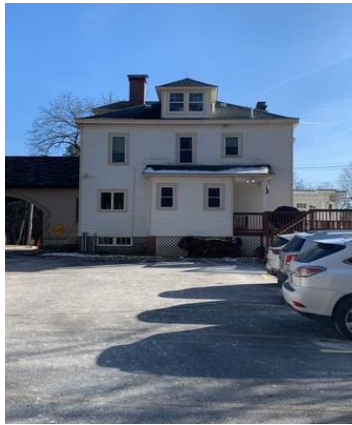
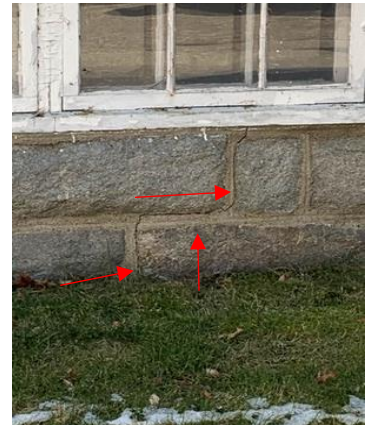
Example of repointing needed.

Budget for concrete and repointing repair to foundation and bulkhead area, 1-5 years \$9,300

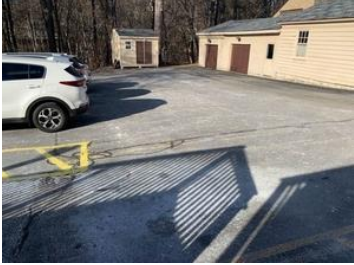
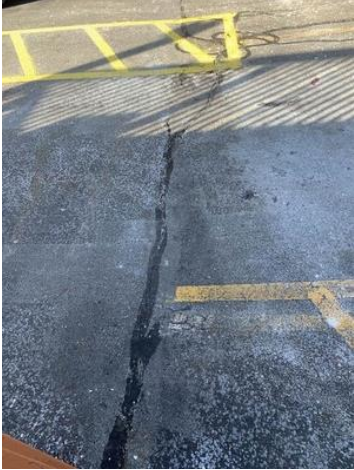
Grounds Assessment	<p>Rear parking area appears to be acceptable with some crack sealing required would suggest sealing and striping, in six to ten years.</p>
Landscaping Photos

Budget for sealing and striping parking area, 6-10 years, \$7800
