St. Anne's Church/Hall/Offices, Littleton, MA, Facilities Assessment

May 2022, Facility Assessment

Prepared by Office of Property Management

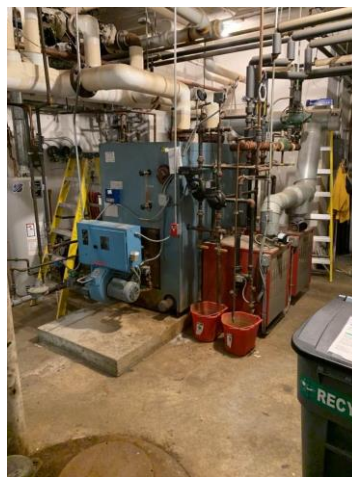
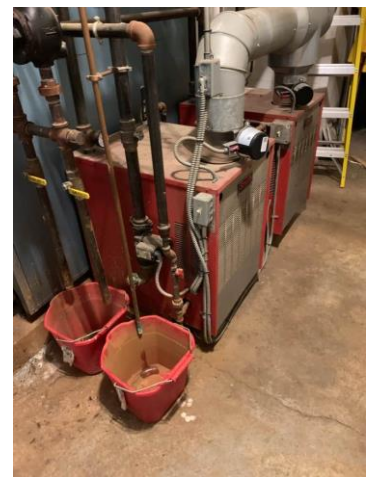
Heating for the church is gas-fired, steam boiler. Heating for the rectory appears to be a gas fired steam boiler

There appears to be staining on the hall ceiling and in the women's handicap bathroom of the lower level that could be from sweating of either steam or condensate pipe. Should be inspected, remediated, two tiles replaced.

Recommend inspection of all rusted fittings as noted in photos below.

Plan for rectory boiler replacement 8-10 years.

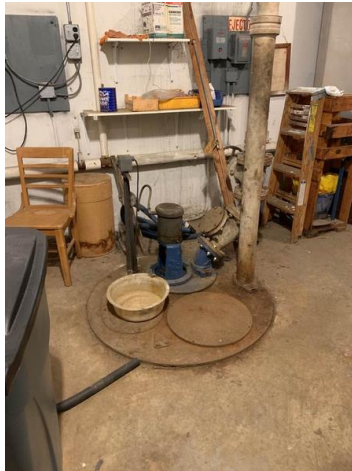
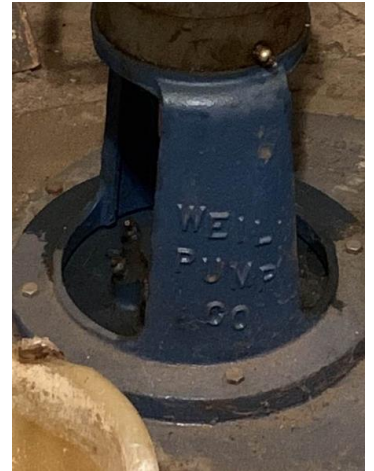
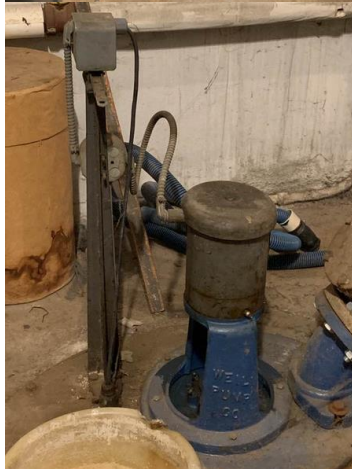
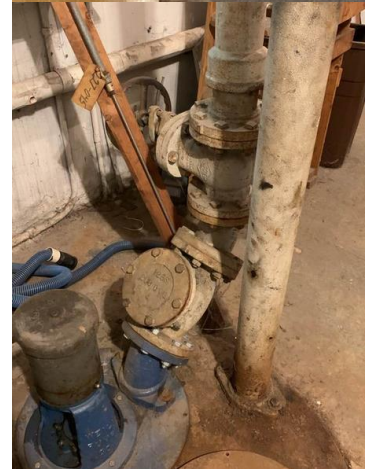
Interior drainage appears to be original to the building consisting of all cast-iron components.

Staff is indicated a section that has been compromised with serious corrosion and weeping, scheduled to be replaced.

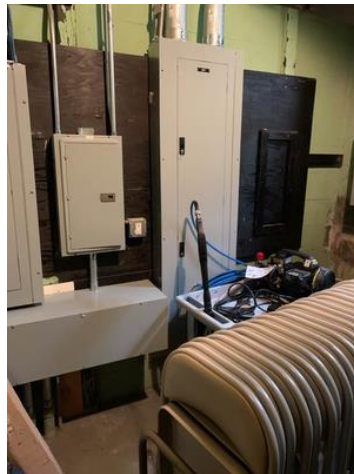
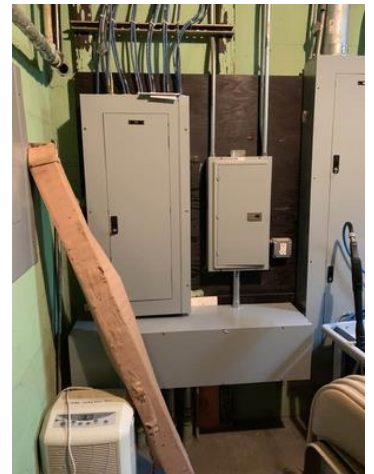
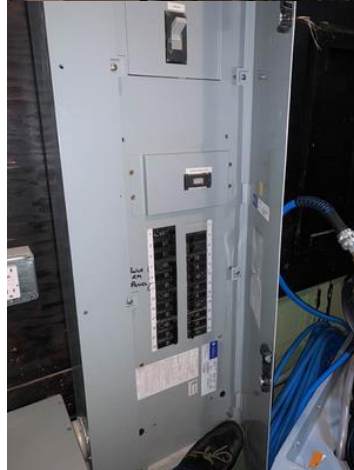
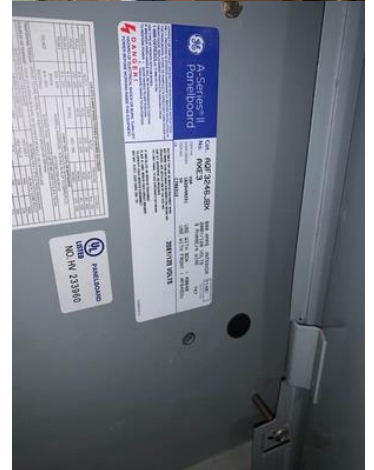
Electrical service appears to be acceptable with no indication of water penetration, weeping or rusting.

Buildings have a combination of LED and compact fluorescent lighting. Recommend eventual installation of all LEDs as needed.

Plate all uncovered switches, outlets, and junction boxes.

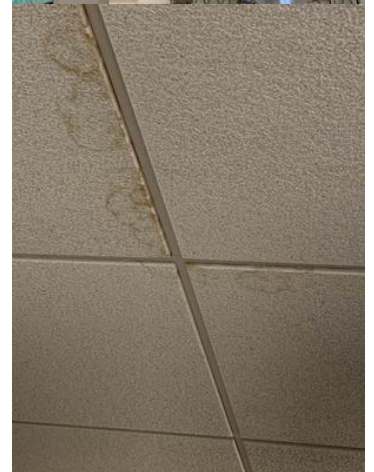
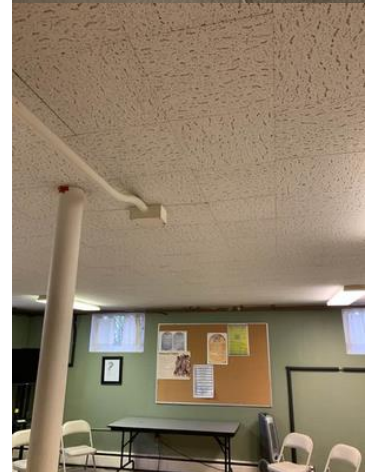
Ceiling Assessment	<p>Ceilings throughout the lower level are suspended tile. All appear to be acceptable except for tiles that appear to be stained by condensation dripping from the steam or condensate lines. Note photos below.</p> <p>Ceilings in the lower level beneath the rectory appear to be acceptable. It's a combination of large, suspended ceiling tiles with integrated lighting and acoustic tile on strapping.</p> <p>Some acoustic tile has let go from strapping above as noted in photo below the repair could be attempted or eventually replace ceiling in 5 to 10 years depending upon how it ages.</p>

Ceiling in the church crying room may need to be replaced in the 5 to 10 year. Depending upon wear and how it performs. It appears to have some sags in it currently.

Ceiling of the chapel off the altar had been damaged from what appears to be a prior leak. Have been told that leak has been remediated, ceiling will eventually have to be repaired. It is possible that the acoustic tile won't be matched and perhaps a ceiling of blueboard and plaster veneer will be quoted.

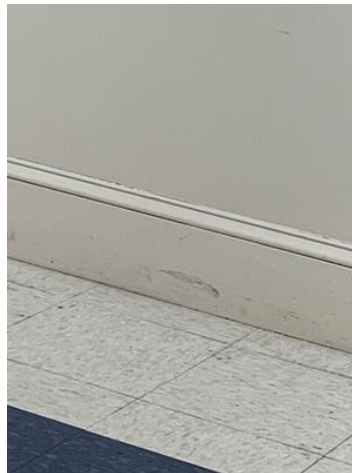
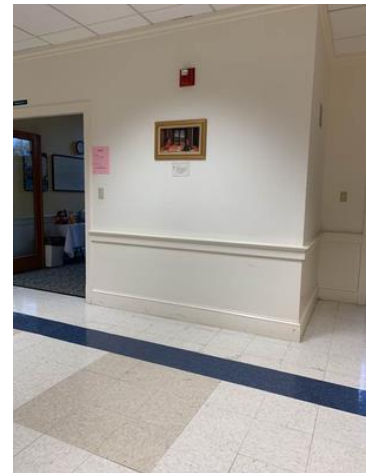
Lower-level walls appear to be acceptable and are a combination of painted wood paneling, drywall, and tile as a tall wainscoting in the bathrooms. Would recommend touchup painting of trim, one to five-year period. This is strictly for aesthetics and it's possible the trim could be washed, and painting could be put off.

Wash or paint

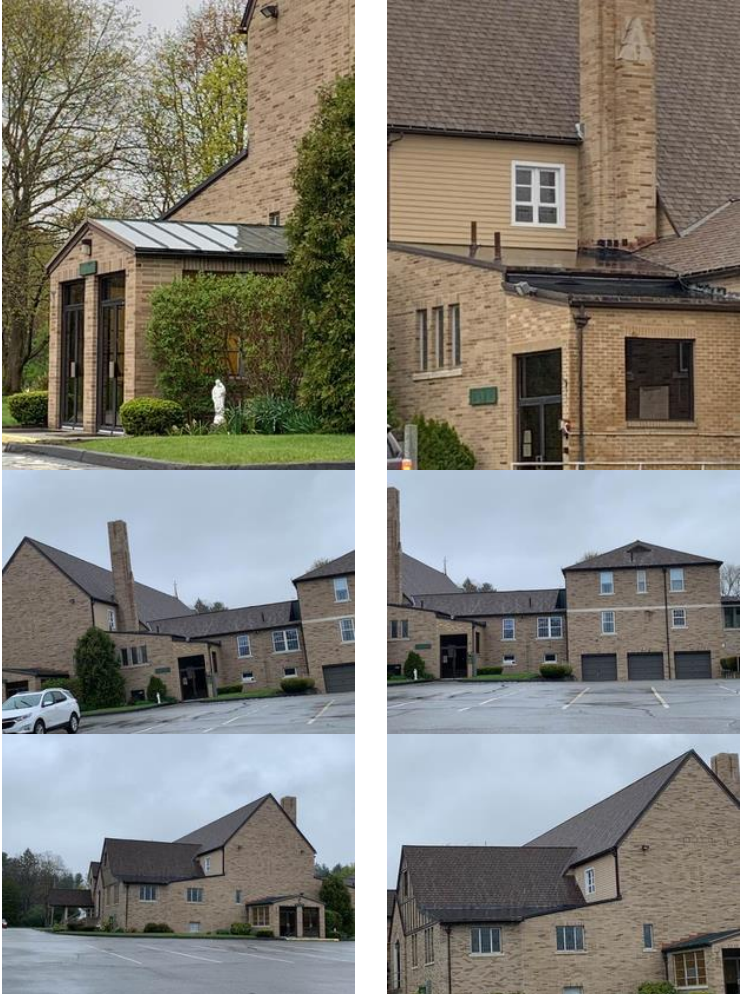
Roof Assessment	<p>Roof appears to be acceptable. There are no missing shingles in field visible from grade. Shallow pitches covered with rubber. Would recommend inspection by roofing contractor for annual maintenance.</p>
Roof Coverage	Architectural, Rubber
Roof Photo

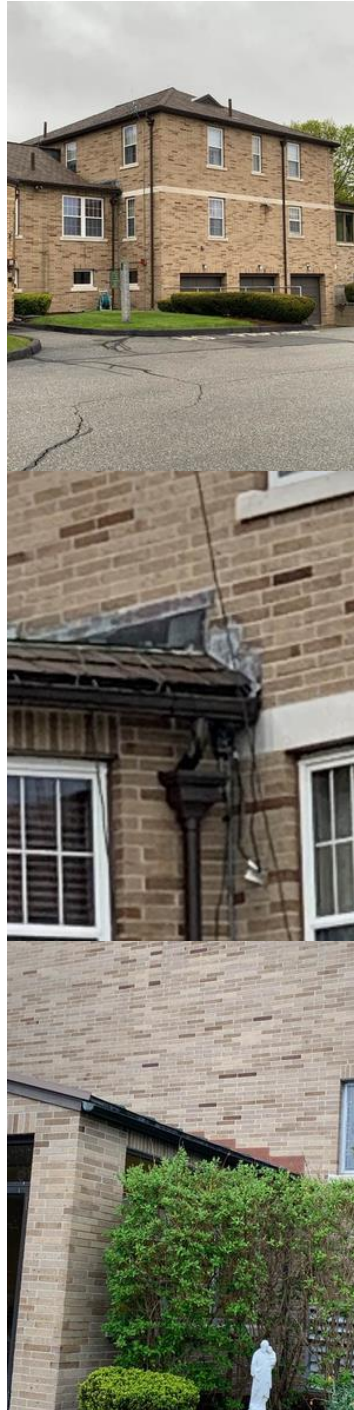
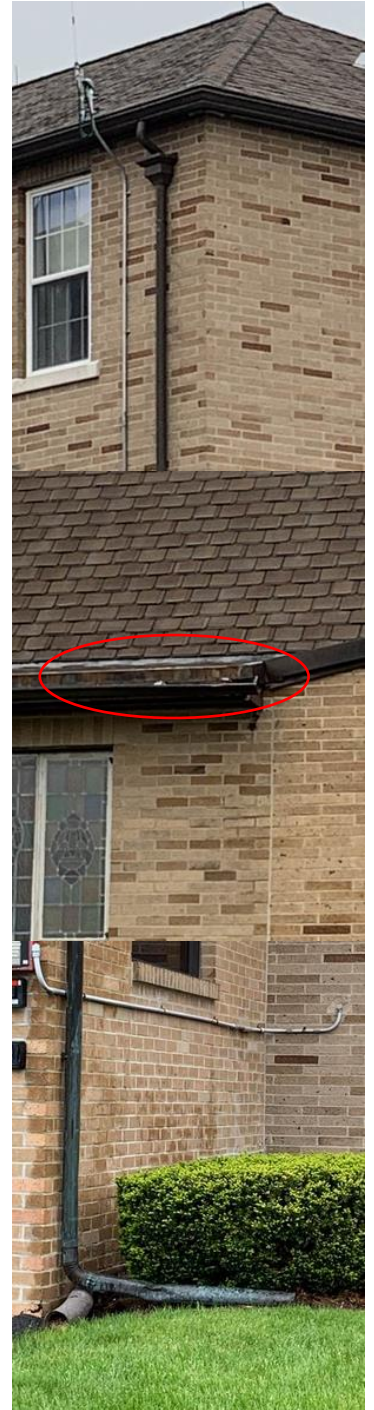
Drainage appears to be in acceptable condition. No staining on the exterior elevations. Appears to be a combination of aluminum gutters and downspouts with some copper downspouts and what appears to be galvanized metal.

Storm heads at the top of the downspouts. Would recommend inspection of gutter system as there is some areas that need to be addressed and will be noted in photos below.

Budget for gutter cleaning and miscellaneous repair, 1-18 months, \$525

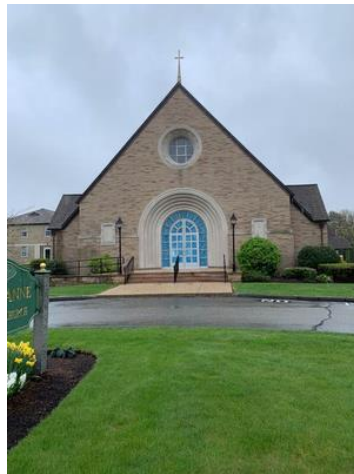
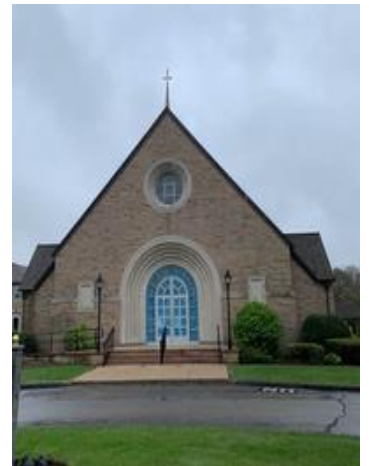
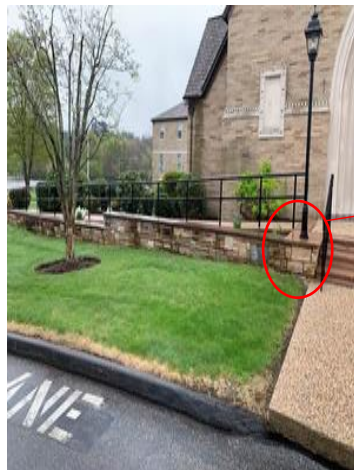
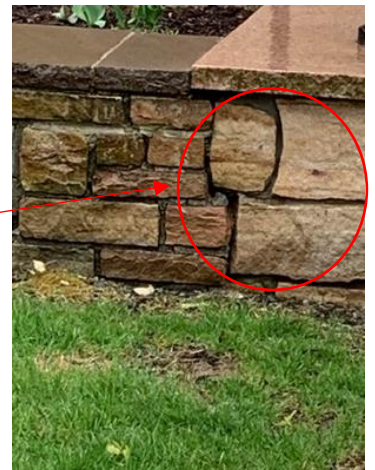
Front elevation appears to be in acceptable condition with minor repair required. Note photos below.

The retaining wall of the ramp should be addressed soon for the degradation from water penetration and freeze/thaw cycle will compound damage and repair cost. Note photos below.

Pointing needed

Budget for masonry repair of ramp, 1- 18 months, \$15,000

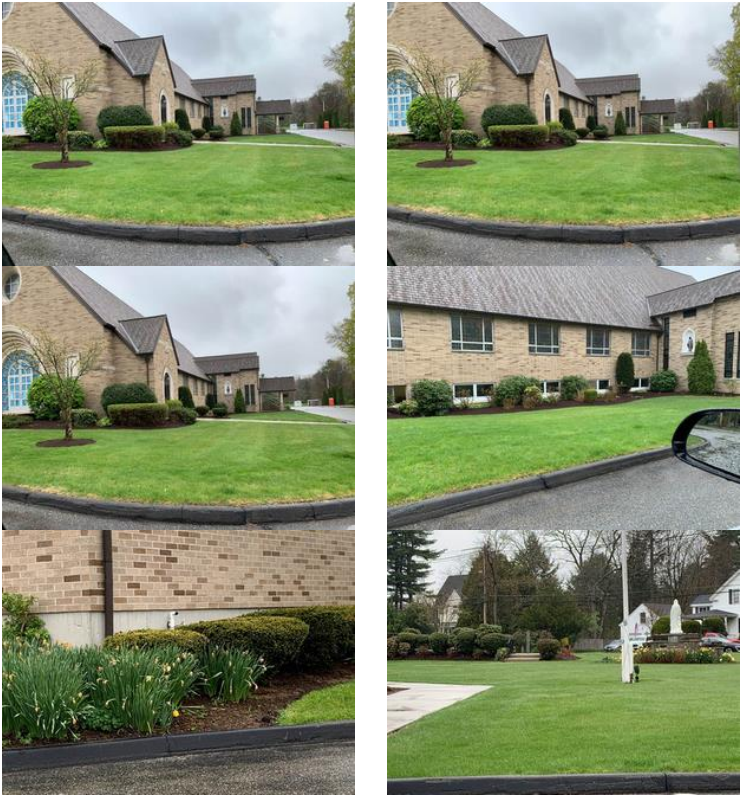
Grounds Assessment	<p>Overall, grounds are in acceptable condition, well-maintained and cared for. Cut back shrubs/bushes minimum 18 inches from the building.</p> <p>Parking lot appears to be in acceptable condition. Would recommend annual inspection for cracking and crack sealing as required. All striping and markings are clearly visible.</p> <p>Church walkways all appear to be acceptable with minor repair required as noted in photos below.</p>
Landscaping	<p>Mature Shrubs, Mature Trees, Mulched, Bark, Flower beds, Plantings, Grass, Cut Back From Building</p>
Landscaping Photos

Budget for cutting back all shrubbery from brick elevations, 1-18 months, \$850
