## FIELD REPORT NO. 04

**Project:** St. Joseph Catholic Church

Structural, Envelope, & Restroom Renovation

**Project No.:** 018.011.00

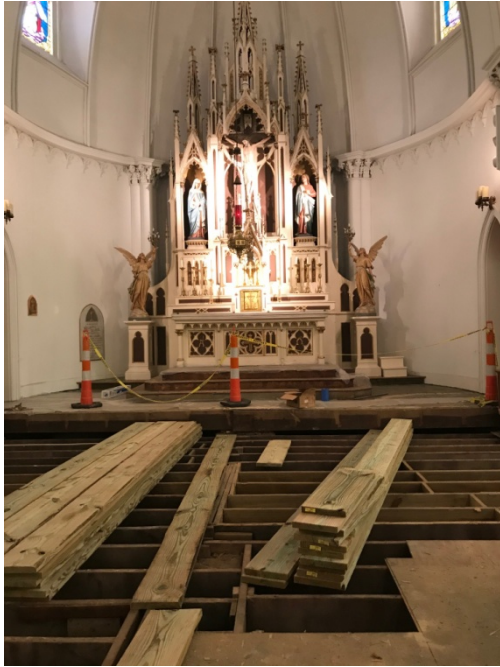
Image#1

View of sanctuary looking east showing flooring removed.

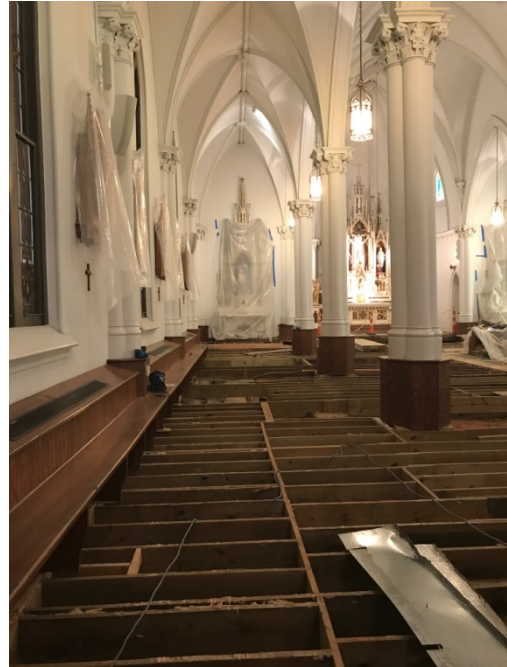
Image#2

View of sanctuary looking east showing flooring removed.

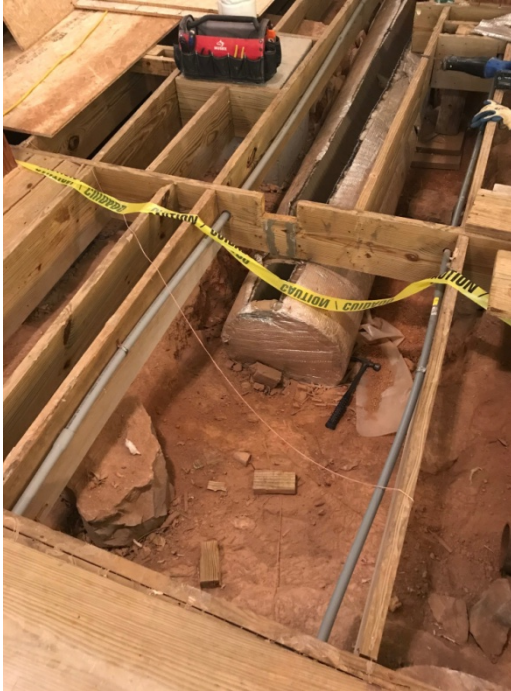
Image #5

View of ductwork piece that was installed but never connected to the main trunk line.

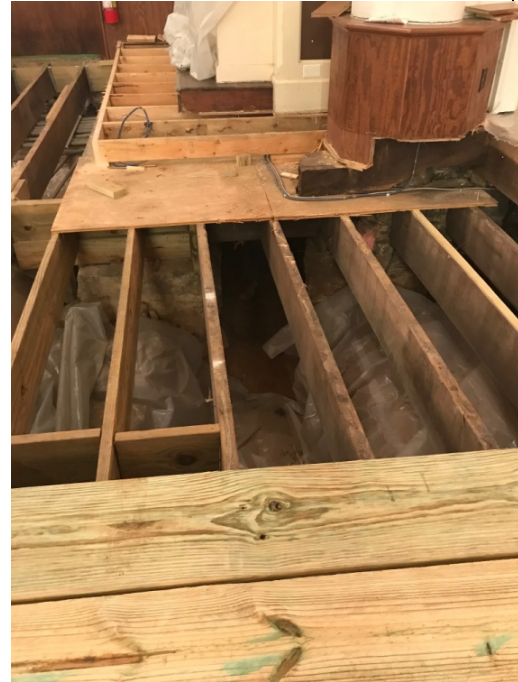
Image #6

View of new vapor barrier being installed,

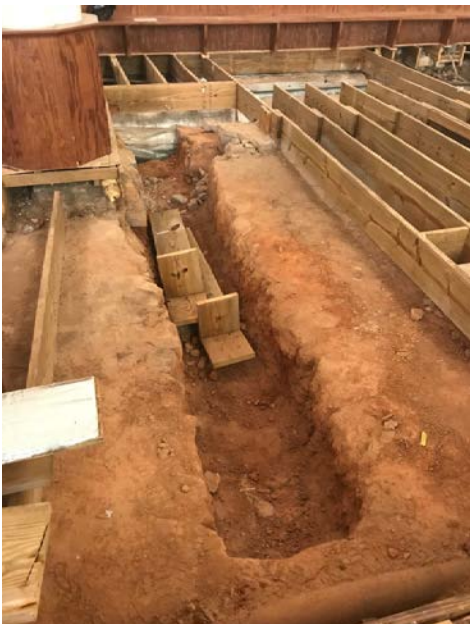
Image #7

View of where non-connected duct branch line was removed. Awaiting vapor barrier and floor joist installation.

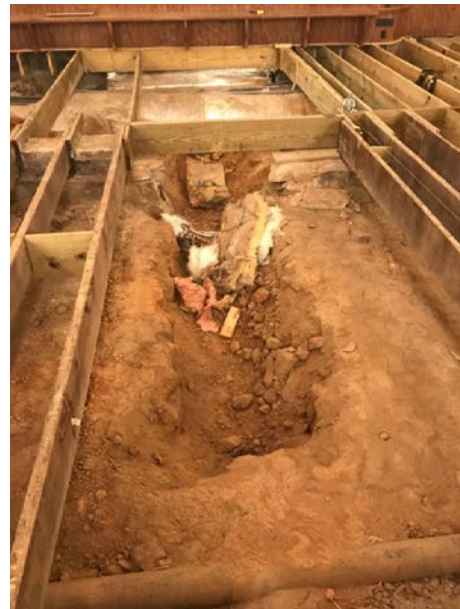
Image #8

View of where non-connected duct branch line was removed. Awaiting vapor barrier and floor joist installation.

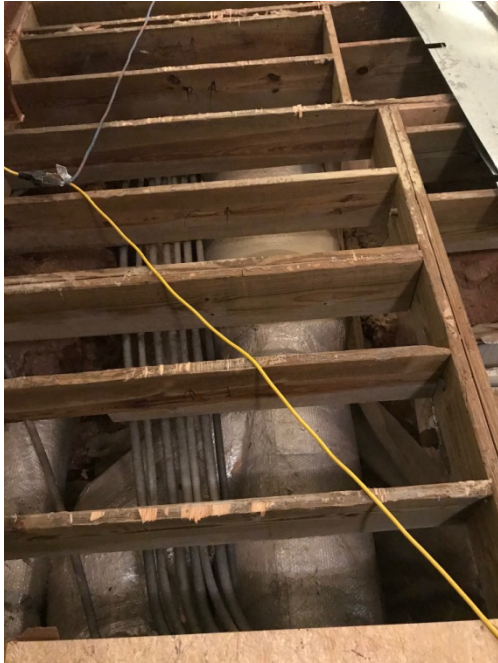
Image #9

View of floor framing, existing ductwork, and electrical conduit near base of stair to the balcony

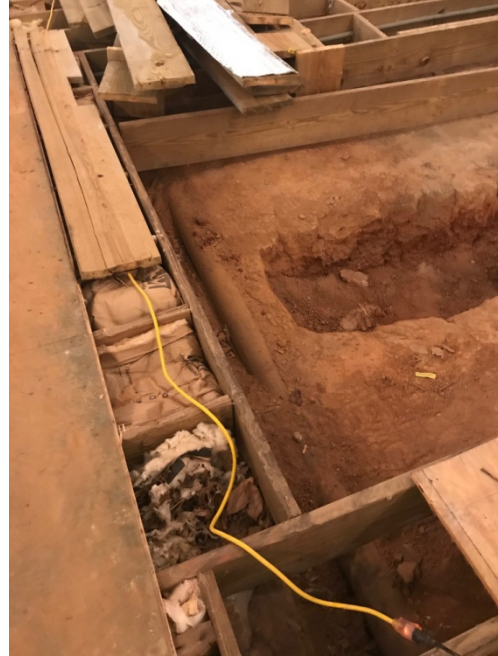
Image #10

View of where non-connected duct branch line was removed. Awaiting vapor barrier and floor joist installation.

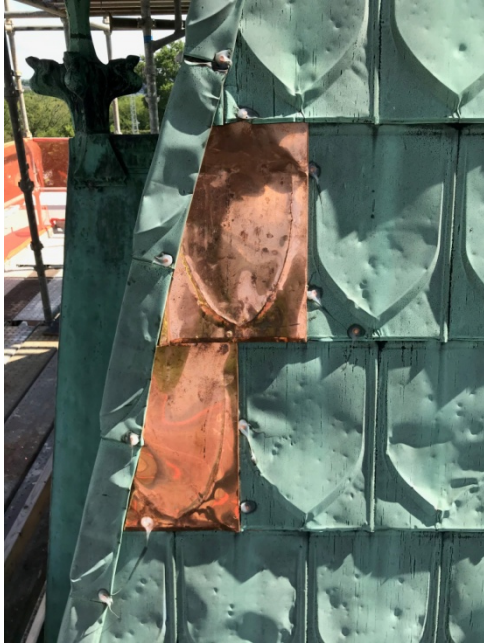
Image #13

New copper shingles installed to replace damaged ones removed.

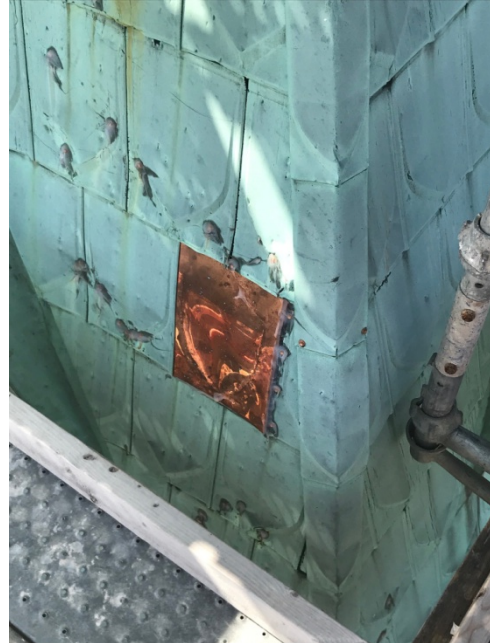
Image#14

New copper shingles installed to replace damaged ones removed.

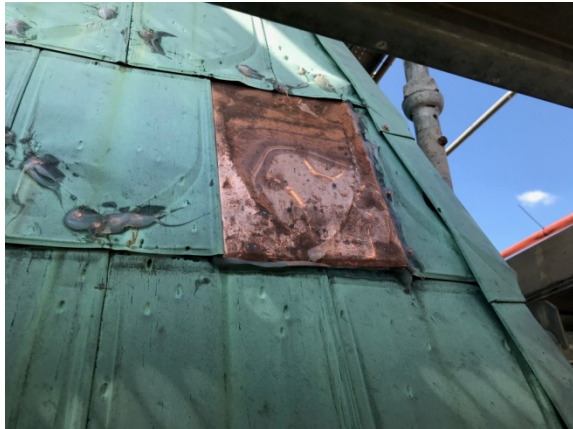
Image#15

New copper shingles installed to replace damaged ones removed.

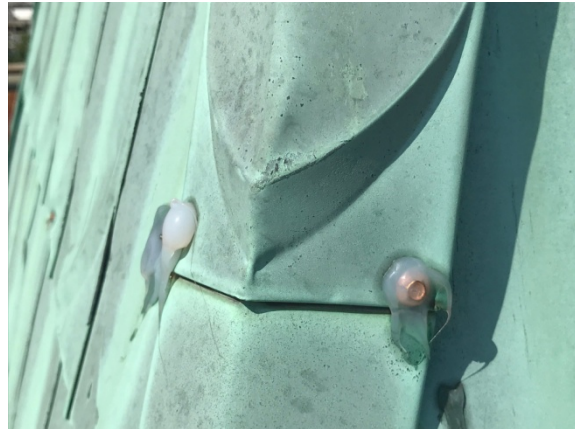
Image #16

New copper anchors installed and sealed to replace missing anchor screws.

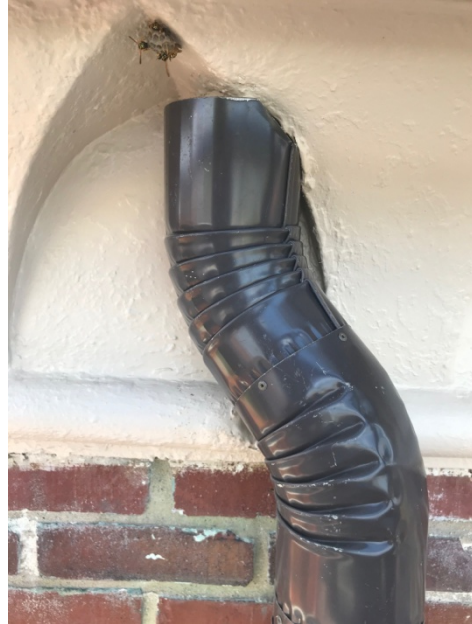
Image#18

New downspout installed where previous downspout was missing.

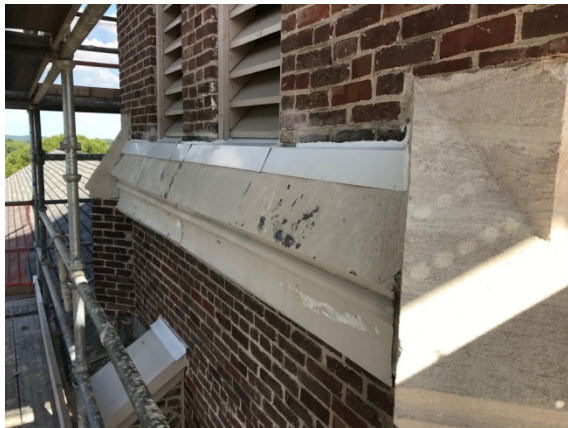
Image#27

View at base of tower louvers with new flashing installed and overlapping onto existing metal base trim profile.

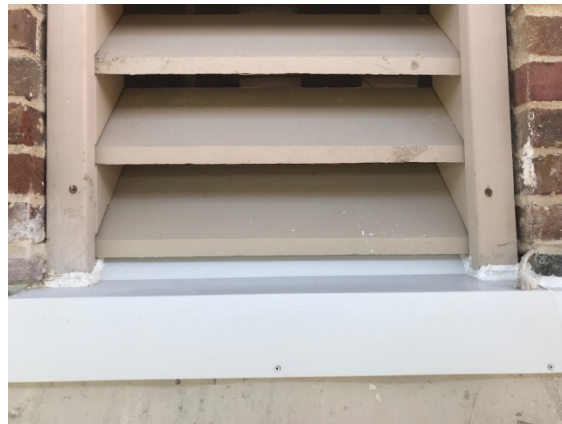
Image#28

Detail view at base of tower louver with new flashing installed under louver base and overlapping onto existing metal base trim profile.

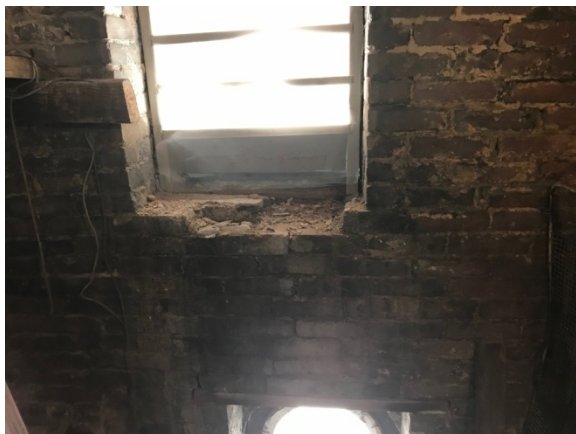
Image#31

View of existing masonry at bell tower louver base. Remove loose brick material

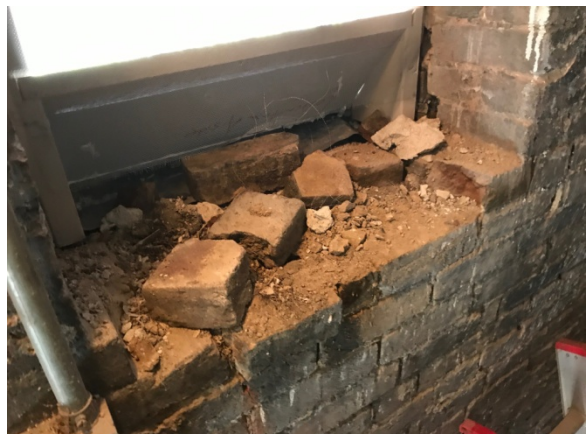
Image#32

View of existing masonry at bell tower louver base. Remove loose brick material and / or set in place with new mortar.

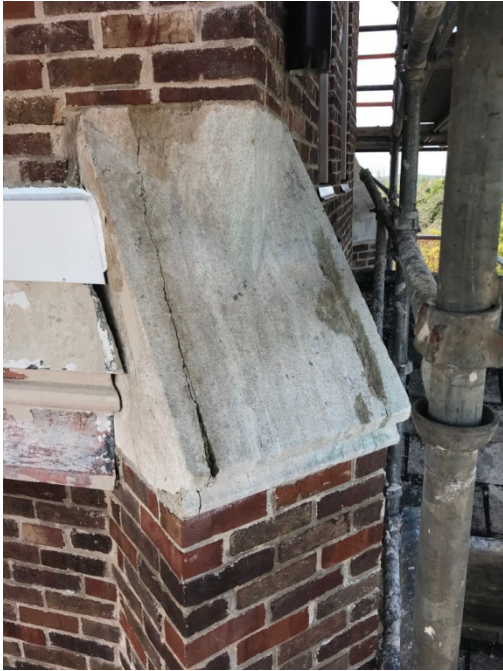
Image#33

Existing cracked stone cap top at corner tower buttress awaiting repair.

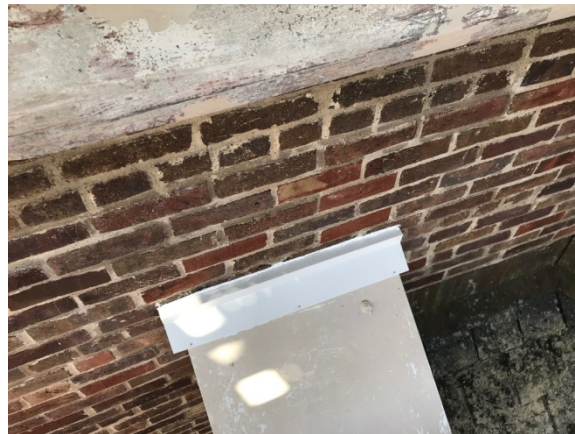
Image#36 New flashing installed at bell tower and front wall parapet cap.

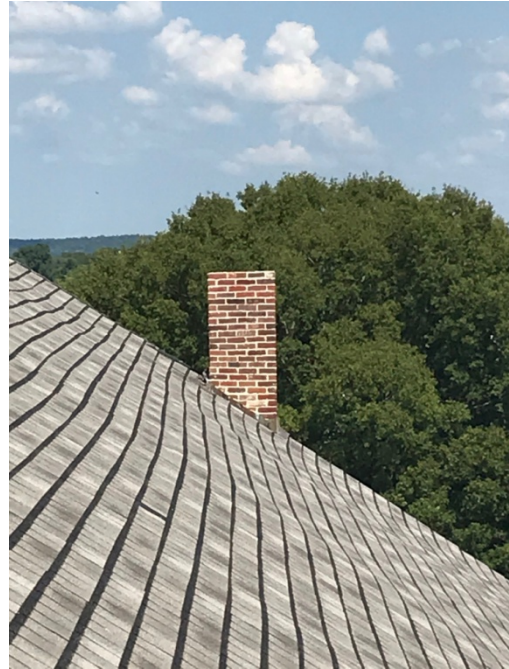
Image#38

South roof slope looking east with existing chimney beyond. New cap to be installed matching the existing

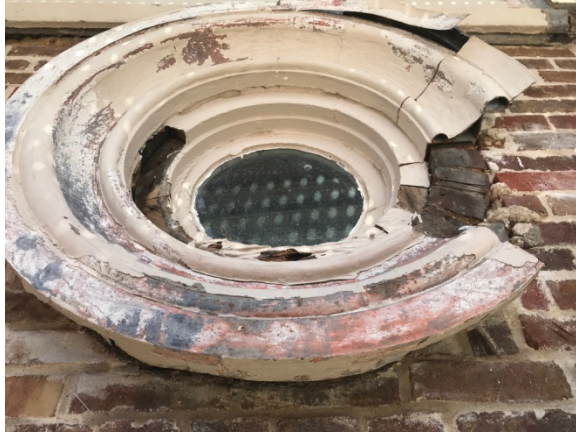
Image#41

Existing circular window at west (front) elevation awaiting repair.

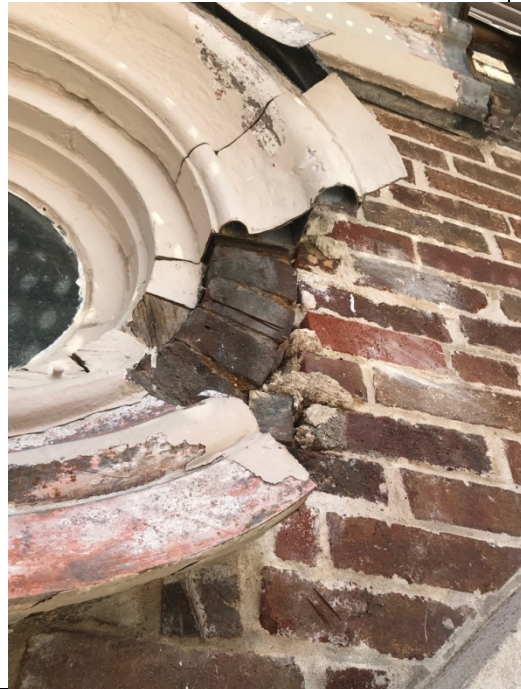
Image#42

Detail of existing circular window at west (front) elevation awaiting repair.

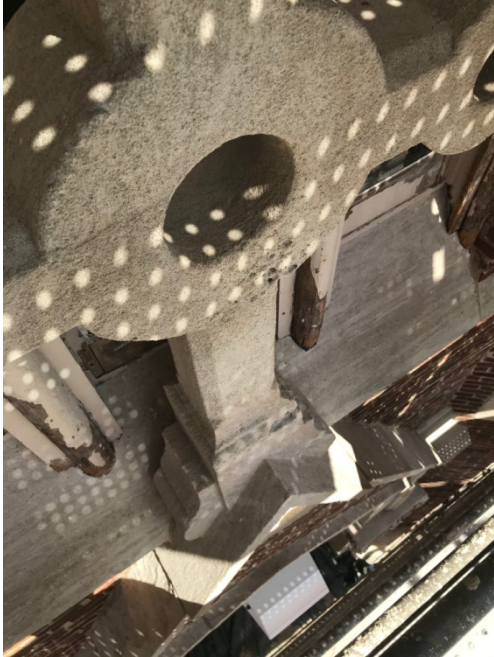
Image#49

Loose set stone cross has now been reset and secured in place with dowel rod & epoxy.

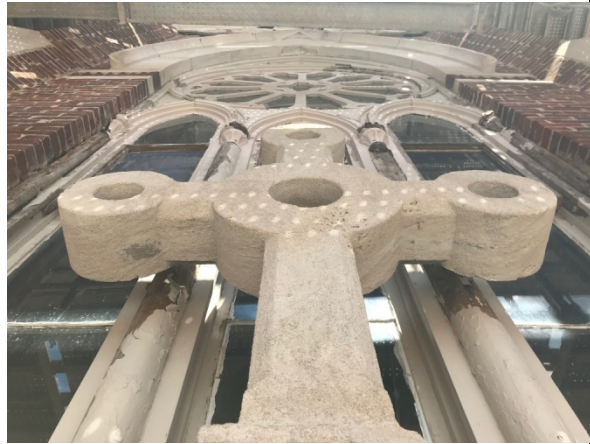
Image#50

Loose set stone cross has now been reset and secured in place with dowel rod & epoxy.

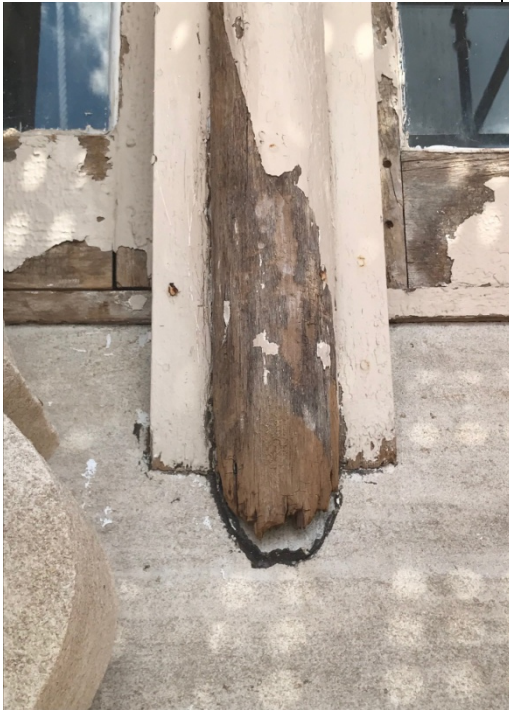
Image#53

Existing condition example of front facade window framing - center mullion.

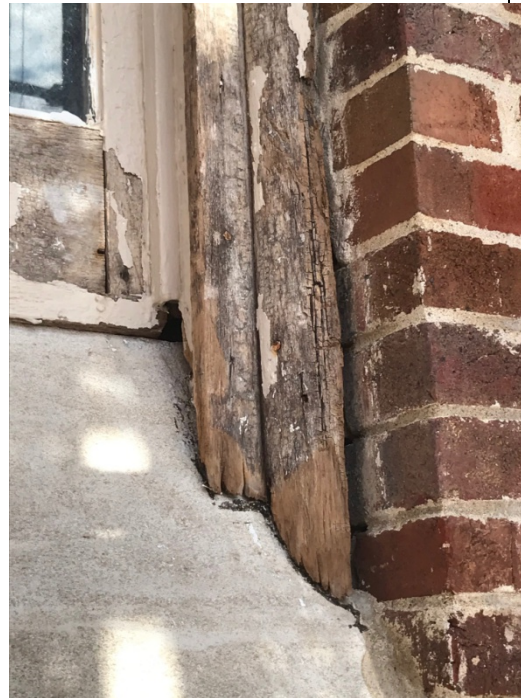
Image#54

Existing condition example of front facade window framing - jamb condition at brick masonry.

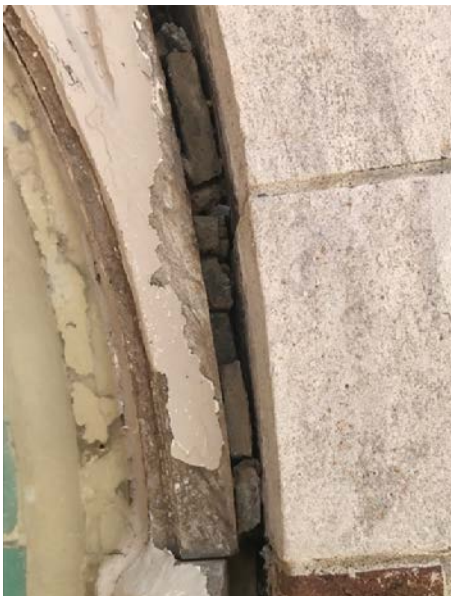
Image#55

View of existing loose joint material between window frame and stone arch.

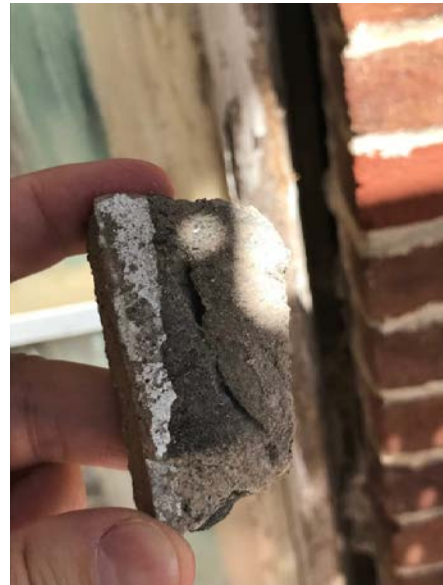
Image#56

Detail view of loose existing joint material.

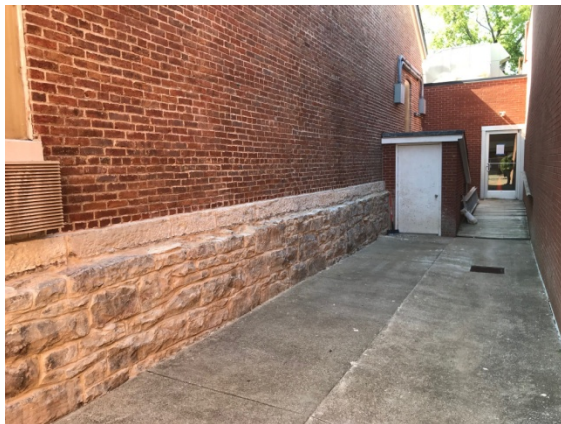
Image#63  
Completed masonry restoration on the east side of the church with the exception of the sloped stone water table to be installed at the foundation offset.

East facade - complete with the exception of installing stone foundation wall stone cap with sloped top for drainage.

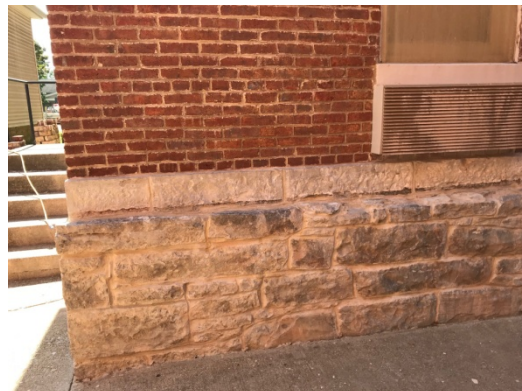
Image#64  
Detail view of masonry restoration on the east side of the church with the exception of the sloped stone water table to be installed at the foundation offset.
