FIELD REPORT NO. 05

Project: St. Joseph Catholic Church

Date: 16 September 2020

Structural, Envelope, & Restroom Renovation

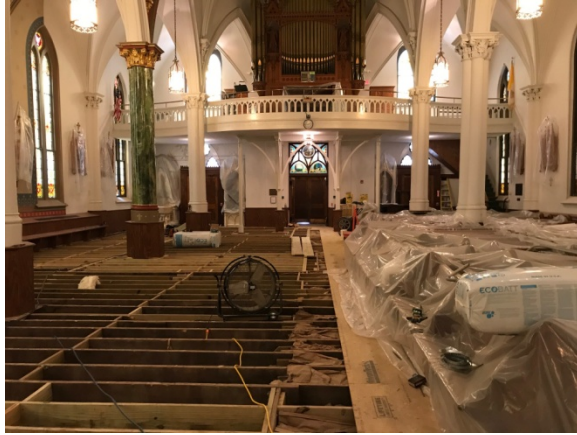
Image#1

View of sanctuary looking west showing flooring removed on the south side of the sanctuary.

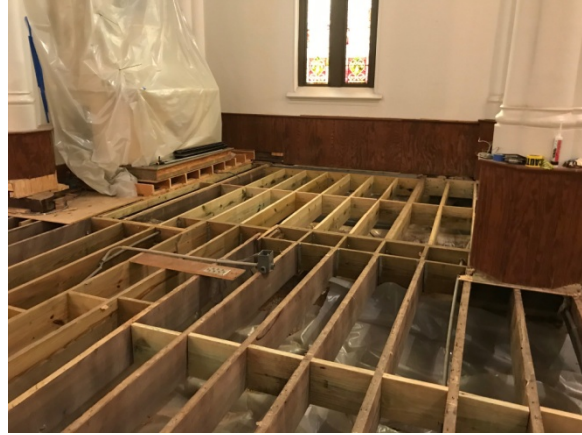
Image#2

View of sanctuary looking southeast showing flooring removed, joist repair, new vapor barrier.

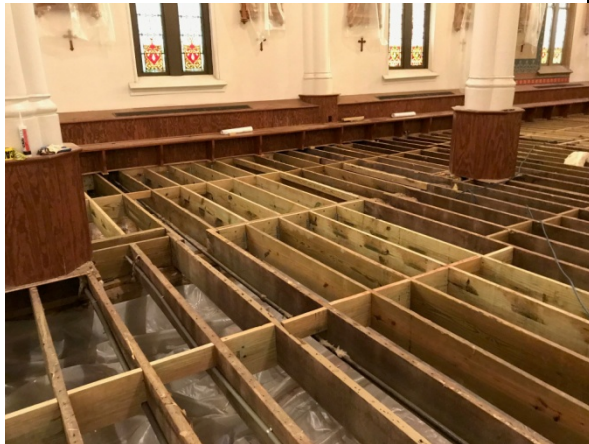
Image #3

View of sanctuary looking south showing flooring removed, joist repair, and new vapor barrier.

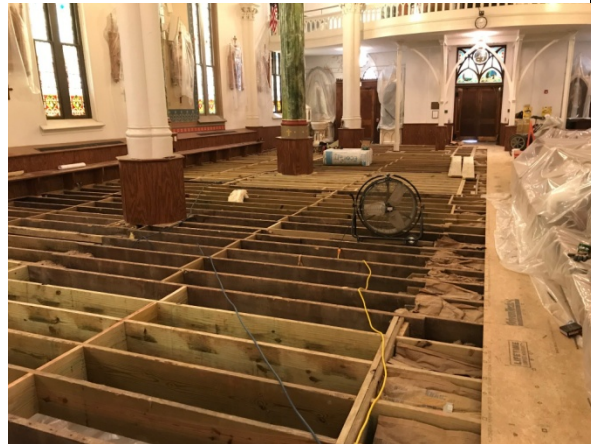
Image #4

View of sanctuary looking southwest showing flooring removed, joist repair, and new vapor barrier.

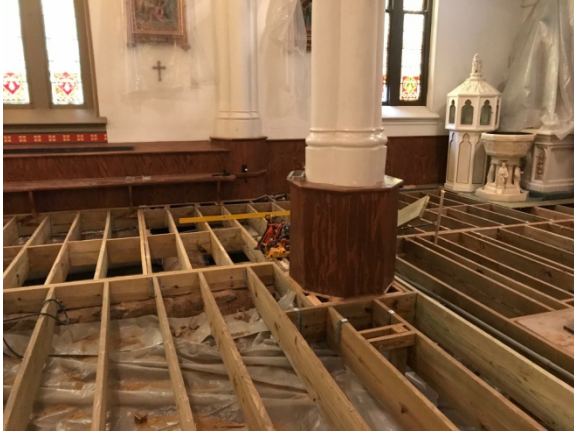
Image #5
Detail view of floor framing repairs.

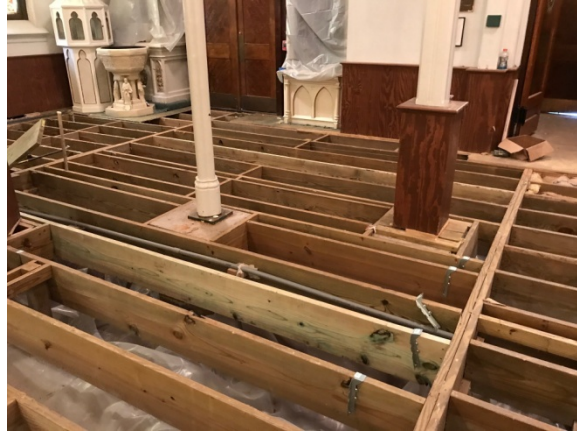
Image #6
Detail view of floor framing repairs.

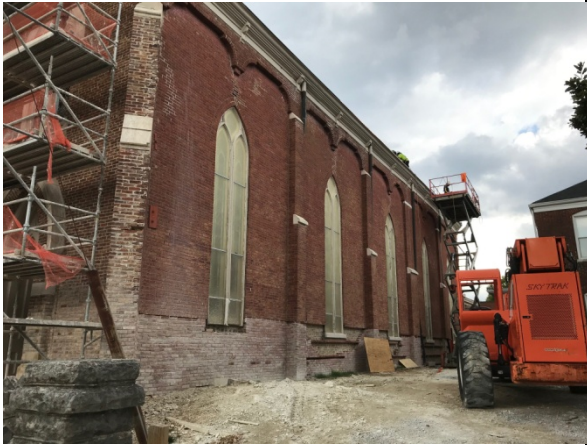
Image #7
View of continued masonry restoration work on the south side.

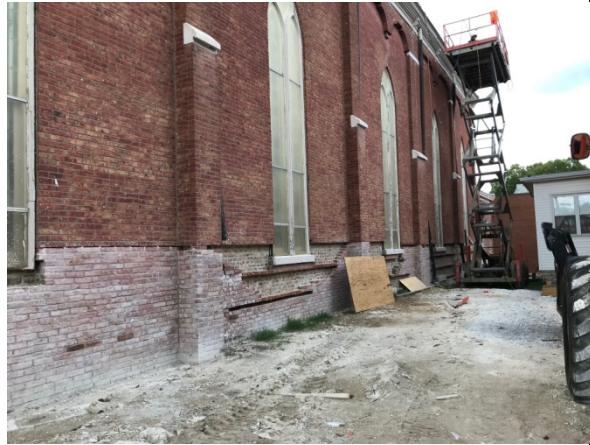
Image #8
Detail view of masonry restoration work on the south side.

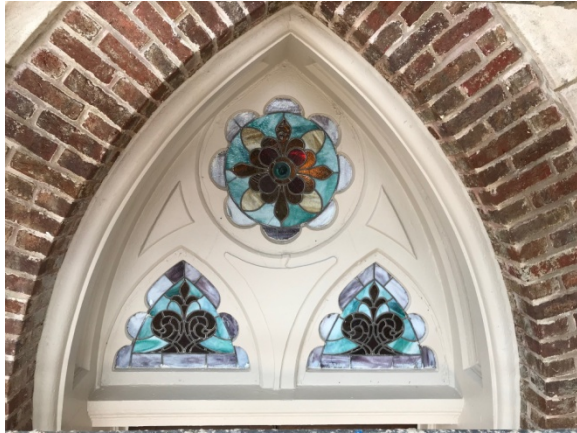
Image #9

Stained glass above left entry door - woodwork painted, new backer rod & sealant installed at joint between frame and masonry arch.

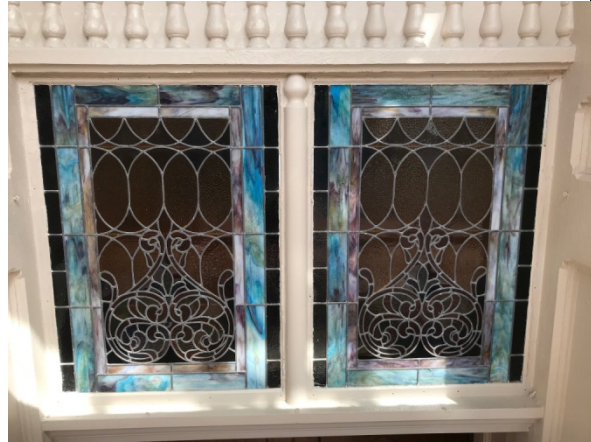
Image #10

Detail view of stained glass frame painted above center entry doors

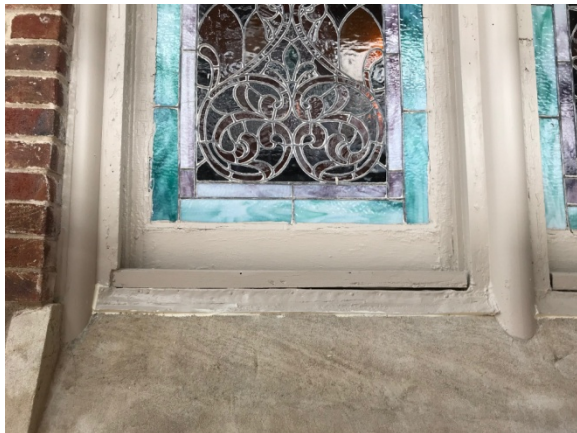
Image #11

View of stained glass window sill where semi-circular jamb components were repaired and painted. (Left Panel) (Balcony Level)

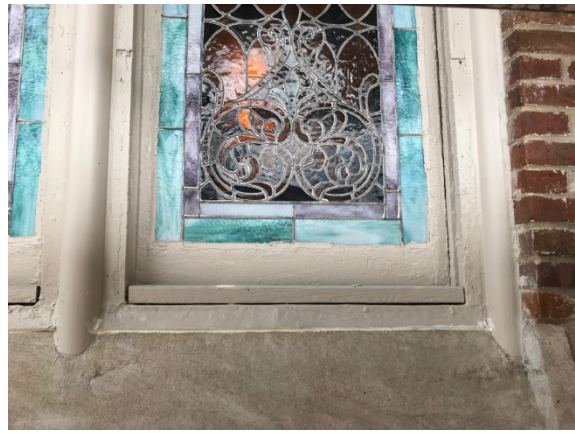
Image #12

View of stained glass window sill where semi-circular jamb components were repaired and painted. (Right Panel) (Balcony Level)

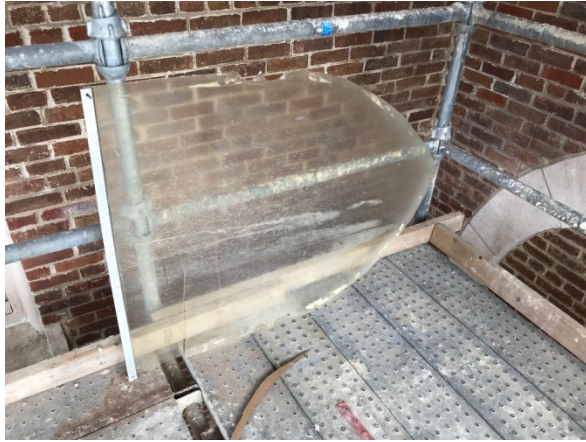
Image#17
Existing Plexiglas form removed for restoration work.

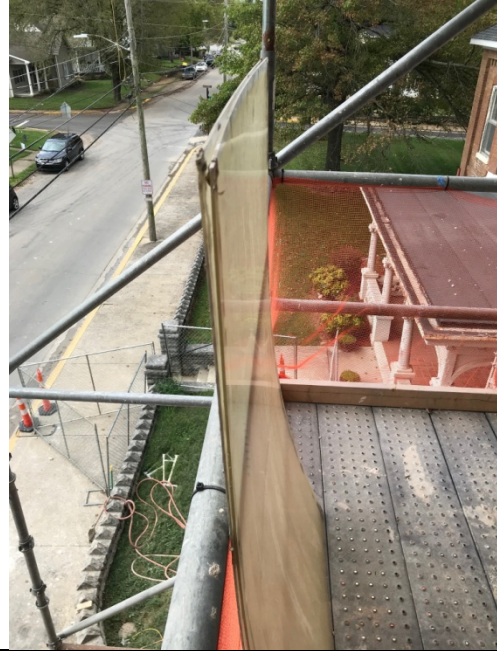
Image#18
Existing Plexiglas form. Note discoloration from Age and weathering.

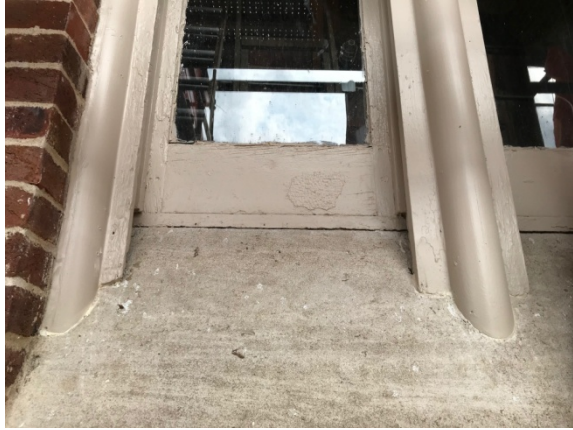
Image#25

Finished repairs at left window jamb trim @ sill - painted. (Lower Bell Tower)

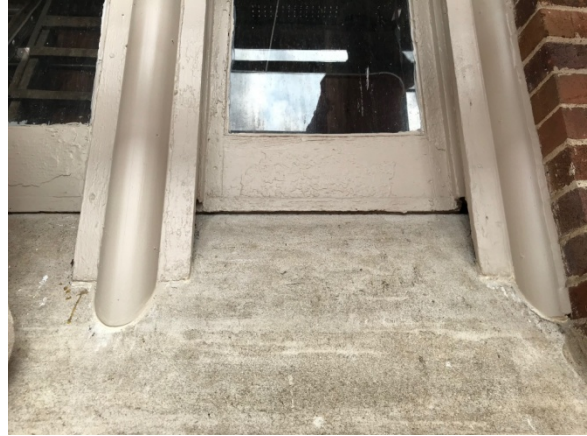
Image#26

Finished repairs at right window jamb trim @ sill painted. (Lower Bell Tower)

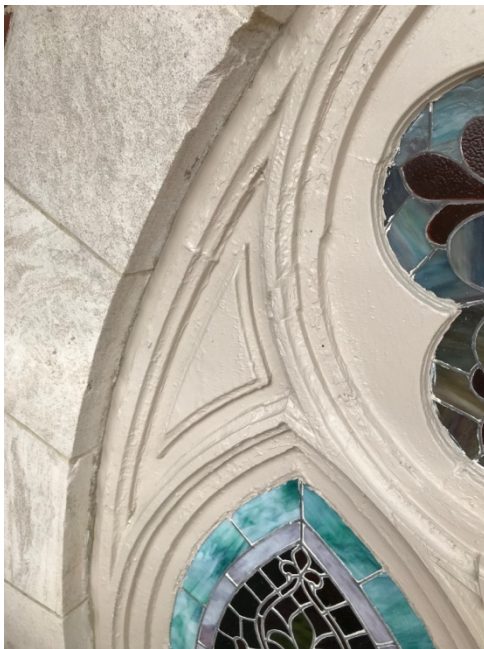
Image#31

Existing stained glass window with painted frames and new backer rod & sealant at joint with existing stone arch. (Balcony Level)

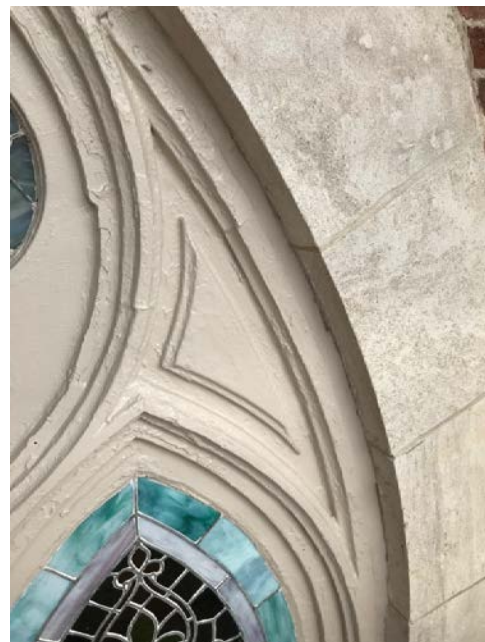
Image#32

Existing stained glass window with painted frames and new backer rod & sealant at joint with existing stone arch. (Balcony Level)

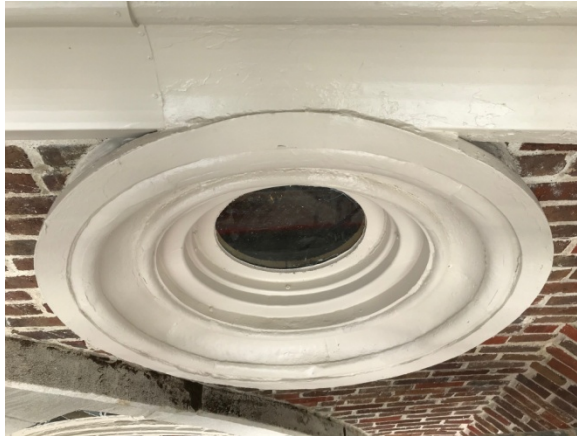
Image#35

Existing metal trim at circular window - painted

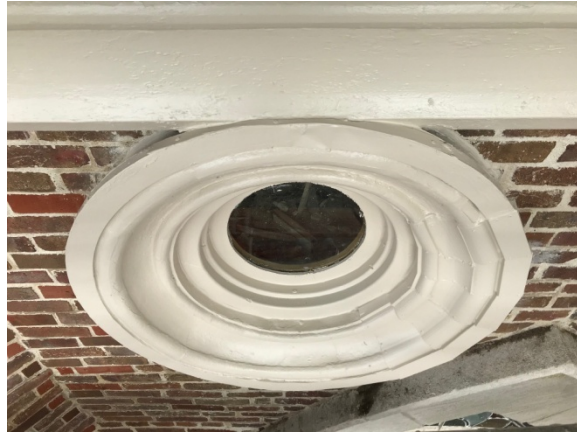
Image#36

Metal trim repair at circular windows - painted

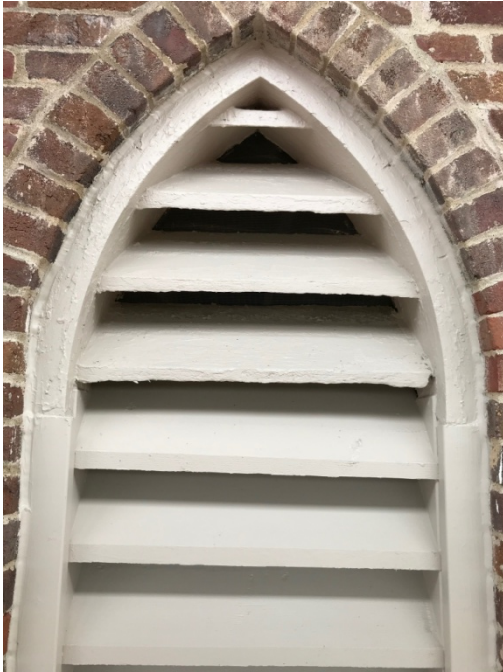
Image#37
Restored tower louver.

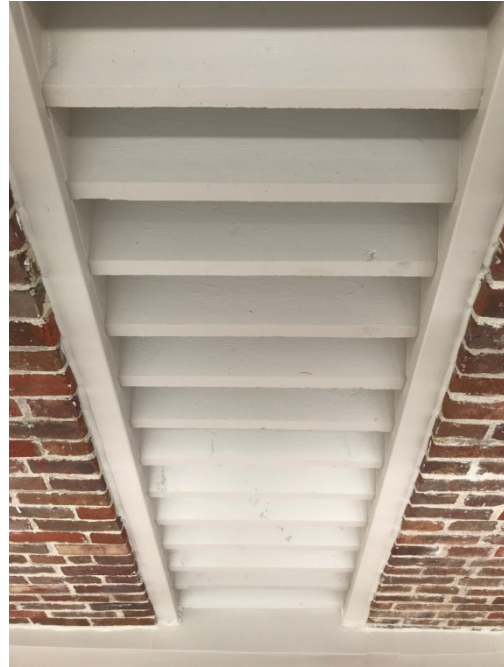
Image#38
Restored tower louver.

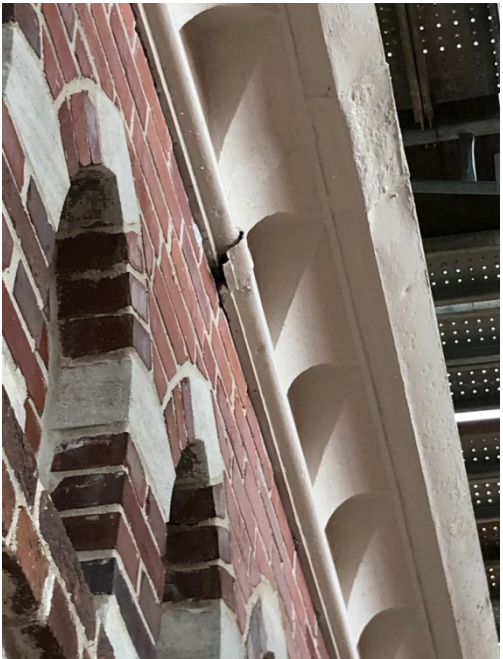
Image#39
SMD to re-attach loose loose coupling bracket.

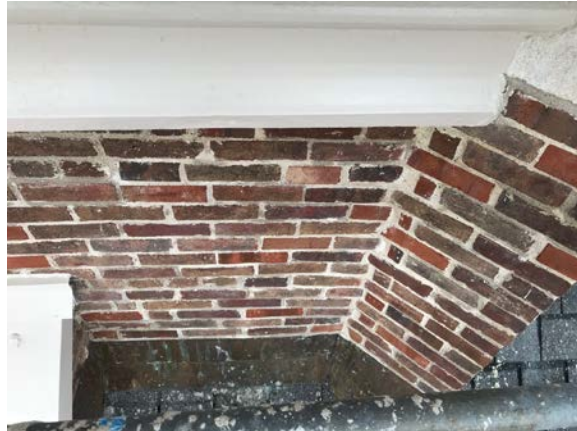
Image#40
Masonry repaired at the southeast corner of the bell tower that was previously severely deteriorated.

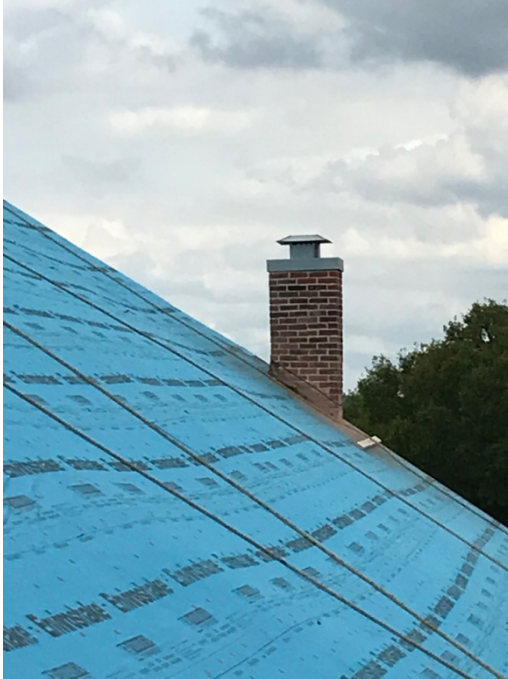
Image#41

New chimney cap installed to match the style of the existing opposite side chimney.

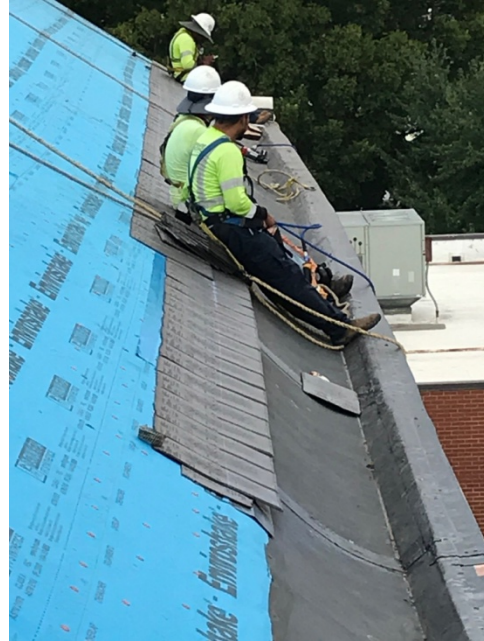
Image#42

New composite simulated slate shingles being installed on the south facing roof slope.

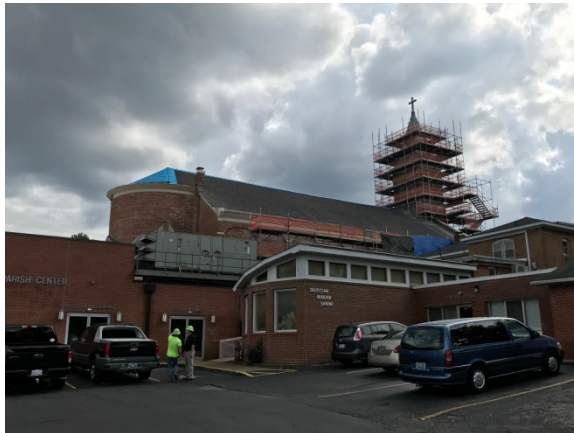
Image#43

View from street at existing rooftop HVAC unit.

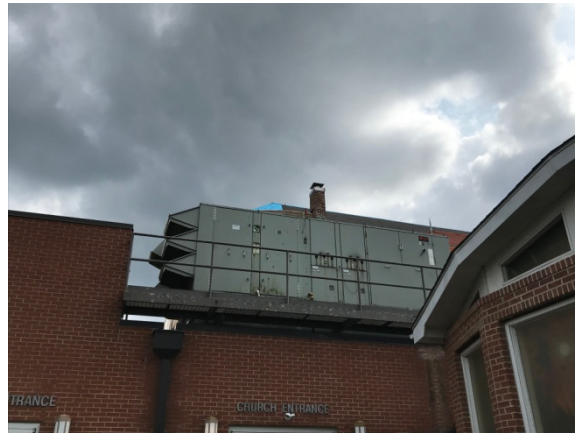
Image#44

Detail view of existing rooftop HVAC unit. Screening options being discussed.

Ideas for screening of existing HVAC unit.
