FIELD REPORT NO. 06

Project: St. Joseph Catholic Church

Date: 12 October 2020

Structural, Envelope, & Restroom Renovation

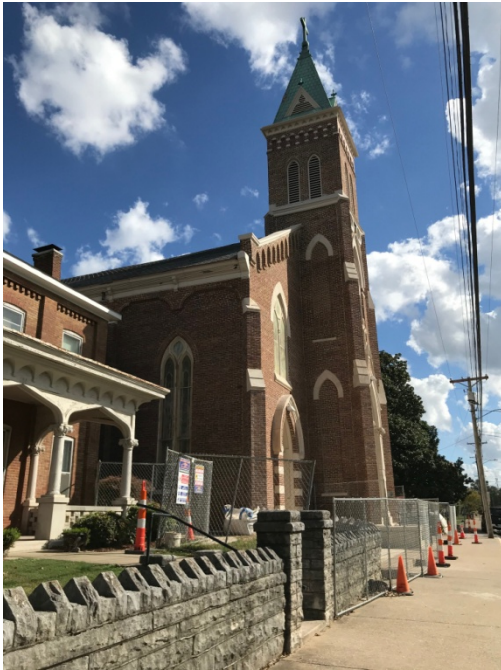
Image#1

View looking south from Church Avenue. Masonry restoration work nearing completion on north and west facades. Tower scaffolding has been removed.

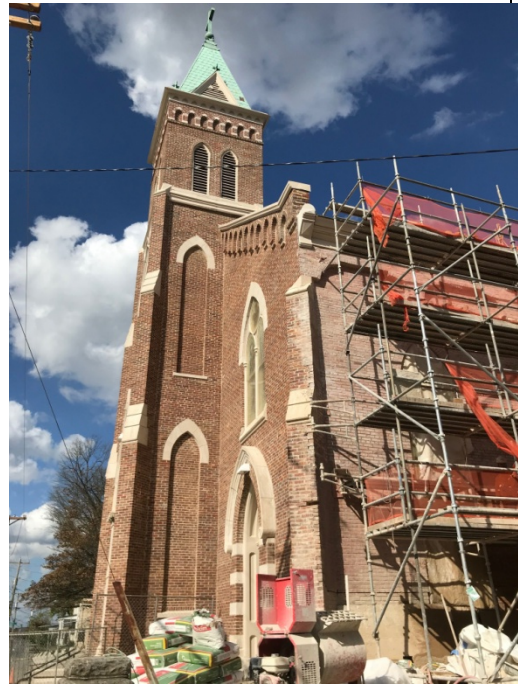
Image#2

View looking to the north. Masonry restoration work in progress on the south facade.

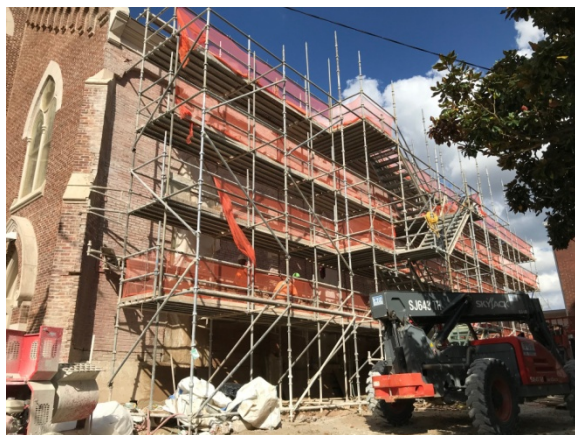
Image #3

View looking to the north. Masonry restoration work in progress on the south facade west end.

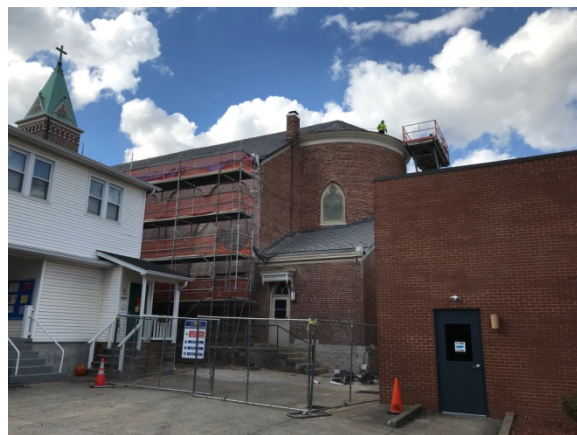
Image #4

View looking to the north. Masonry restoration work in progress on the south facade east end. Installation of simulated slate roofing nearing completion at the apse.

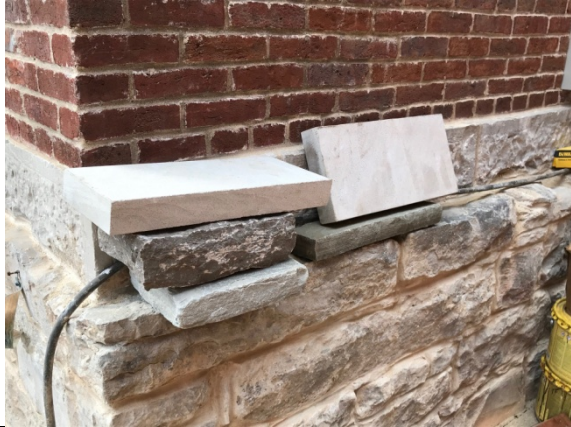
Image #5
View of water table stone samples.

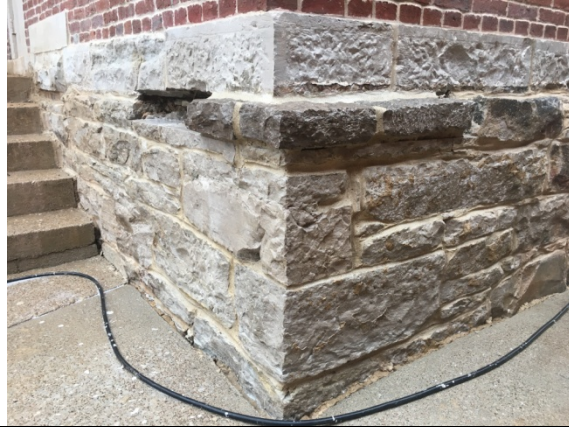
East facade - Complete with the exception of installing stone foundation wall stone cap with sloped top for drainage. **Samples being reviewed.**

Image #6 Image dated **10-18-20** with one of the stone samples installed after existing stone was cleaned. **This sample was deemed too dark.**

Submit image of mock-up stone water table for match comparison with existing stone foundation for review. **See Image #6 below:**

Review stone water tables for appropriate match.

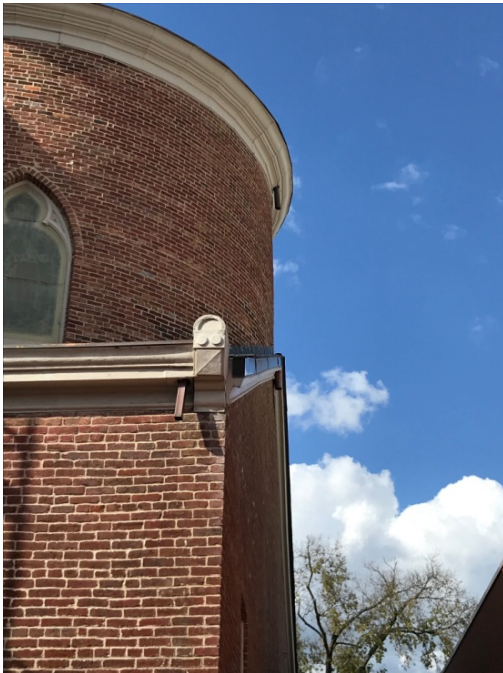
Image #7
View of the southeast corner of the building.
New downspouts yet to be installed.

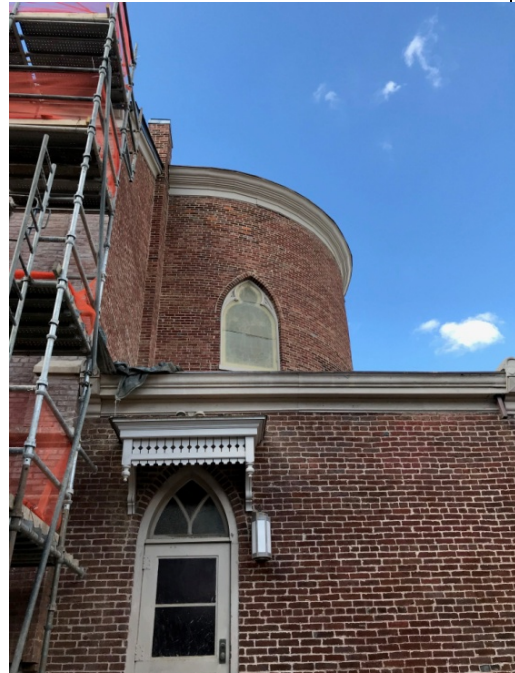
Image #8
View of the southeast corner of the building.
Simulated slate will also be installed at the doorway awning.

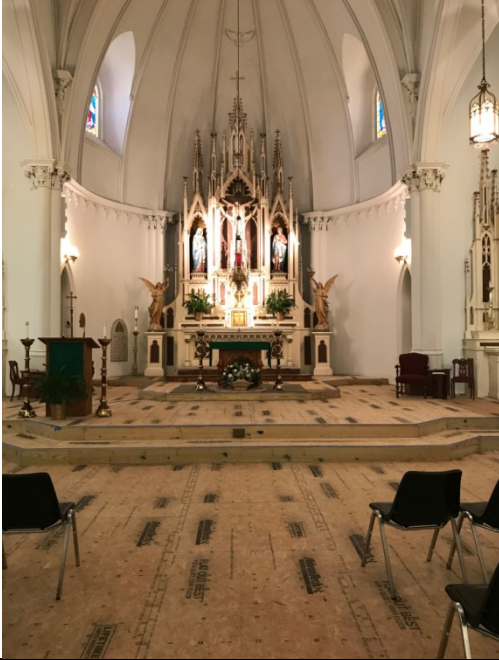
Image #9

Interior view looking east. New floor decking in place.

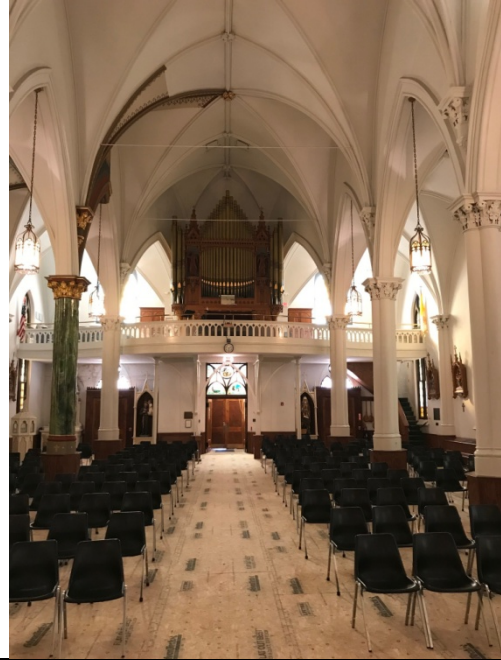
Image #10

Interior view looking west. New floor decking in place.

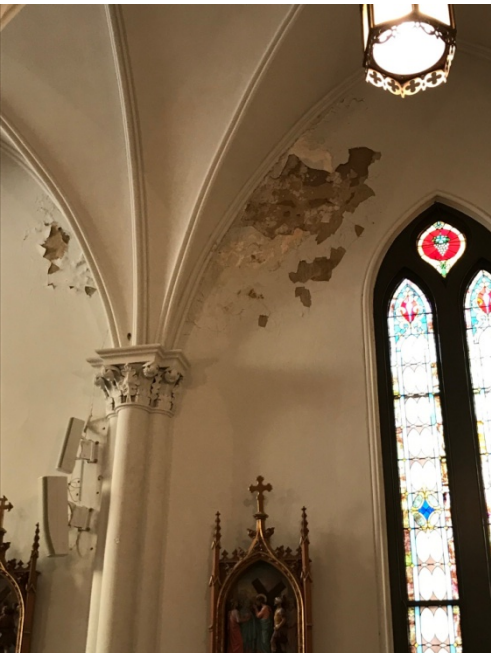
Image #11

Interior view at north wall - Conrad Schmitt Studios to do plaster restoration work in 2021.

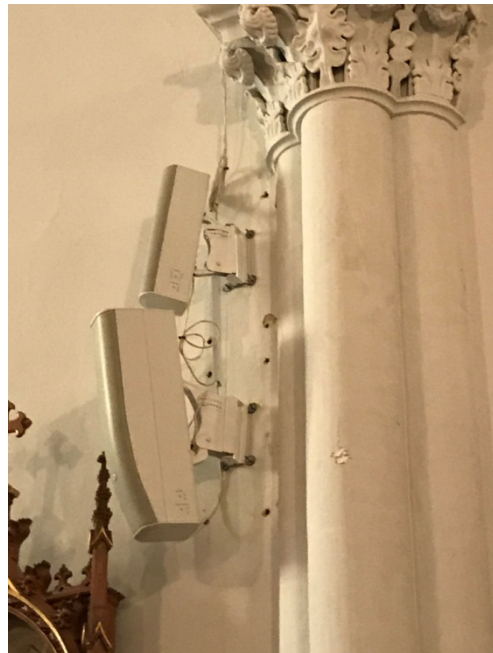
Image #12

View of speaker with new anchor bolts mounted in wall eliminating large anchor plates.

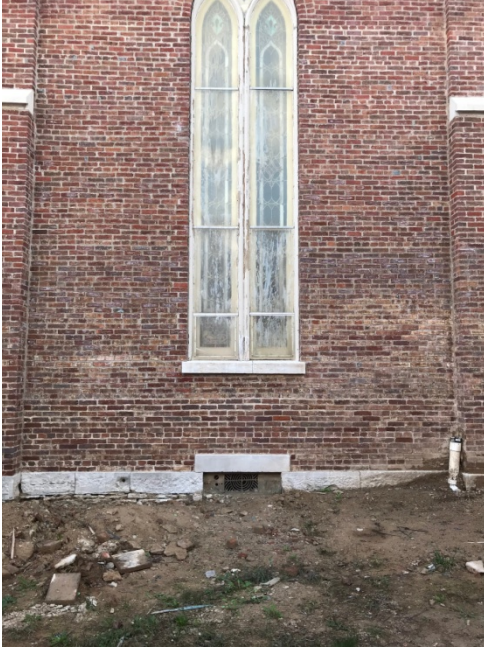
Image #13

View of north facade restoration work. View of lower stained glass window.

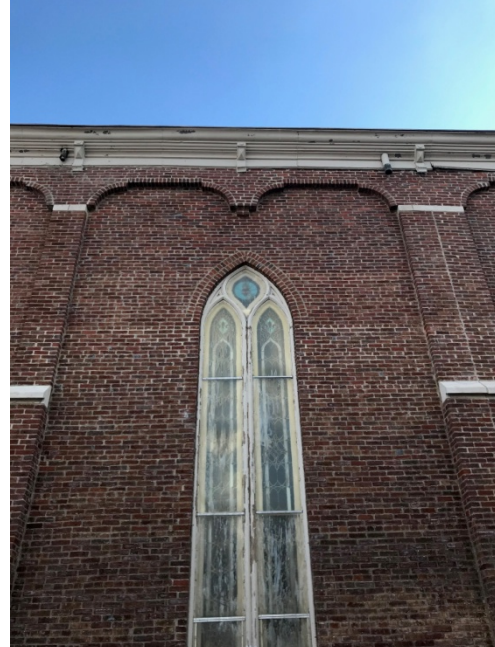
Image#14

View of north facade restoration work. View of upper stained glass window.

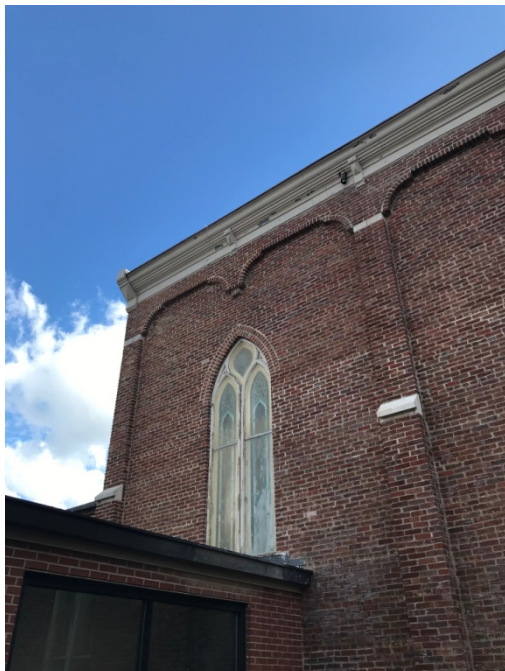
Image#15

View of northeast upper facade restoration work.

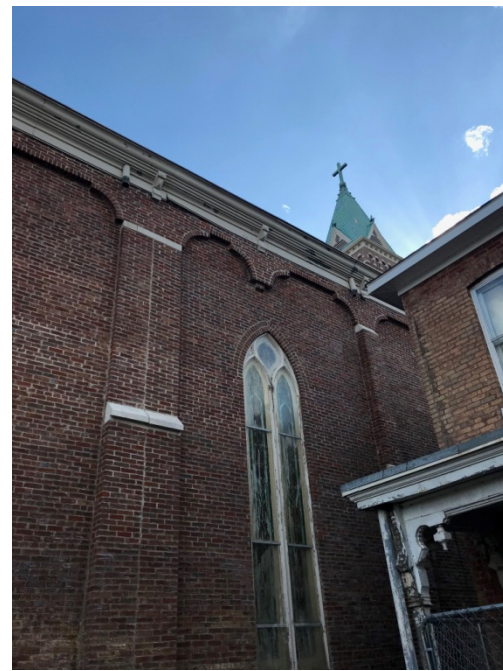
Image #16

View of northwest upper facade restoration work.

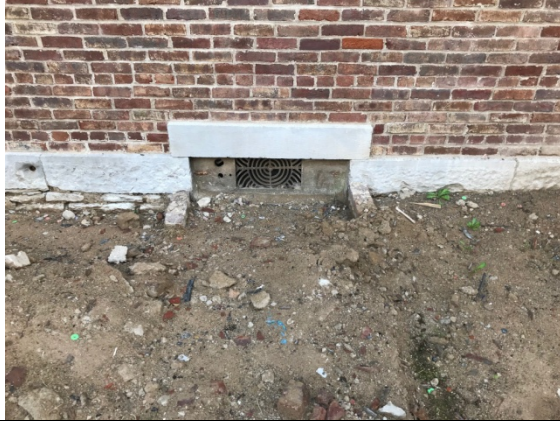
Image#17

Existing crawl space vent areaways to be cleared and re-constructed.

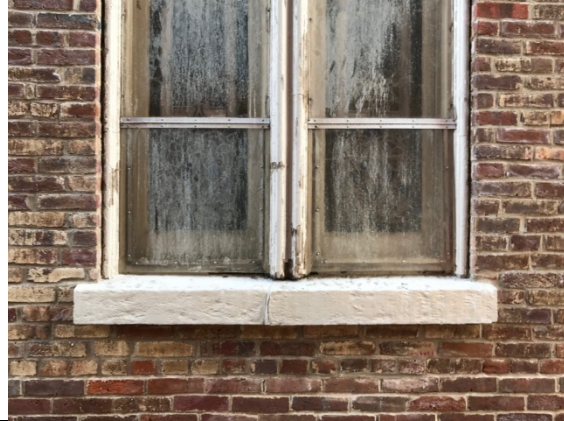
Image#18

North stained glass windows are being prepped for installation of new backer rod and sealant between the window frame and masonry. Existing Lexan coverings are being re-installed until new glass protection system is installed in 2021.

Existing stained glass window on the north side of the building awaiting new backer rod and sealant at joint between wood frame and masonry.

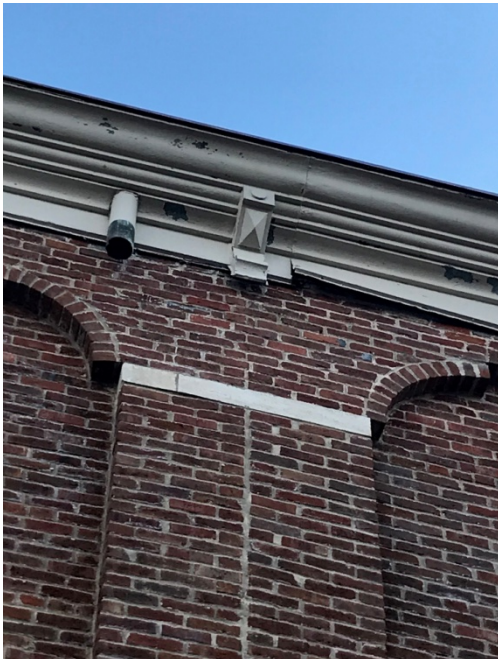
Image#19

Upper wall detail on the north facade. Downspouts yet to be installed. Existing loose metal fascia will be re-attached.

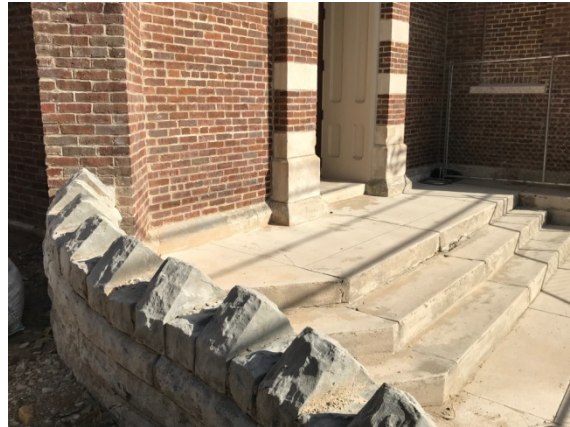
Image#20

Area where new ADA approach will be constructed at the front of the church.

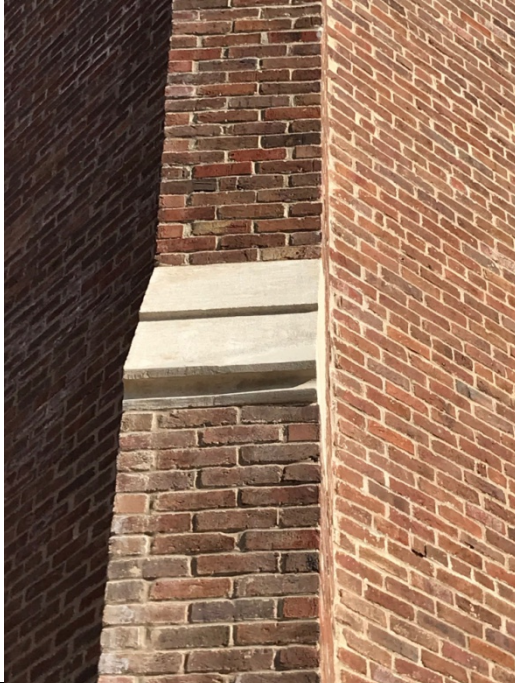
Image#21

Detail view of stone patch at northwest buttress at lower right corner.

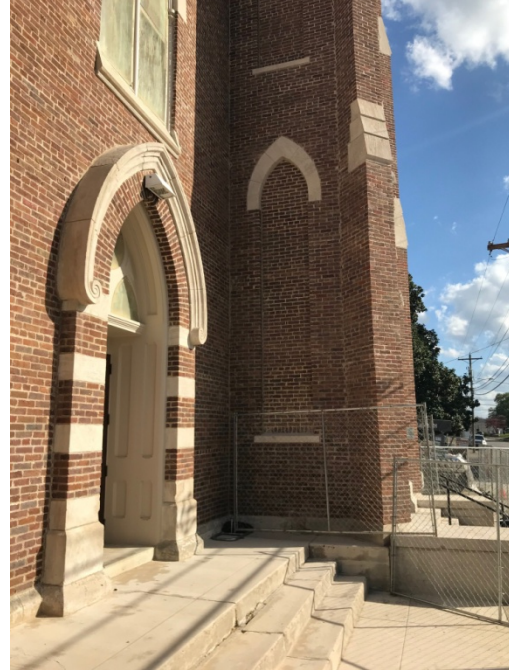
Image#22

View of west entry and bell tower base.

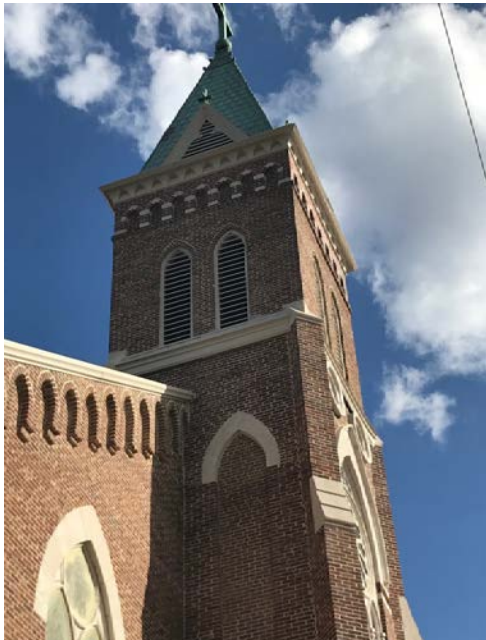
Image #23

Detail view of upper bell tower.

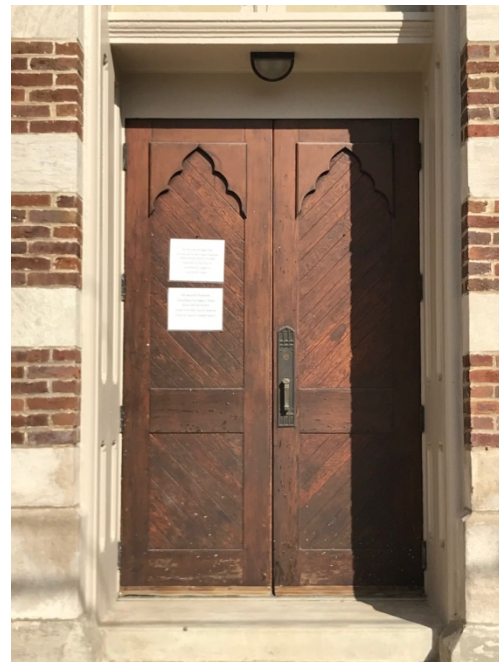
Image#24

Detail of entry doors. Doors and hardware are to be cleaned and existing weather seals replaced.

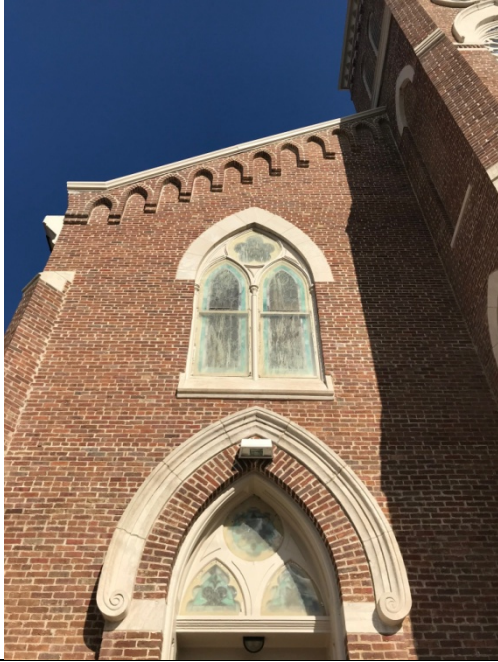
Image#25

View of west facade north end - existing protective covering temporarily re-installed until new protective system is fabricated.

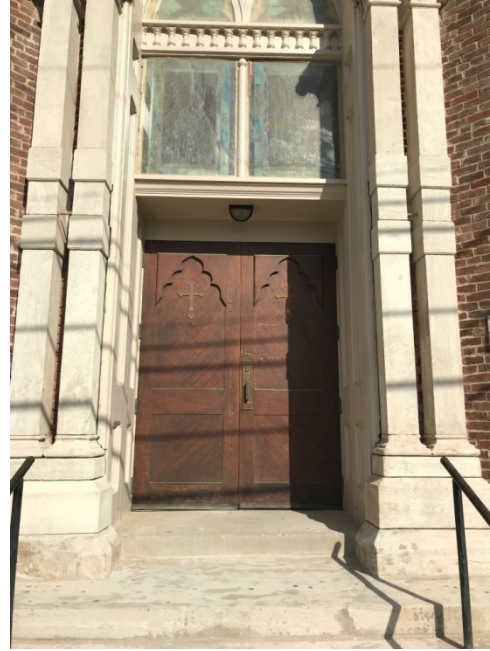
Image#26

View of central entry doors at the base of the bell tower.

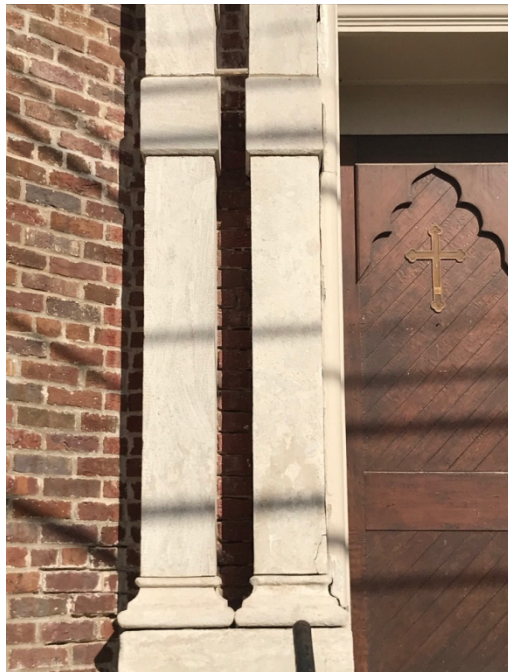
Image#27

Masonry mortar pointing to continue in between paired pilasters.

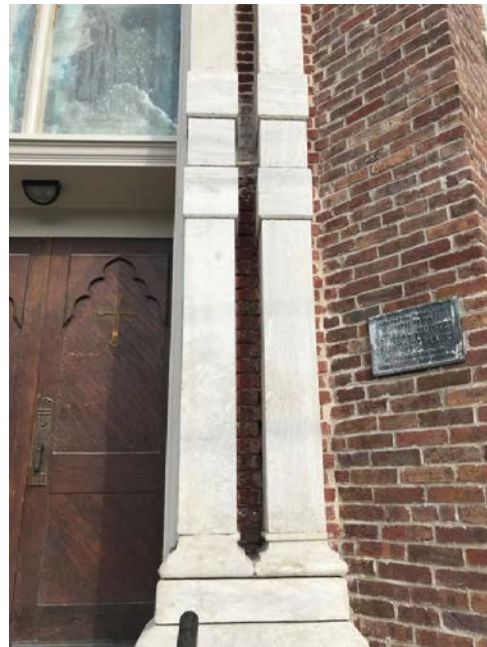
Image#28

Masonry mortar pointing to continue in between paired pilasters.

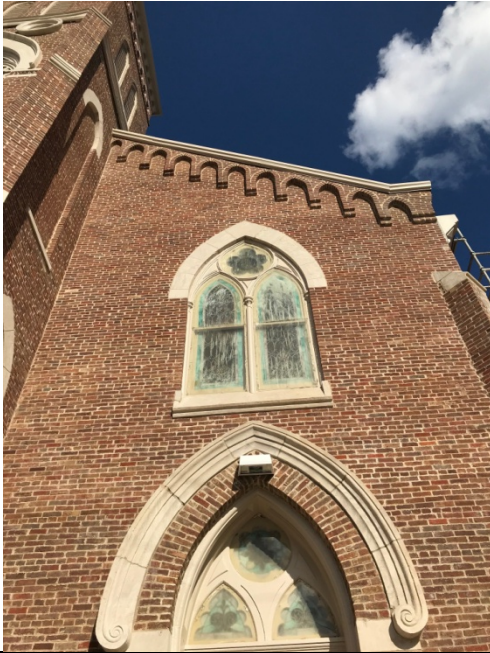
Image#29

View of west facade south end - existing protective covering temporarily re-installed until new protective system is fabricated.

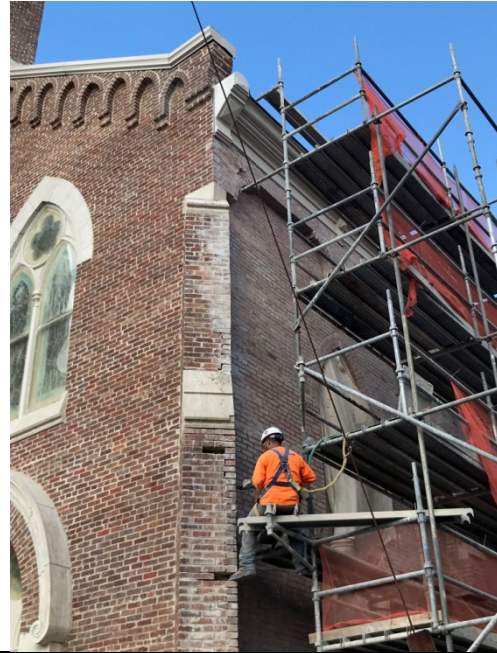
Image#30

Detail view at southwest corner of the church at corner buttress.
