## FIELD REPORT NO. 07

**Project:** St. Joseph Catholic Church  
Structural, Envelope, & Restroom Renovation

**Date:** 18 December 2020

**Project No.:** 018.011.00

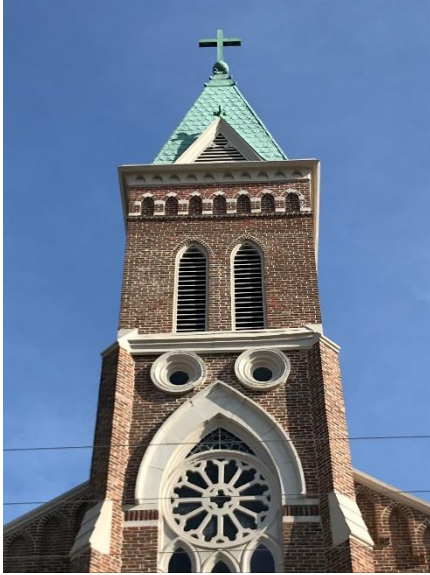
Image # 1

View of upper bell tower.

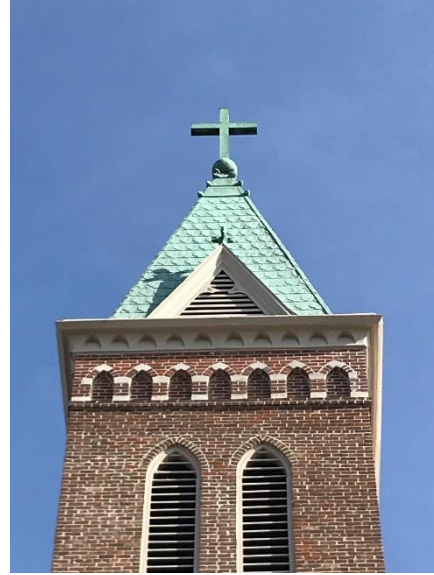
Image # 2

Detail view of upper bell tower.

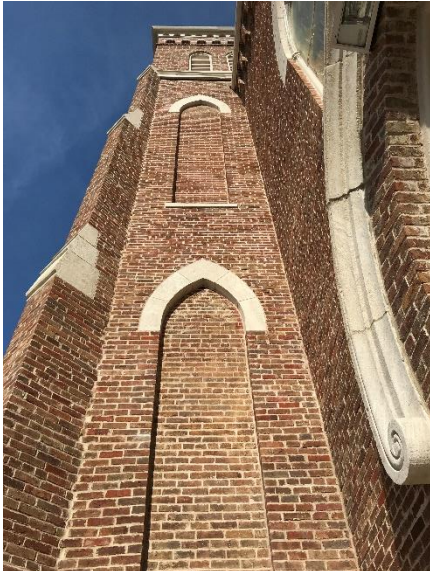
Image # 3

View of the west side of the bell tower.

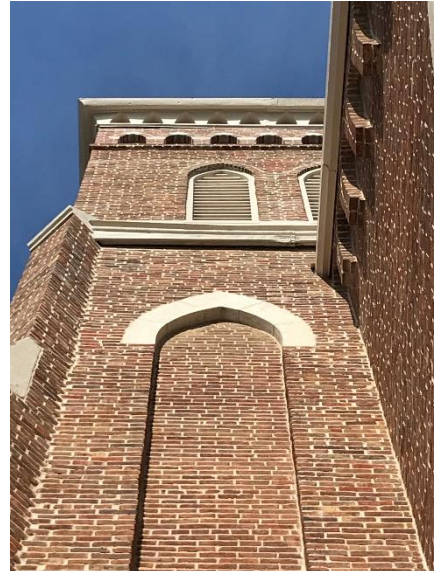
Image # 4

Detail view of the upper portion of the west side bell tower.

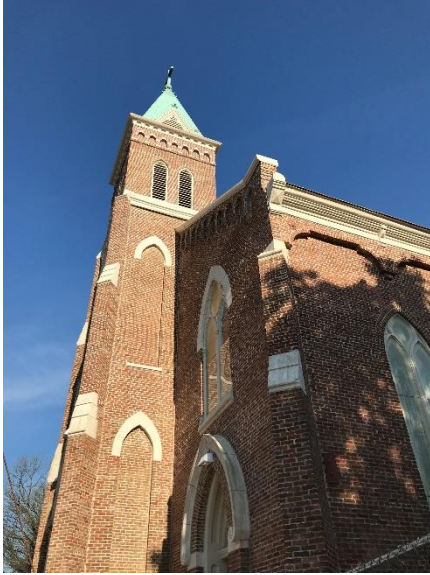
Image # 5

View of the southwest corner of the church taken from Church Avenue.

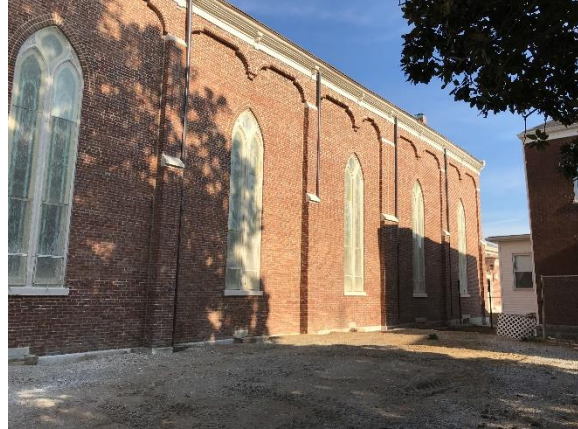
Image # 6

View of the completed south façade. All scaffolding has been removed.

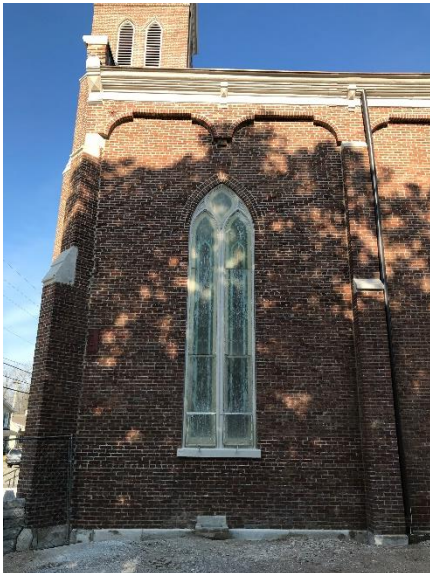
Image # 7

View of the first bay on the south façade.

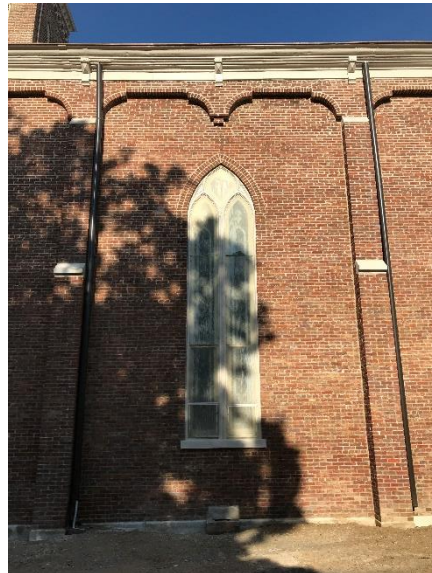
Image # 8

View of the second bay on the south façade.

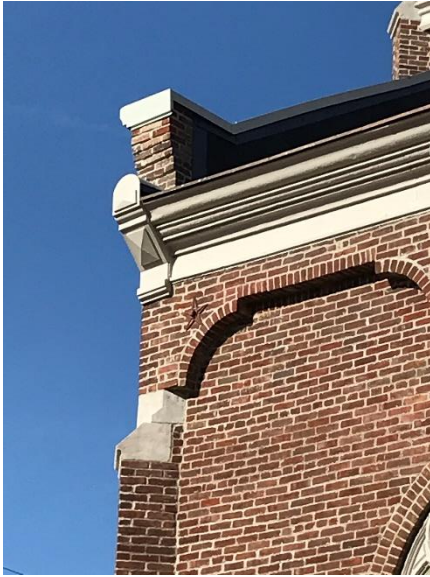
Image # 9

Detail view of the upper corner on the south façade, first bay, at the parapet.

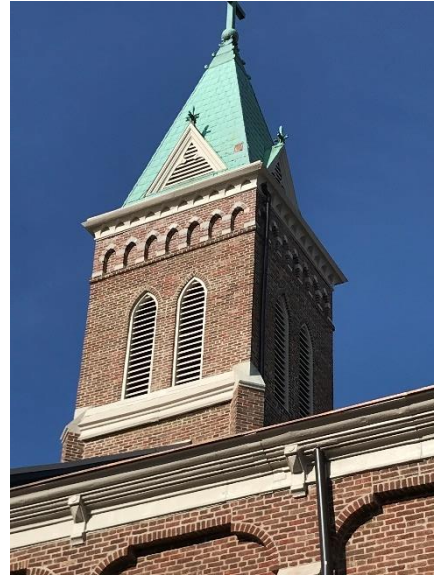
Image # 10

View of the southeast corner of the bell tower.

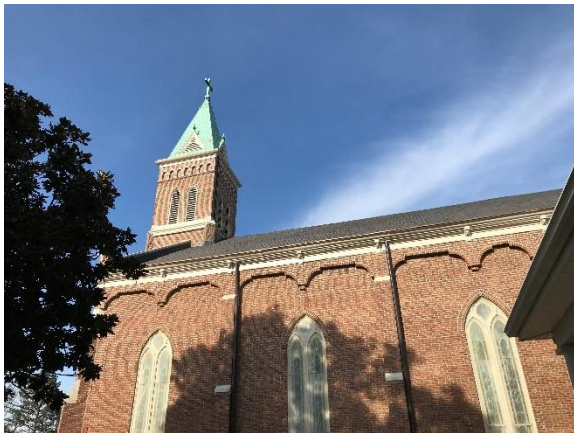
Image # 11

View of the upper south façade.

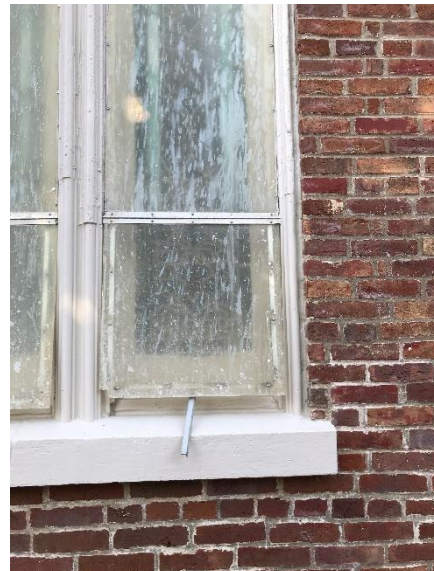
Image #12

View of southside window with wood repair, new sealant and paint. Existing window protection has been re-installed until the new system is fabricated and installed.

Stained glass windows repair work to take place in early 2021. Existing Lexan coverings have been re-installed until new glass protection system is installed in 2021.

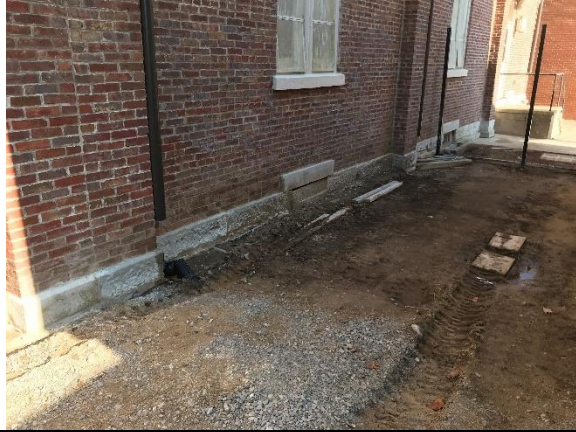
Image # 13

View of south façade at grade. New downspouts will be connected to underground drainpipe.

Downspouts to be connected to underground piping where not already connected.

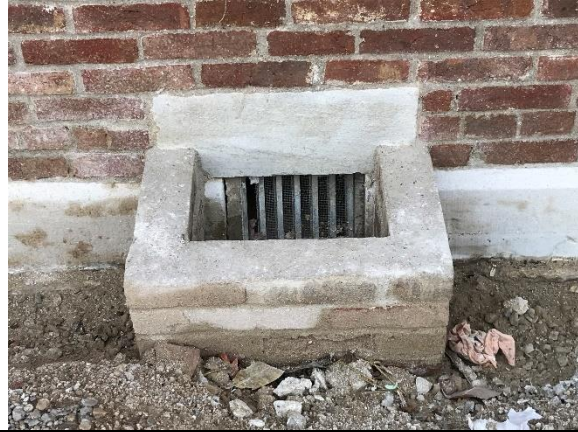
Image# 14

Areaway for crawlspace vents re-built. Top course of brick to be removed so to align with the stone foundation.

Areaway re-construction in progress

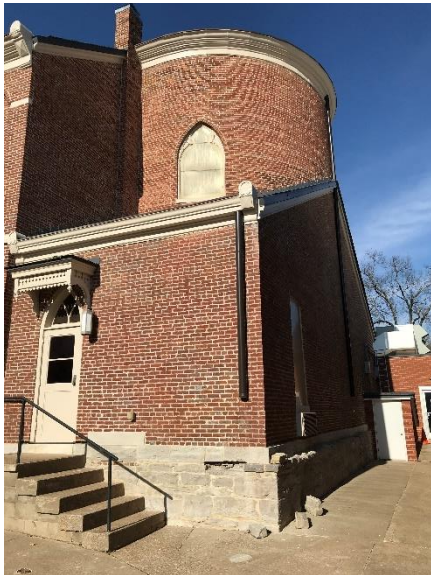
Image # 15

View of the southeast corner of the church.

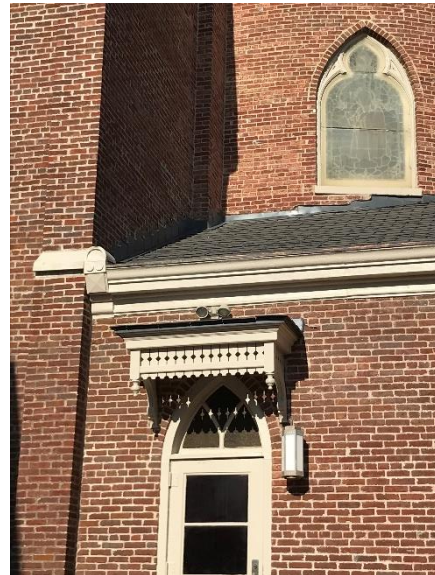
Image # 16

Detail view of the southeast corner of the church at the entry to Vestments.

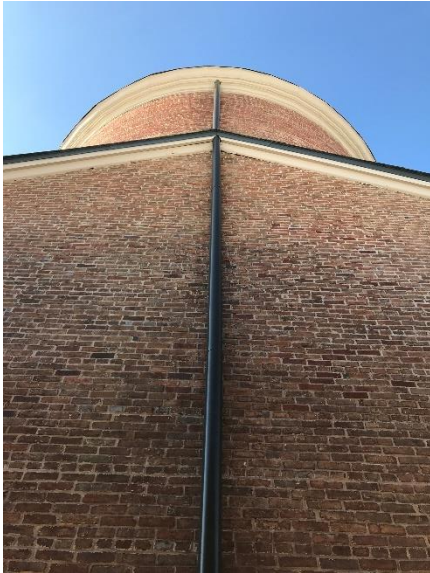
Image # 17

View of the upper portion at the east façade.

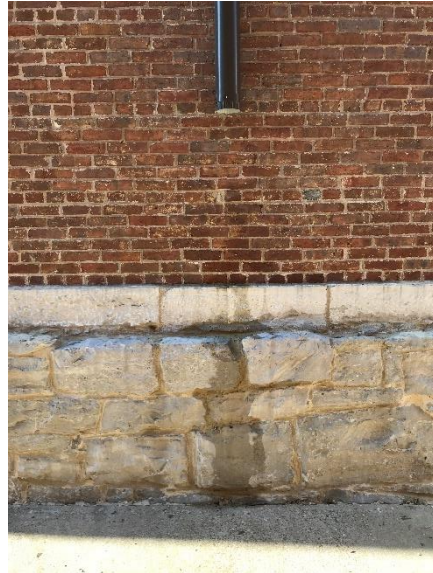
Image # 18

View of the lower portion of the east façade at the new downspout. This will be connected to an under-ground pipe and no longer discharge onto the walkway path between the church and parish hall.

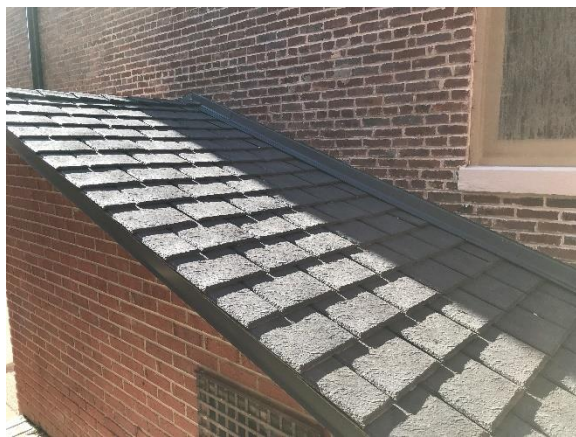
Image # 19

New simulated roofing installed on the roof of the stair leading down to the basement.

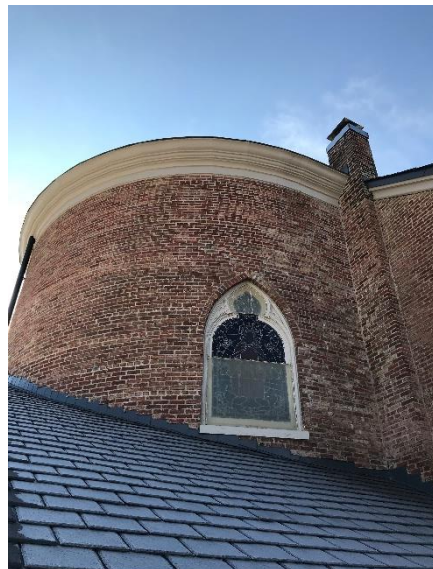
Image # 20

View of the northeast side of the apse.

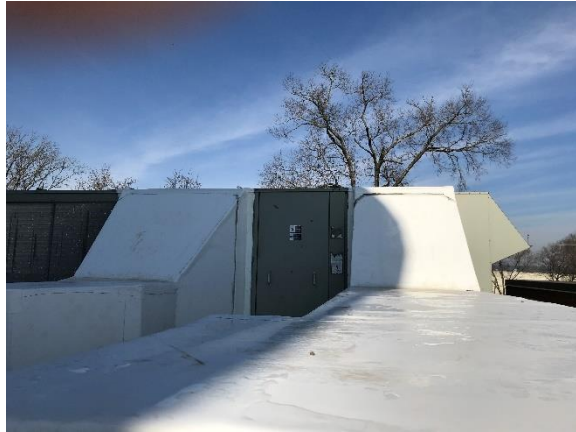
Image # 21

View of the connector area roof with existing ducts wrapped.

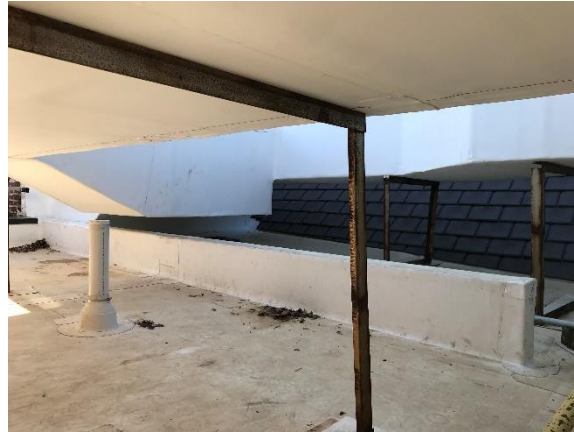
Image # 22

View underneath the connector area raised ductwork.

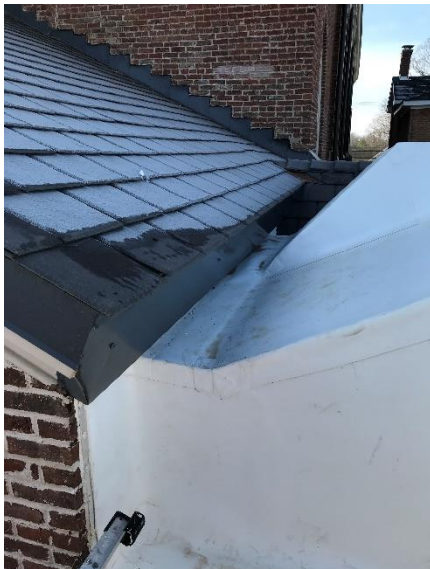
Image # 23

Detail view of the duct connection into at the exterior upper wall of the Sacristy.

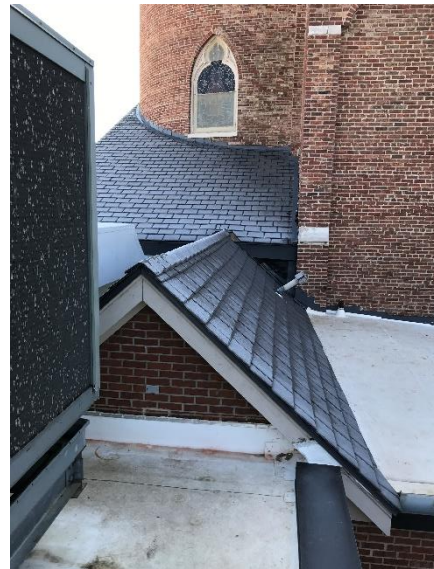
Image # 24

View of the connector roof area from the west end of the existing HVAC rooftop unit looking south.

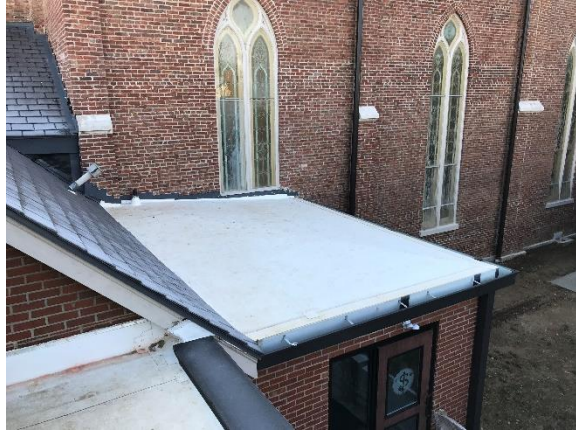
Image # 25

View of the new roof at the connector area.

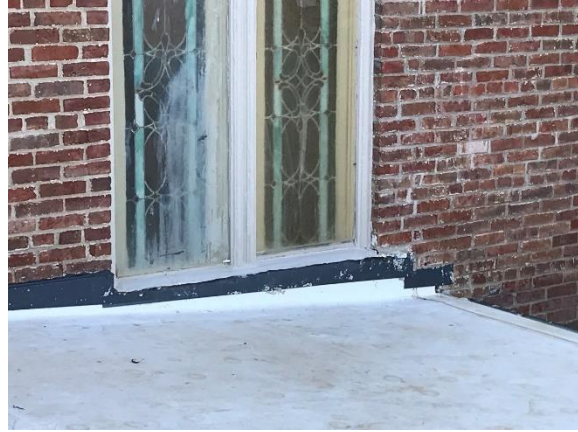
Image # 26

Detail view of the roof and flashing at the window located above the doorway from the connector into the church.

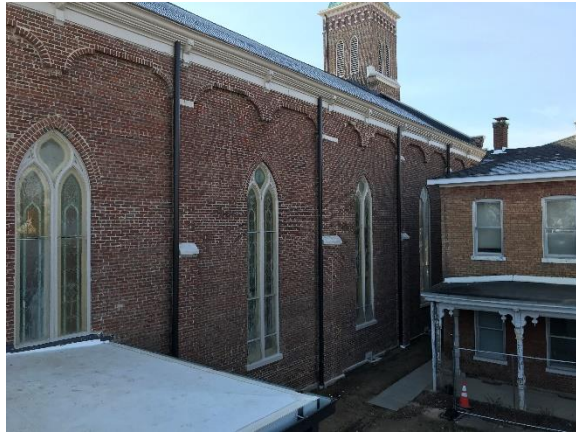
Image # 27

View of the north façade.

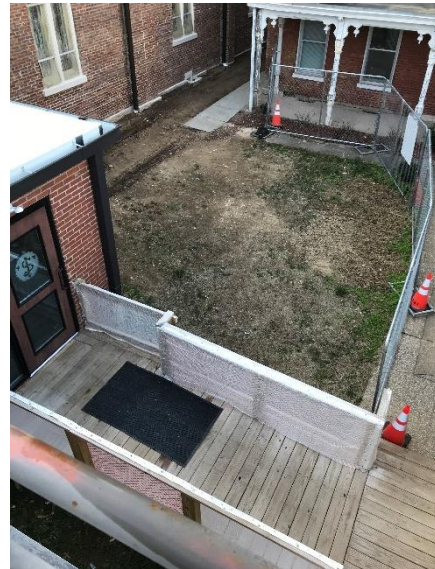
Image # 28

View looking down into the courtyard where the new ADA ramp will be constructed.

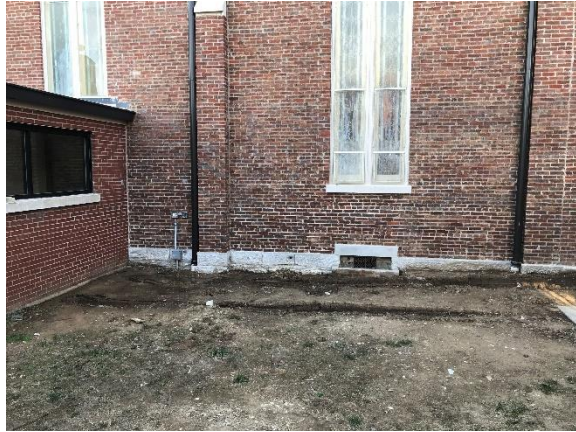
Image # 29

View of the lower north façade at the courtyard.

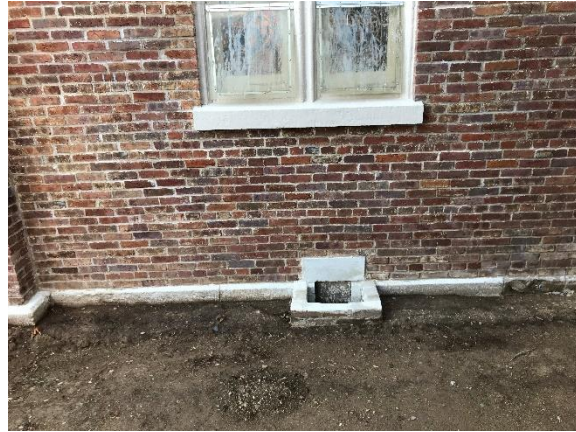
Image # 30

View of lower north wall where crawlspace vent areaway has been re-constructed.

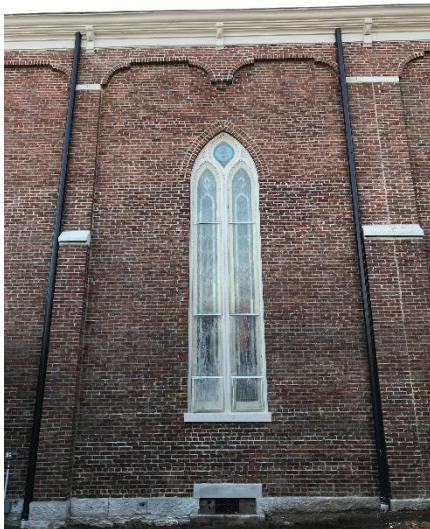
Image # 31

Upper view of the fourth bay of the north façade.

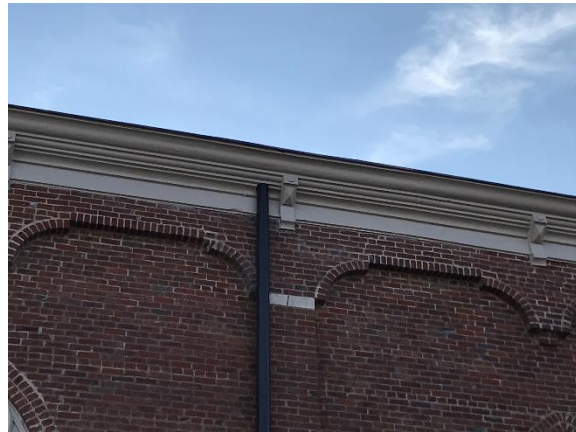
Image # 32

Detail view of the upper north façade at downspout connection into the built-in gutter.

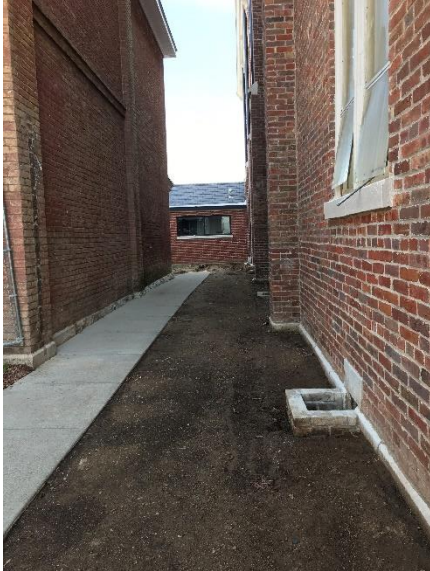
Image # 33

View along the north façade looking east between the church and DeVries house.

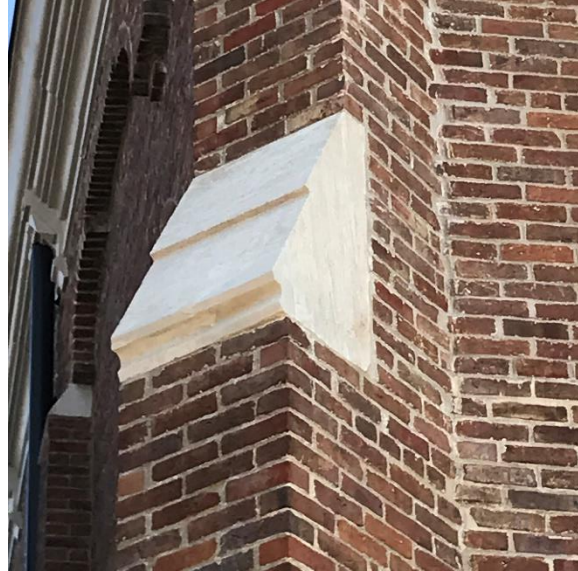
Image # 34

Detail view of intermediate stone cap at the northwest corner buttress where lower right corner has been repaired.

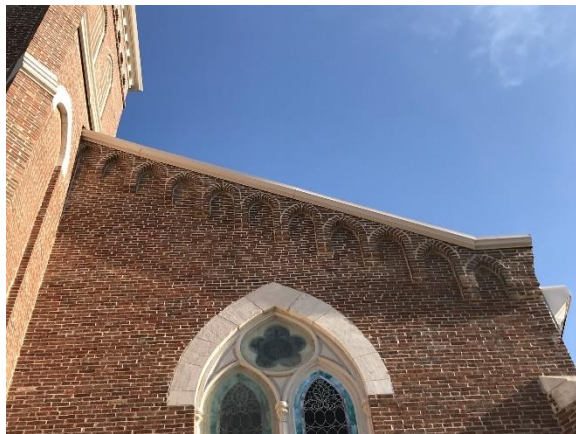
Image# 35

View of upper west façade on the south end.

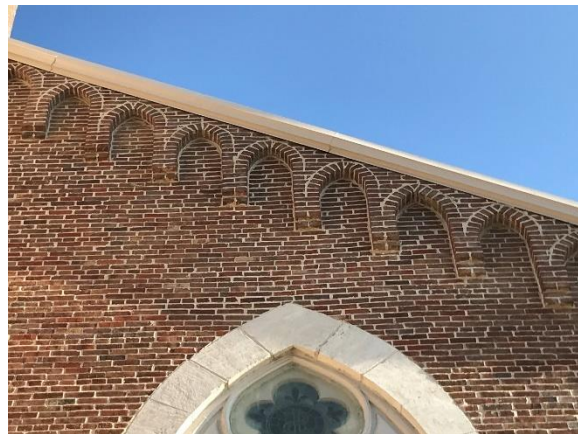
Image# 36

Detail view of the upper west façade at the south end.

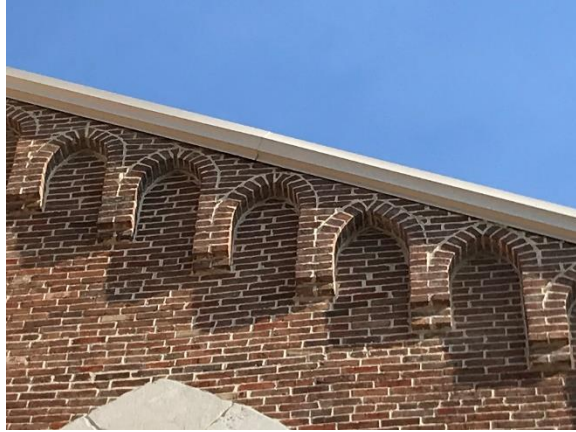
Image # 37

Detail view of the upper west façade at the south end. This area previously had deterioration of the mortar and cracking.

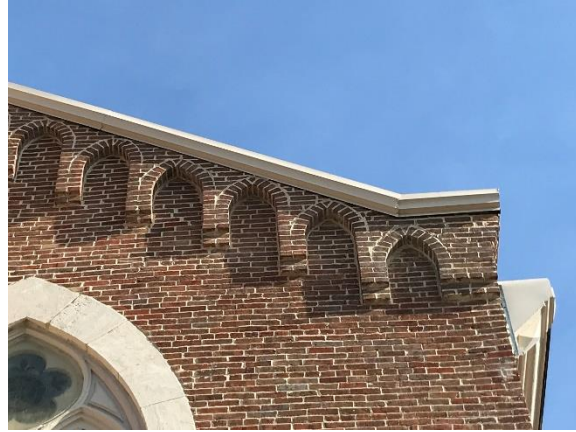
Image # 38

Detail view of the upper west façade at the south end. This area previously had deterioration of the mortar and cracking.

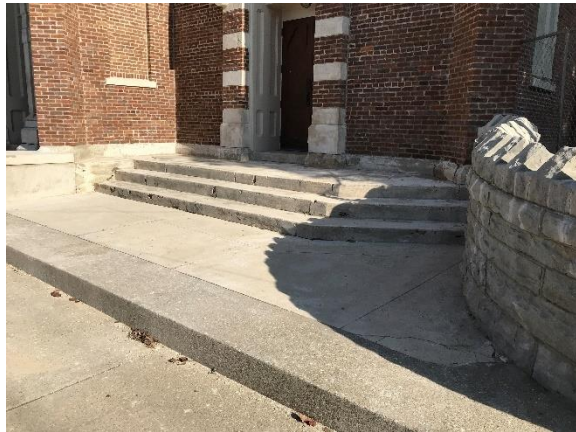
Image # 39

View of the west entry area south end.

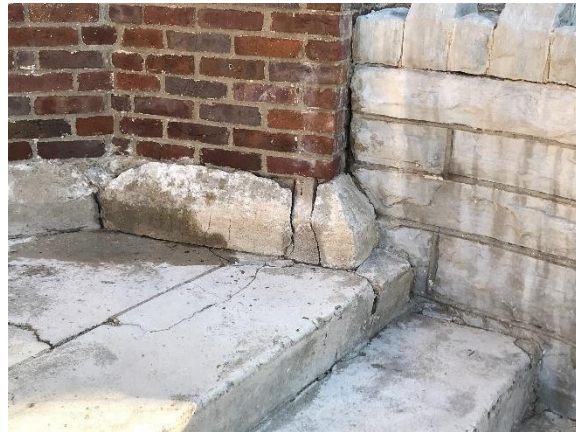
Image # 40

View of existing stone spalling at the base of the southwest buttress. This area to be repaired along with the re-construction of the steps and upper landing.

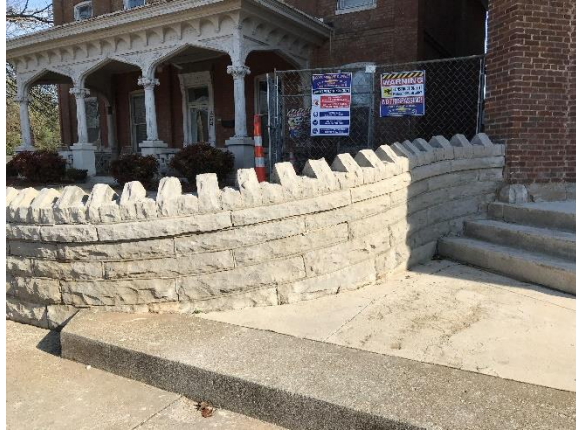
Image # 41

View of the existing stone wall on the northwest side of the church. The stone has been cleaned. A portion of this wall will be removed to create an accessible route

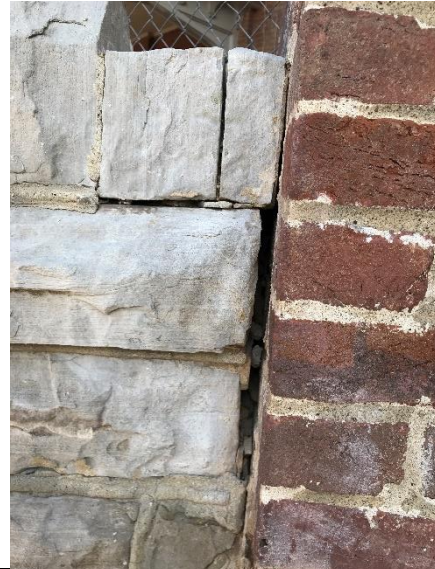
Image # 42

View of where existing stone wall meets the Northwest buttress. Note: Although not a part of the current work scope, the mortar at the existing stone wall has visible signs of deterioration.

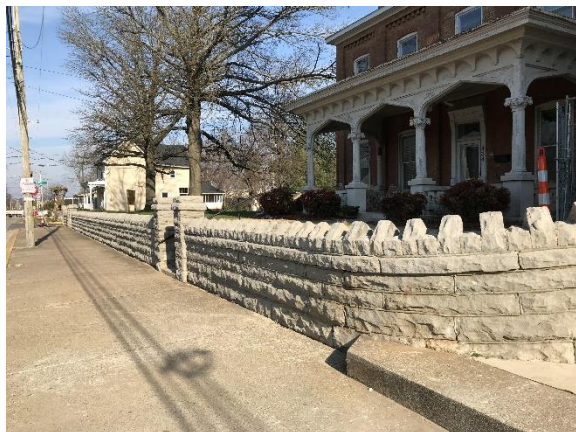
Image # 43

View of the existing stone wall, cleaned, looking north.

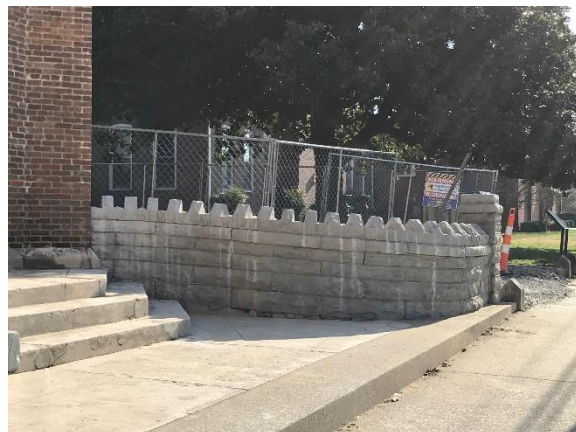
Image # 44

View of the existing stone wall looking at the toward the south.

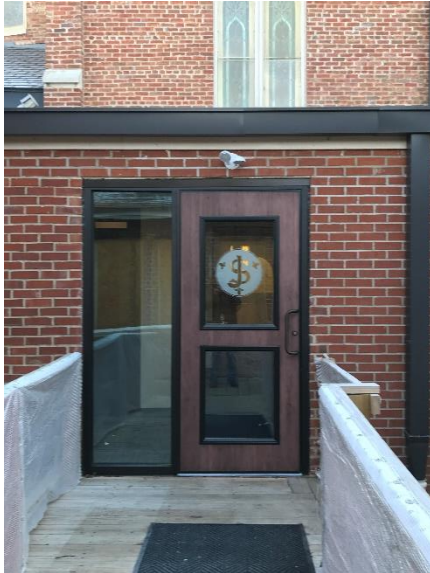
Image # 45

View of new entry door to the connector area where the new ADA ramp will be constructed.

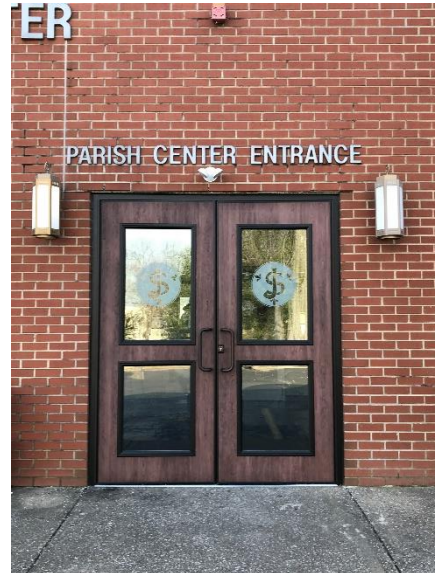
Image # 46

View of new door to the Parish Hall.
