St. Catherine of Alexandria Church  
107 North Main St.  
Westford, MA 01886  
Prepared for Reverend Peter F. Quinn, Reverend Joseph M. Rossi

Prepared by Office of Property Management  
Archdiocese of Boston  
66 Brooks Rd., Braintree, MA 02184

## **St. Catherine of Alexandria Church/Offices Facilities Assessment**

### **EXECUTIVE SUMMARY**

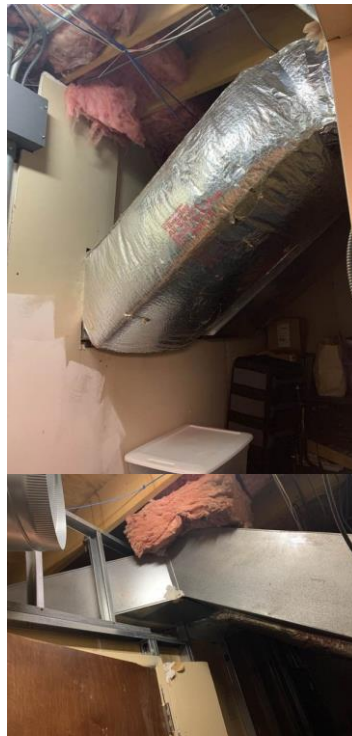
#### Heating Plant Photos

Units are combination heating/cooling by Carrier. No boiler in the building.

Based on age of units, parish should start budgeting for replacement potentially at the five-year to ten-year mark.

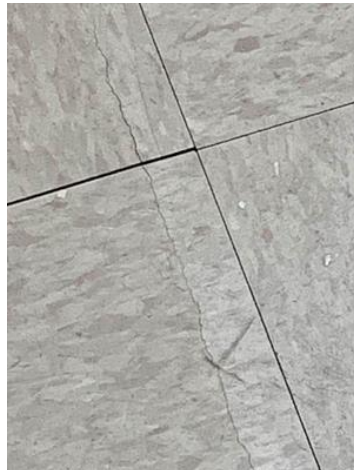
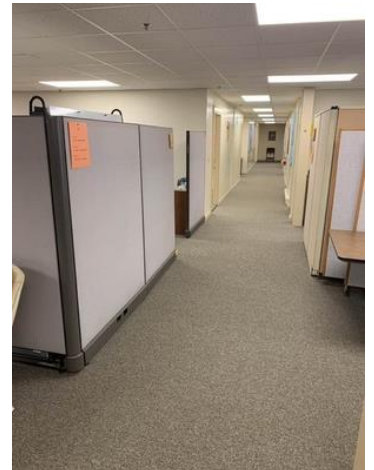
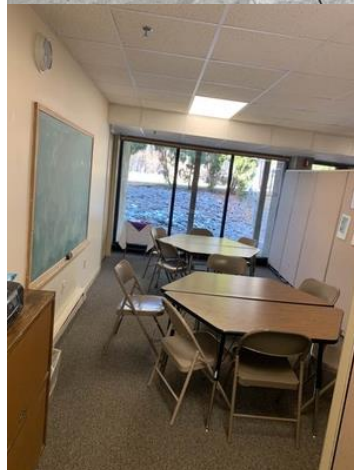
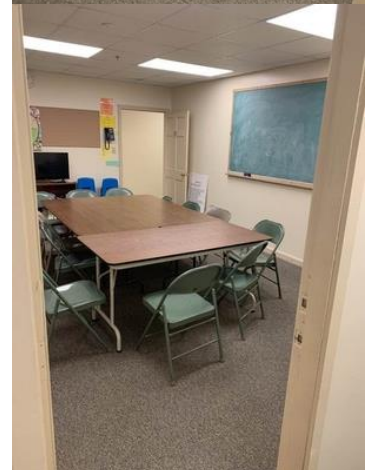
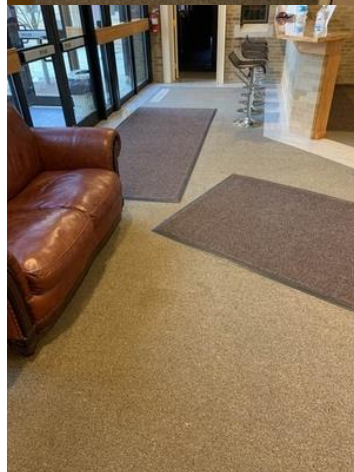
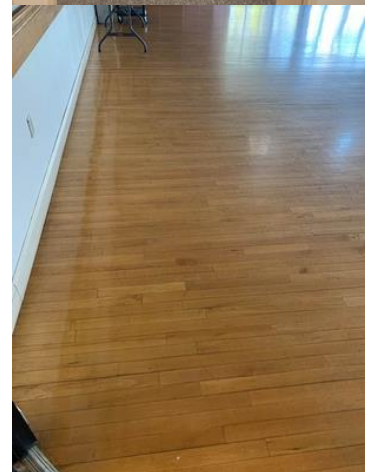
Floor Types	Wall to Wall Carpeting, VCT Tiles, Granite Tile, Hardwood, Ceramic Tile
Floor Photo

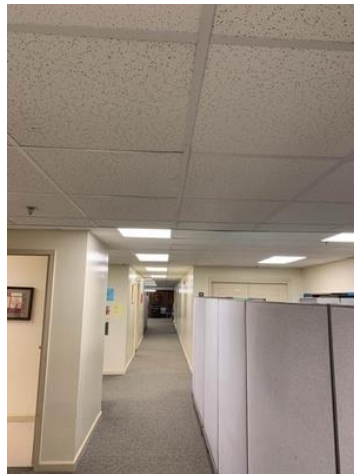
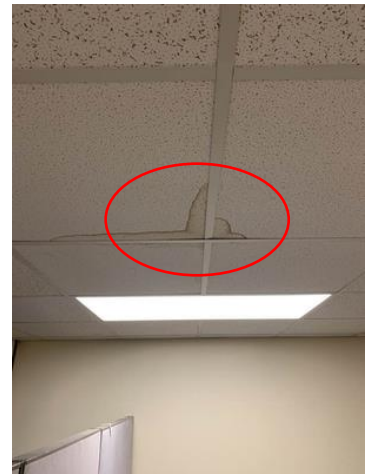
**Ceiling Photo**

Lower level ceiling is dropped grid, 18 x 18 tiles. Appears to be acceptable. There's evidence of prior leaking, confirm cause has been remediated, and repair.

Replace tiles as needed. Examples noted in photos below. Main level ceilings are sheet rock. Appear to be acceptable. There is some remaining evidence of water penetration. The leaks have been remediated with the installation of a new roof, fall 2022.

Ceiling of the upper floor appears to be painted sheet rock and acceptable with minor repairs needed as noted in the photos below. Upper room roof trusses are trimmed in pine that appears to be shrinking, with joints opening. Recommend inspection of trusses for structural integrity. With integrity confirmed, repair/paint trusses as needed.

Church ceiling appears to be acceptable with minor repair

required as noted in photos below. Specifically, mildew or mold that is appearing on some ceiling, sections, and gable ends.

With new roof, it is assumed moisture/water penetration has been remediated on these planes. Mildew/mold will need to be remediated ceiling repainted. Budget number will be provided for painting entire plane of this area. Recommend masonry contractor inspect exterior wall sections where there is interior mildew/mold growth.

Budget numbers will appear high as it requires working at height and lift rental.

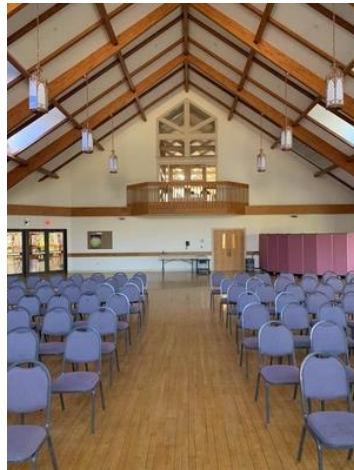
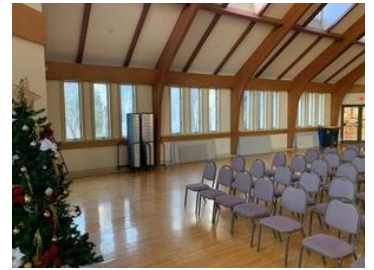
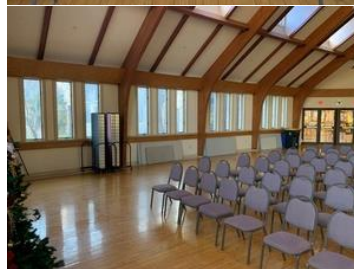
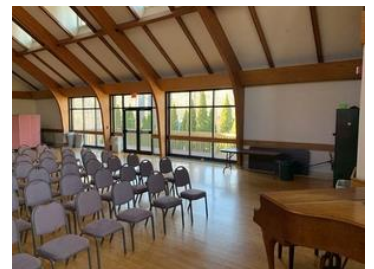
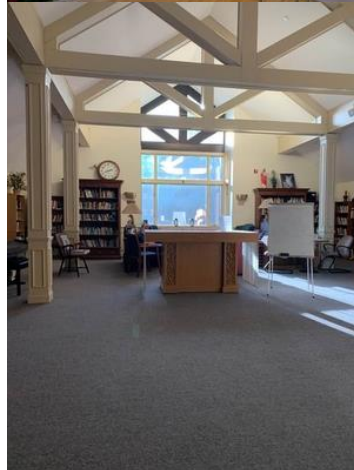
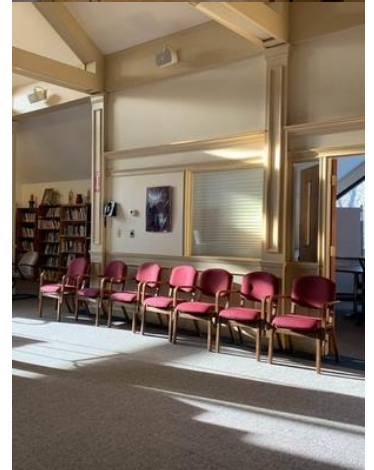
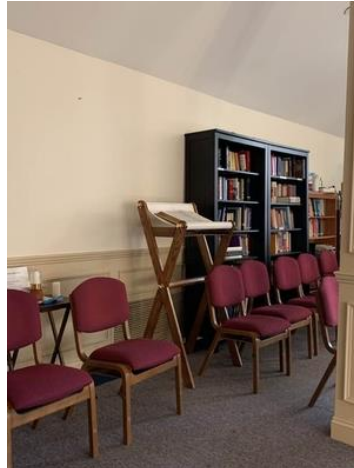
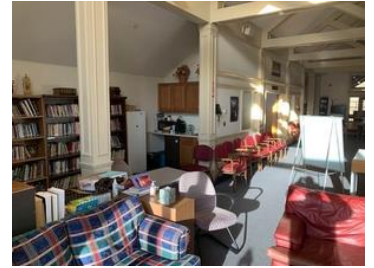
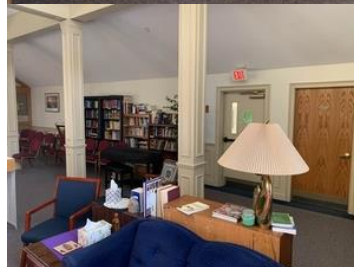
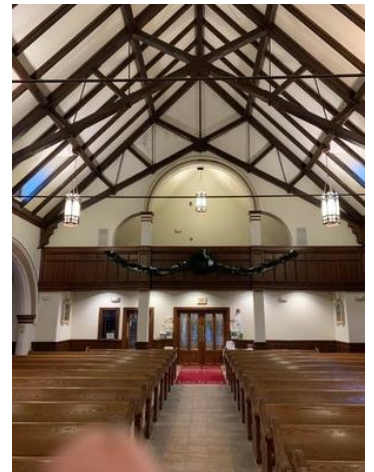
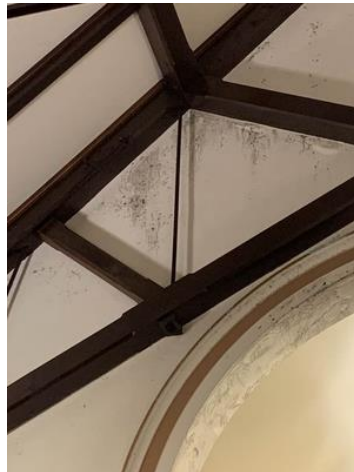
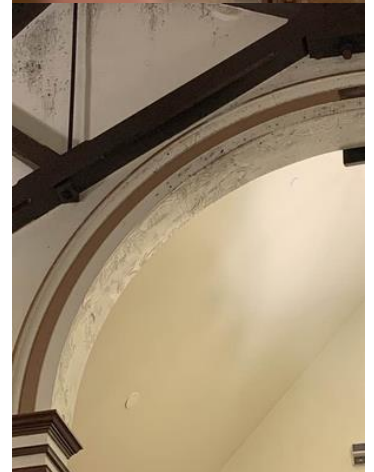
### Wall Assessment

Walls appear to be acceptable, painted sheet rock.

Minor repairs required as noted in photos below.

Main level walls are combination of painted sheet rock and brick. Some areas have flat wood panel with trim accents, wainscoting as noted in photos below. All wall surfaces appear to be acceptable.

Church walls are acceptable with repair needed as noted in the photos below.

Wall behind door on the way to the basement needs repair last photo in the section.

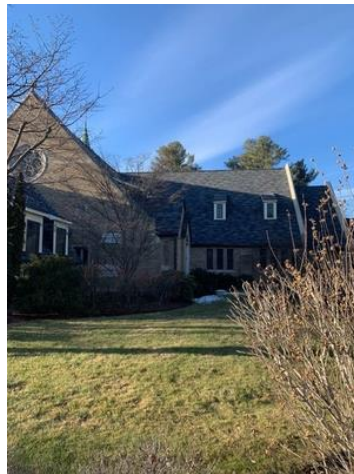
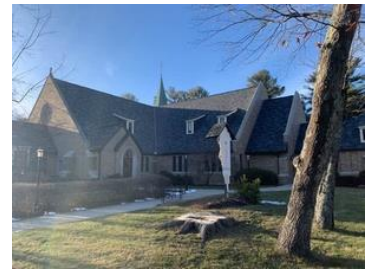
#### Roof Photo

Copper and rubber roof at rear should be inspected annually.

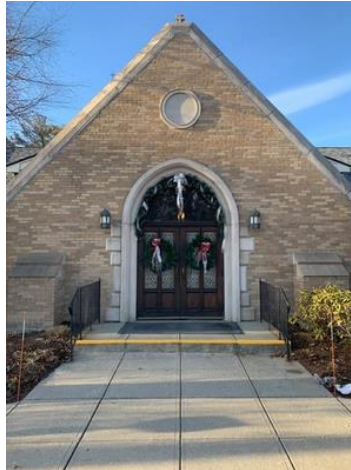
Exterior right wall appears to be acceptable with minor repair required.

Budget for masonry repointing/repair and precast restoration, all elevations, 1-5 years, \$80,000

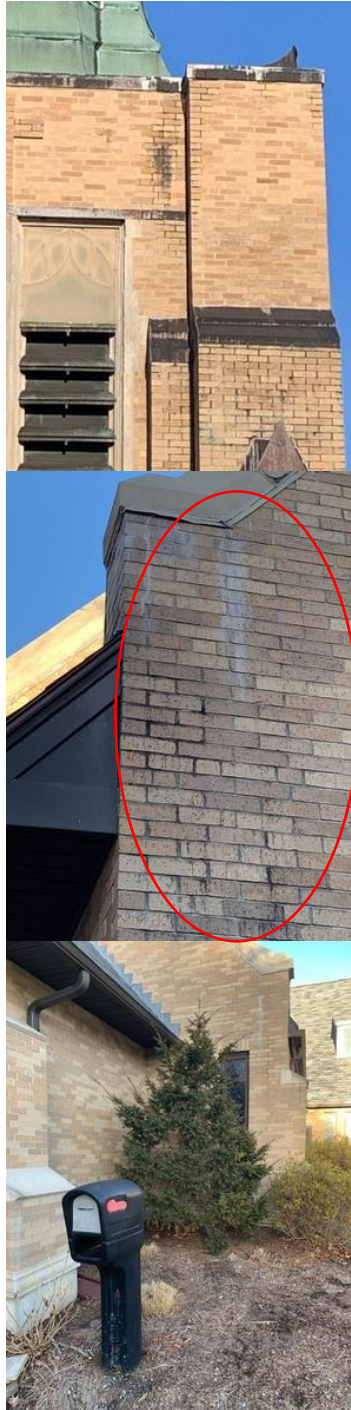
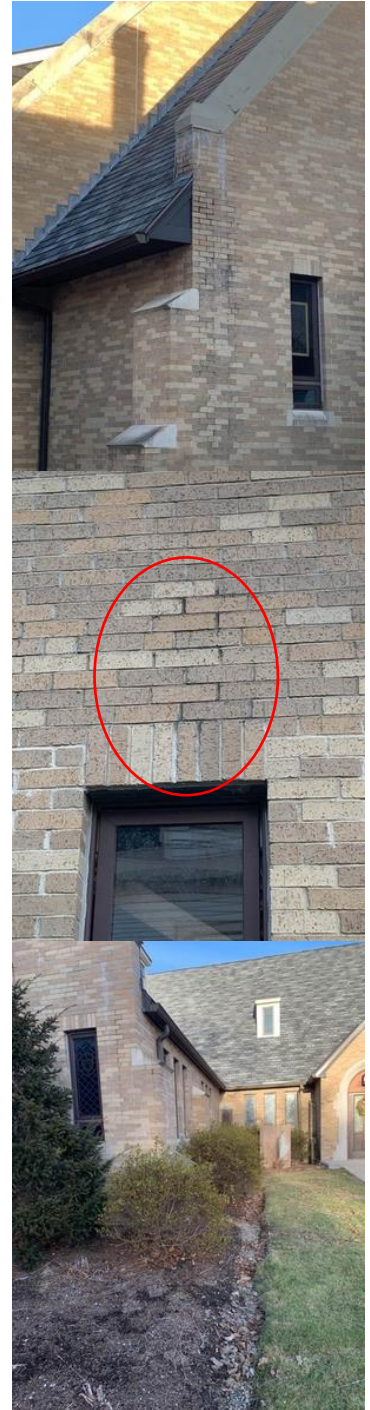
Exterior left side appears to be acceptable with some repointing required as noted in the photos below.

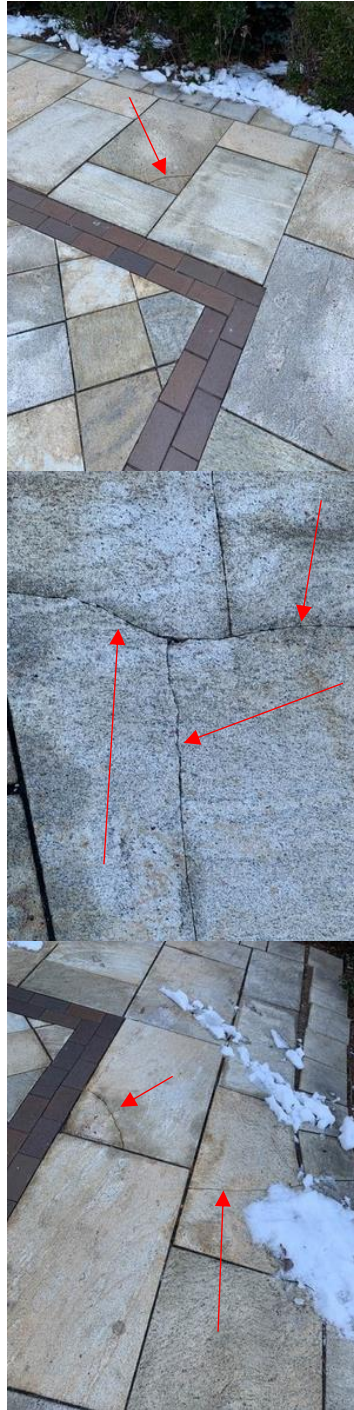
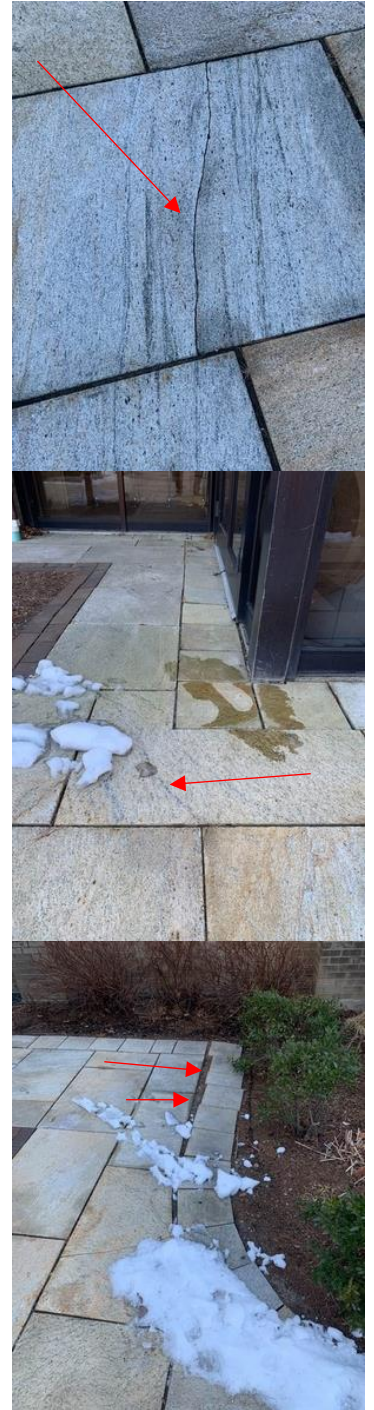
<b>Walkways</b>	Flat, slight incline, stairs, stamped concrete, other, in field repair needed
<b>Walkway Photos</b>

Budget for concrete walkway repair, 1-18 months, \$1,800
