St. Catherine of Alexandria Rectory
109 North Main St.
Westford, MA 01886
Winter 2023
Prepared for Reverend Peter F. Quinn, Reverend Joseph M. Rossi

Prepared by Office of Property Management
Archdiocese of Boston
66 Brooks Rd., Braintree, MA 02184

St. Catherine of Alexandria Rectory, Facilities Assessment

EXECUTIVE SUMMARY

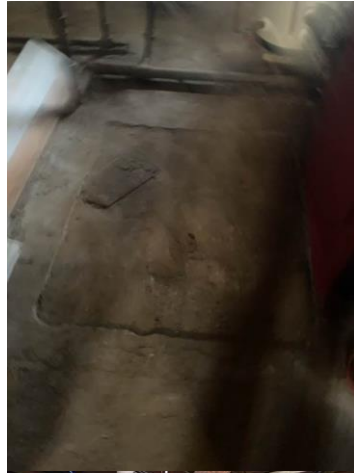
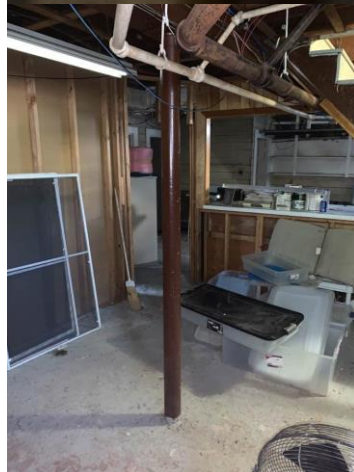
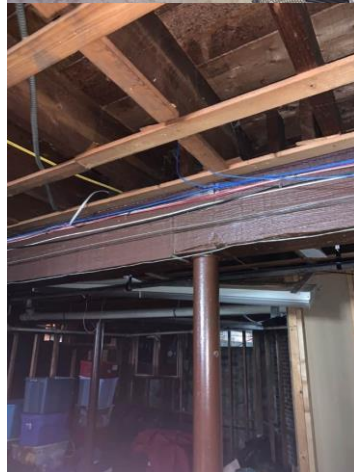
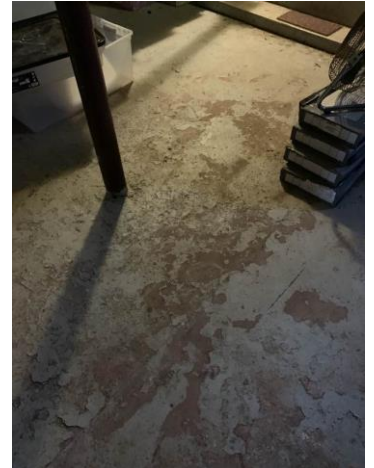
Lolly columns and timber support dimensional lumber deck.

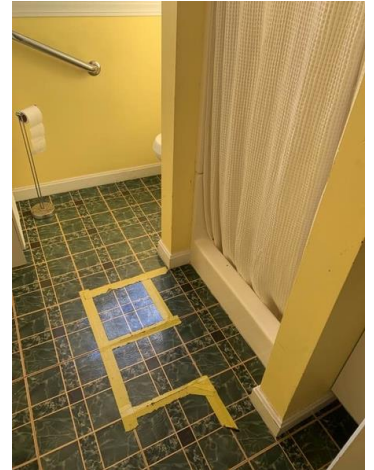
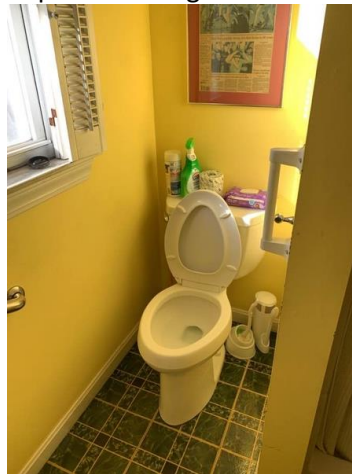
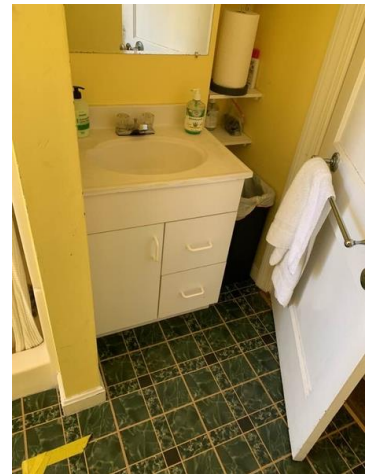
First floor bathroom needs repair as noted in photos below. Color of the walls are yellow.

Replace flooring

Budget for replacement of first floor bathroom floor, 1-18 months, \$1,200

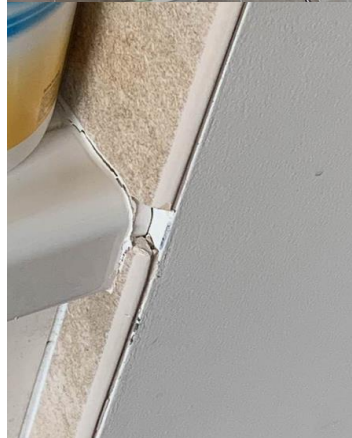
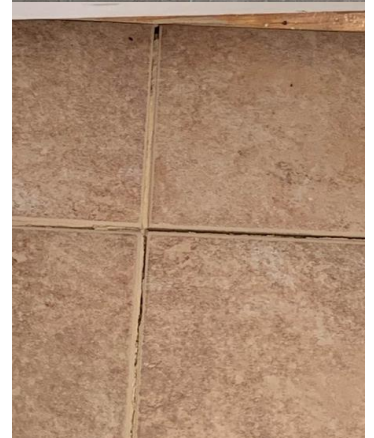
Minor regrouting needed.

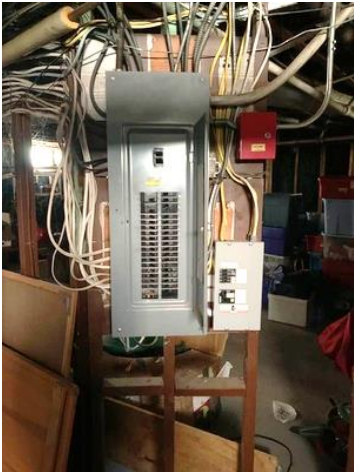
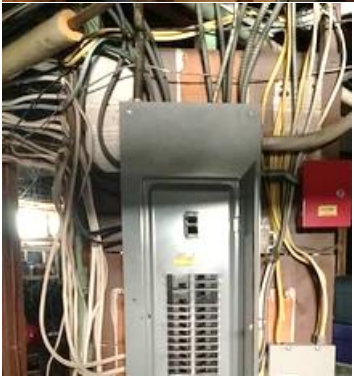
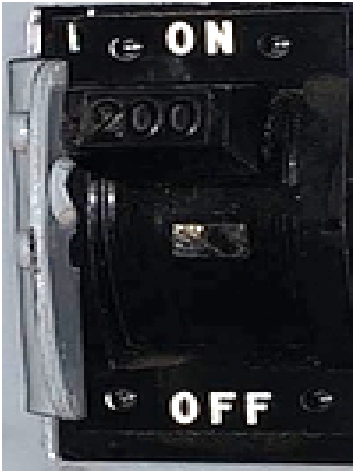
Electrical Service	Electrical service is a combination of conventional wiring and existing knob and tube. If budget permits, recommend phasing out knob and tube. As it is operational without incident no budget number is provided. Recommend getting an assessment and proposal to dead the knob and tube and wire as needed.
List	Single Phase, 120/240
Branch Wiring	Knob and Tube, Romex
Electrical Service Photos	<div>

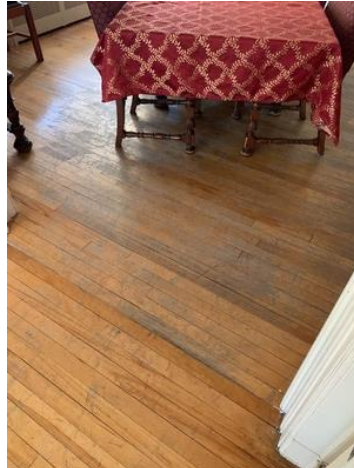
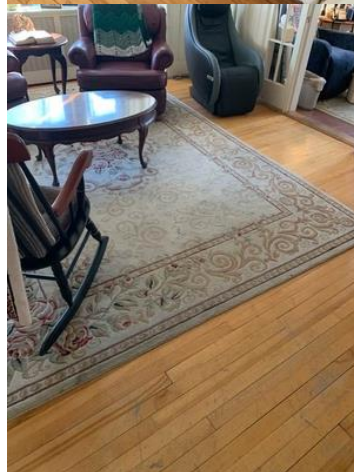
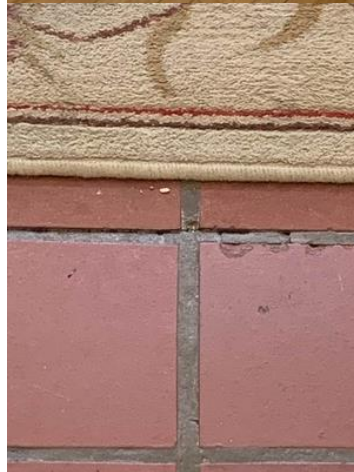
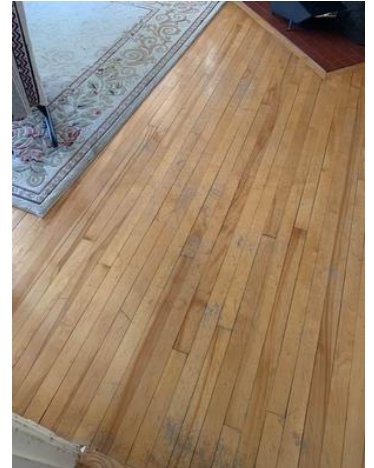
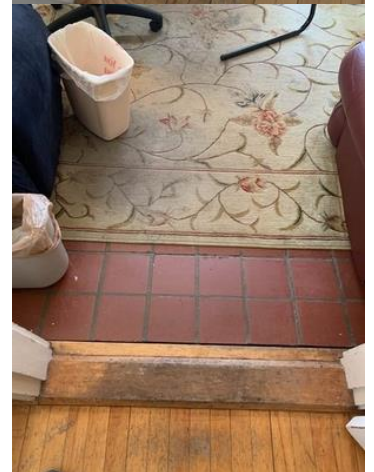
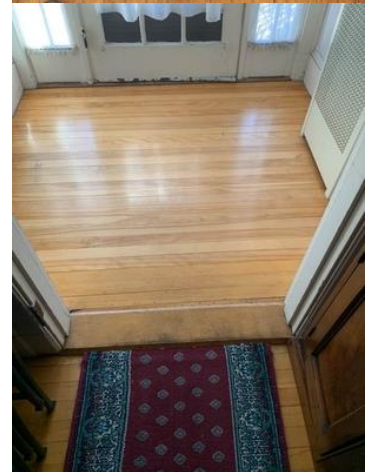
Floor Photo

Interior Assessment Overview	<p>There is a fair amount of deferred maintenance on the first and second floors of the rectory. The issues are noted in the sections and photos below.</p>
Floors Assessment	<p>First floor floors are a combination of vinyl tile in the kitchen, people, thin strip in other rooms, as well as runners and room rugs.</p> <p>Recommend refinishing of maple floors in the dining room, and living area. It will be a number that would include all areas except for the foyer, which appears to have been done recently.</p> <p>Entryway to sunroom appears to be slanted. It's unknown if that is the design or it has settled. Recommend inspection of sunroom by framing by contractor.</p> <p>Second floor floors are combination of thin strip maple, room rugs, and runners.</p> <p>Second floor floors could be sanded and refinished.</p> <p>There is what appears to be considerable settlement in the hall of the second floor.</p> <p>Third floor floors are a combination of what appeared to be 2 1/2 inch or 3 inch tongue and groove oak and wall-to-wall carpeting. Some of the eaves could be insulated. However, it was noted there is concern of active knob and tube. If that could be deadheaded and Romex run insulation could occur.</p>

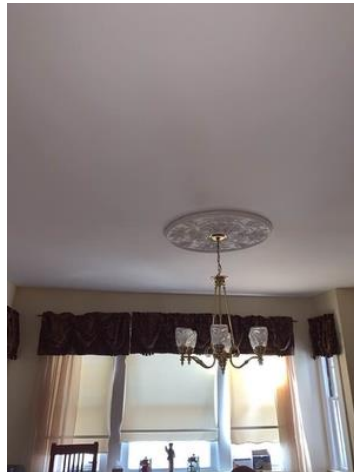
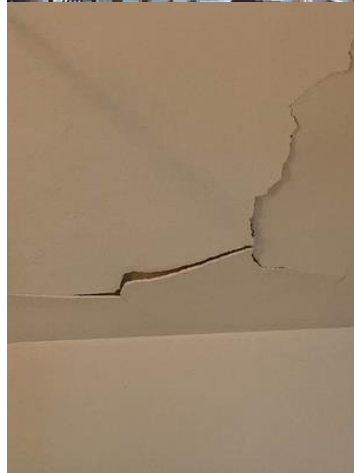
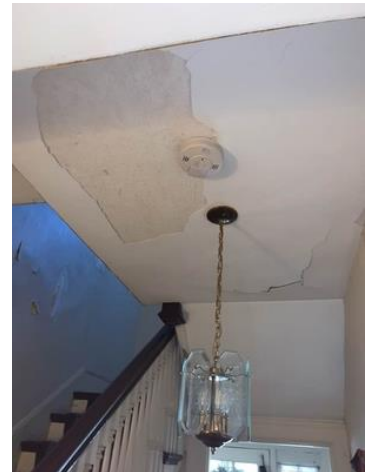
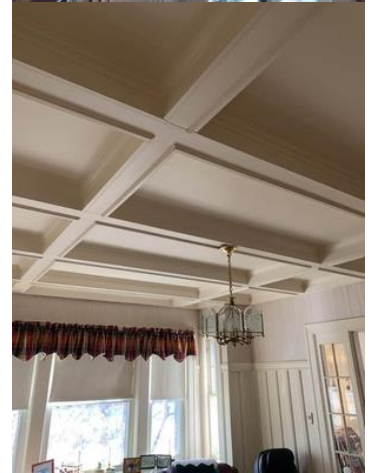
Ceiling Photo

The first-floor ceilings are in need of repair. This will be noted in the photos below.

Second floor ceilings appear to be acceptable with any repairs required noted in the photos below.

Third floor ceilings be to be acceptable given the age of the building. Repairs will be noted in photos below.

Budget for ceiling repair throughout building, 1-18 months, \$14,500

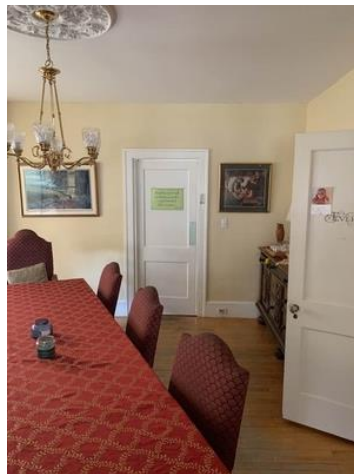
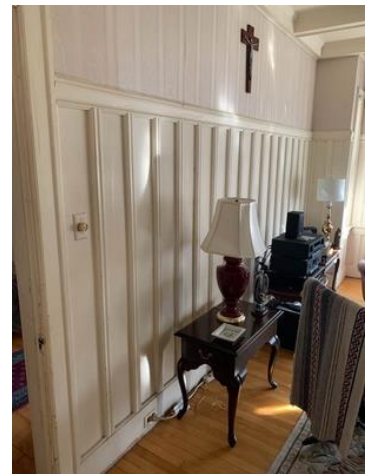
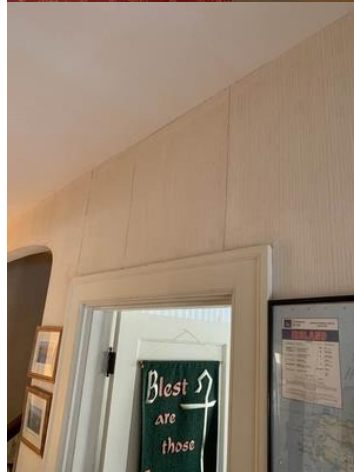
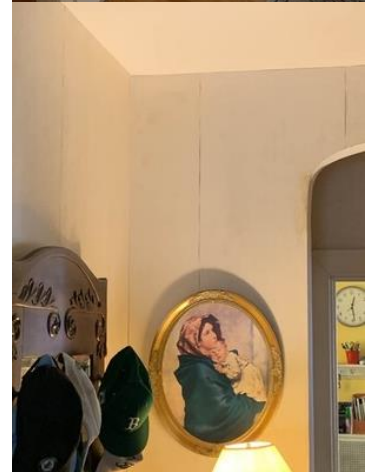
Wall Photo

Wall Assessment	<p>First floor walls are a combination of what appeared to be painted plaster or sheet rock, paneling, and wallpaper. Wallpaper should be stripped and replaced or strip walls prep and paint. Approximately 75% of first floor could be repaired and painted.</p> <p>Majority of wallpaper seams have begun to curl.</p> <p>Second floor walls need repair as noted in photos below.</p> <p>Walls of third floor appear to be acceptable. It would be minor prep required for painting.</p>

Budget for repair and painting. Of walls, as noted in report, 1-18 months, \$20,500

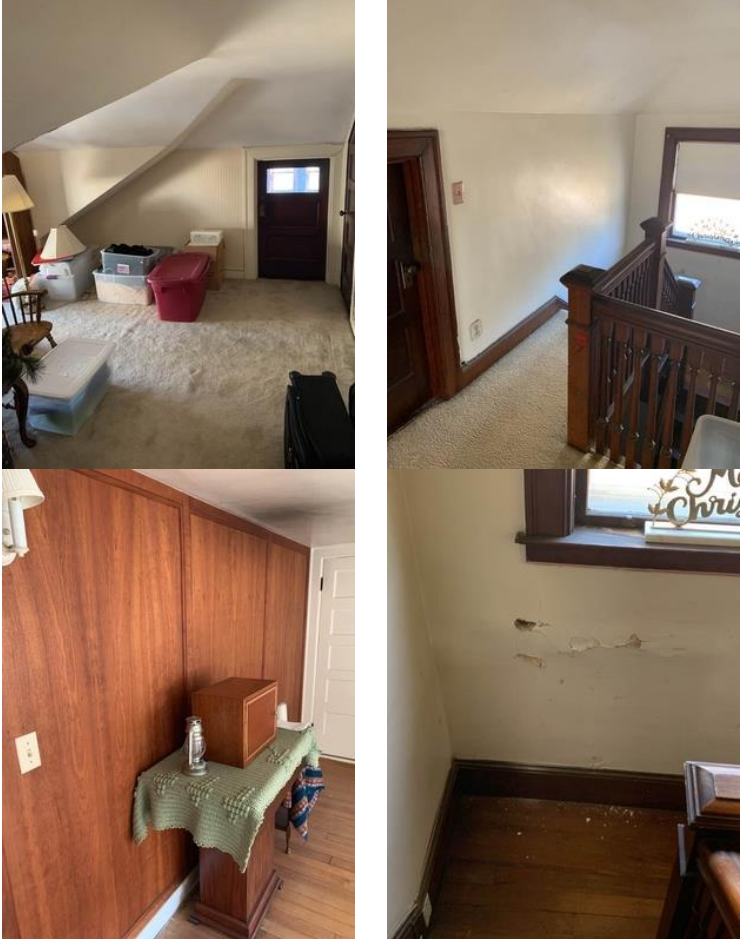
Door Assessment	<p>First floor doors swing as intended but adjustments would need to be made to confirm catching and latching.</p> <p>Second floor doors are similar to the first.</p> <p>Third floor doors swing, latch and catch as intended.</p>

Budget for door repair as noted in report, 1-18 months, \$3,800

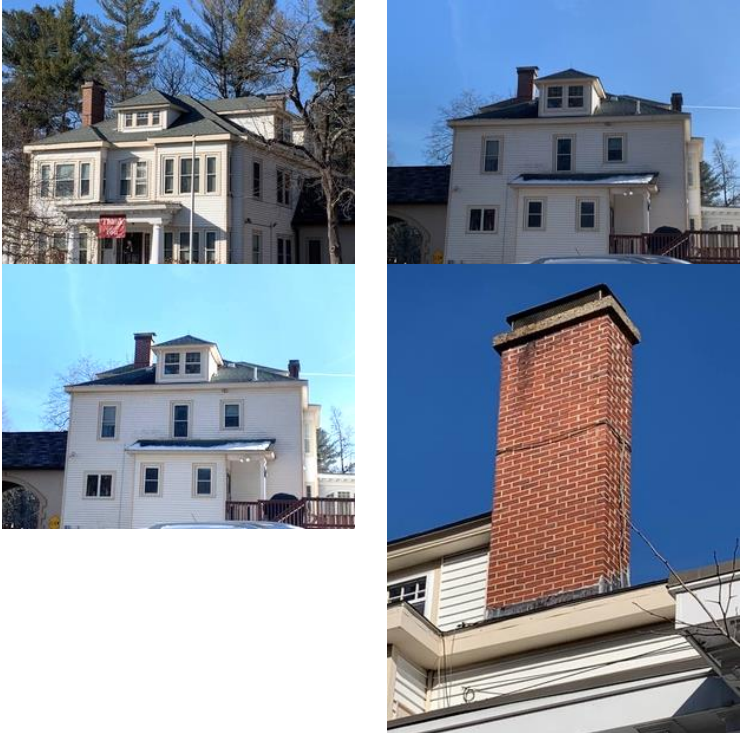
Roof Assessment	Asphalt shingle replaced approximately 5 to 10 years ago.
Roof Photo

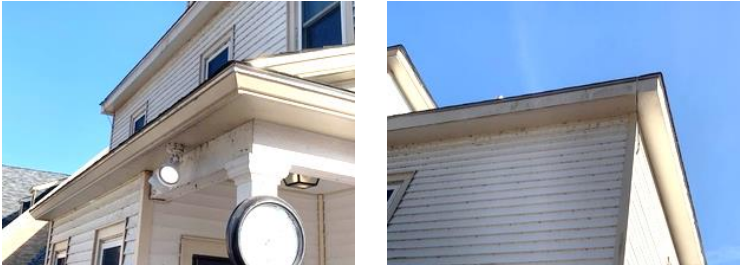
Drainage Assessment	Drainage is gravity to grade.
Drainage Photos

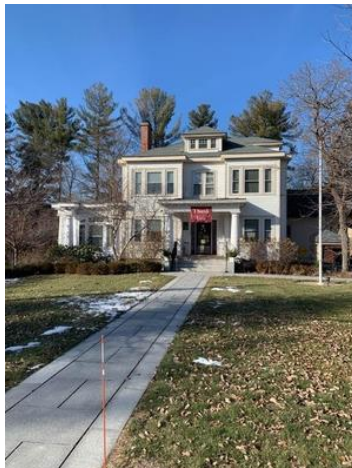
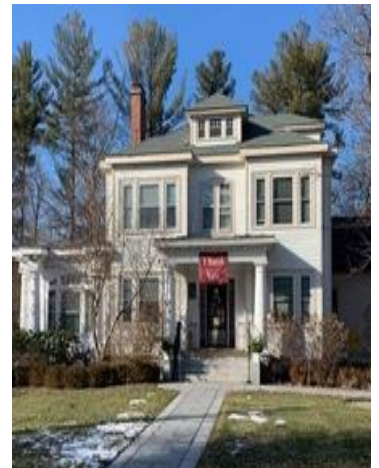
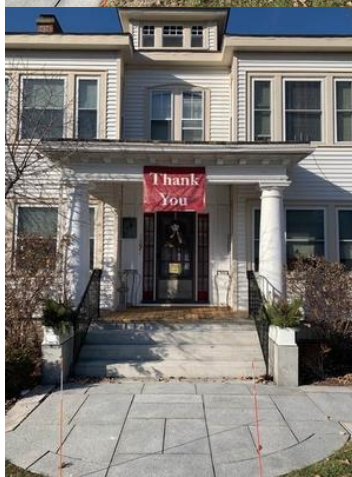
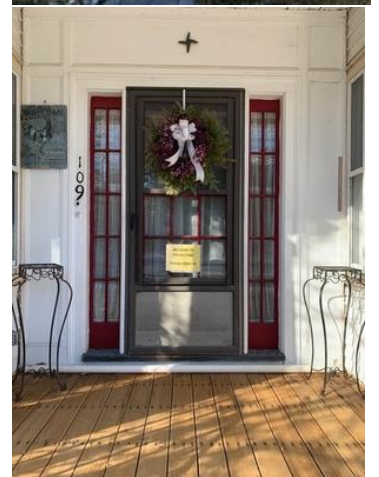
Front Photos

Front elevation appears to be acceptable with repairs required as noted in photos below. Specifically, wooden surfaces need to be scraped, repaired, primed and painted. The stops on the replacement windows should be scraped and painted. There is some pointing required of the granite block of the front stoop, and some resetting of the granite pavers of the walkway.

Budget for front stair repair, painting, and repointing, 1-18months, \$16,500

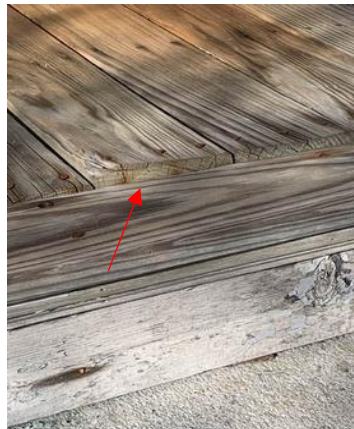
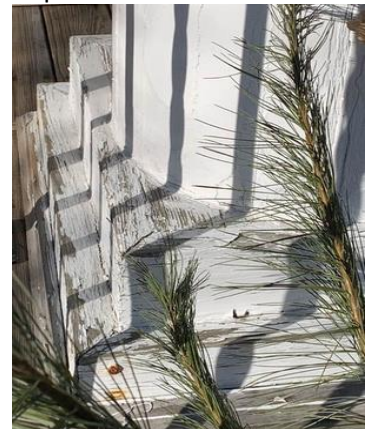
Trip hazard.

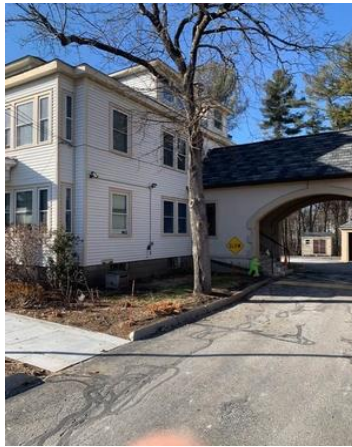
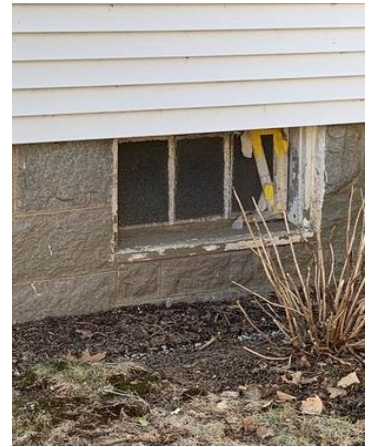
Side Photos

Exterior right elevation appears to be acceptable with minor repairs required as noted in photos below.

Repair, scrape and paint all hopper windows.

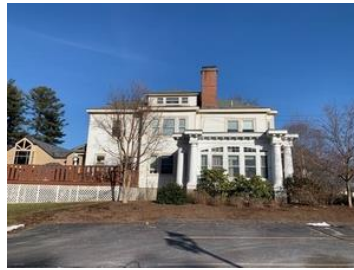
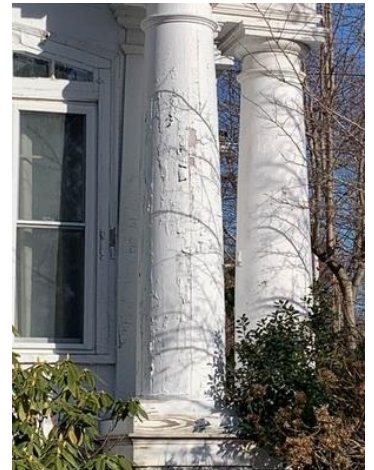
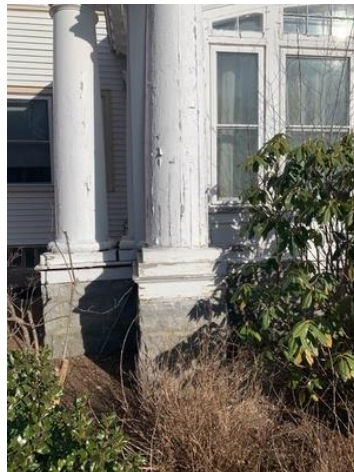
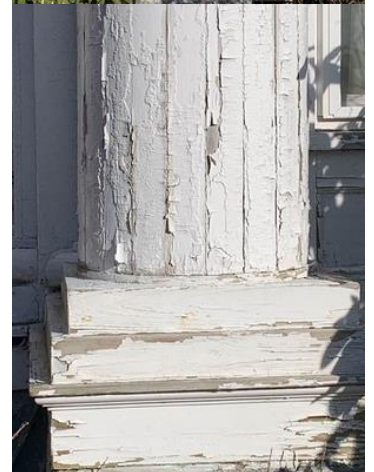
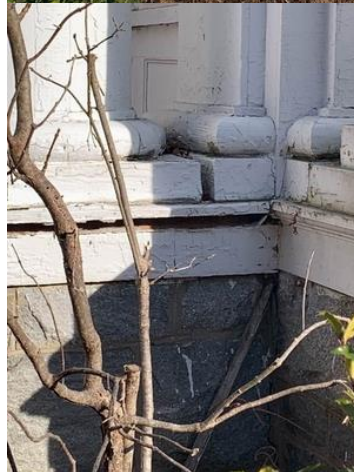
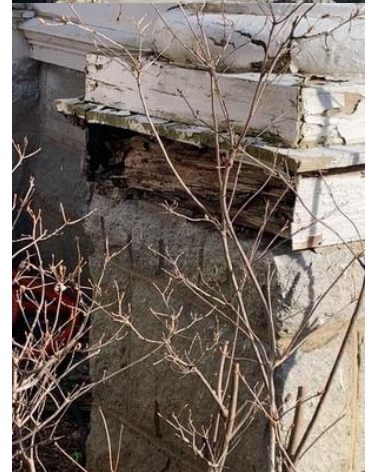
Side Photos

Exterior left side of building appears to be acceptable with repairs required as noted in photos below. Repairs are primarily focused on exterior of the sunroom. Columns need to be scraped repaired primed and painted. They should be done sooner than later. It also should be noted recommendation of inspecting the floor framing. The suggestion is based on what appears to be settling of the floor inside.

Budget for sunroom repair, repainting, and assessment of framing, 1-18months, \$14,800

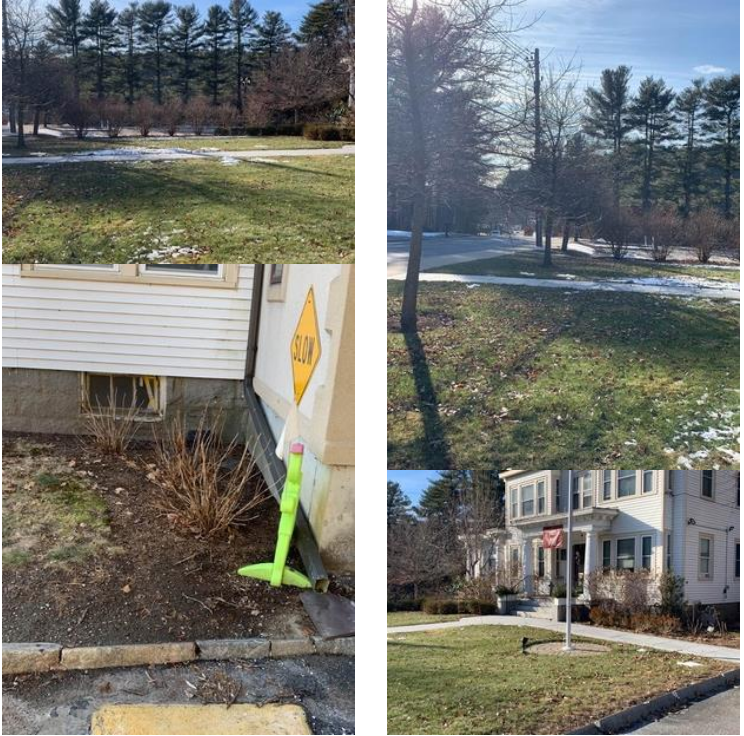
Grounds Assessment	<p>Rear parking area appears to be acceptable with some crack sealing required would suggest sealing and striping, in six to ten years.</p>
Landscaping Photos
