St. Anne's Church/Hall/Offices, Littleton, MA, Facilities Assessment

May 2022, Facility Assessment

Prepared by Office of Property Management

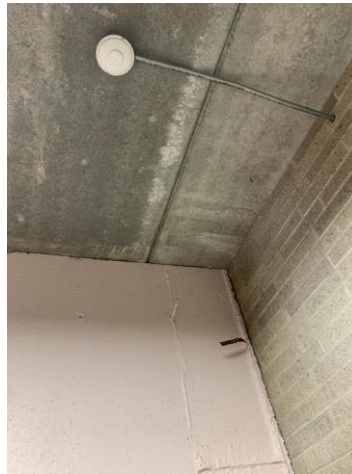
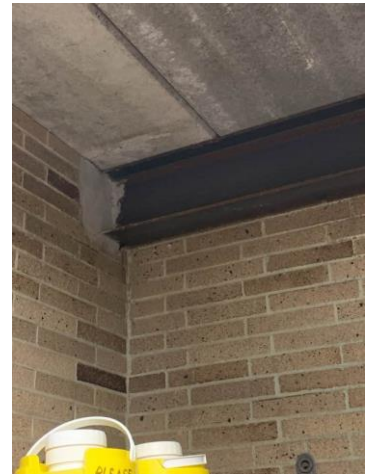
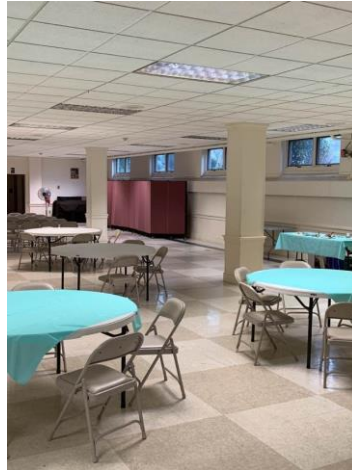
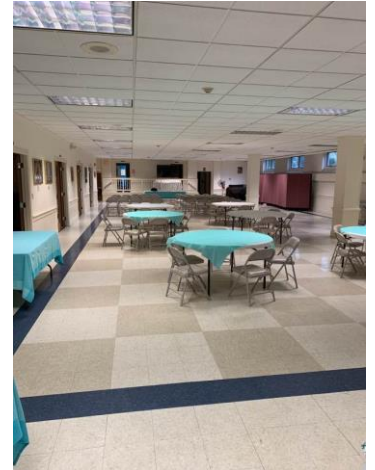
First floor deck is supported by columns that have been trimmed out and aren't visible. First floor deck is appears to be concrete slab construction as noted in photos below supporting members of the first-floor deck also includes steel beams.

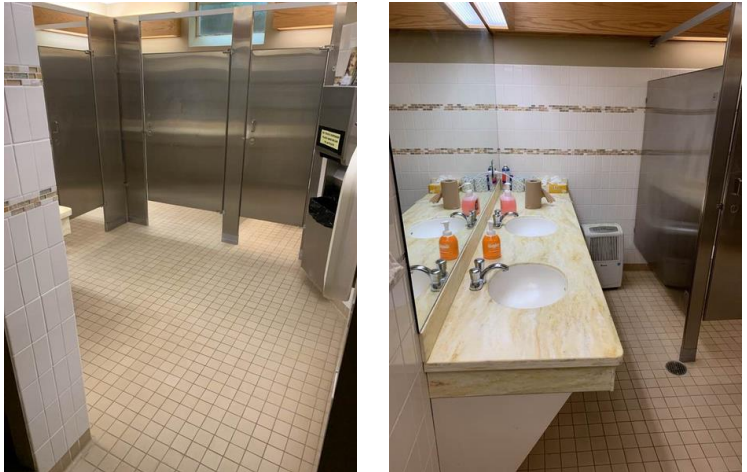
<p>First floor bathroom of the rectory appears to be in acceptable condition. Tile floors, walls, and wallpaper. It is also equipped with the proper GFCI.</p> <p>First floor rectory bathroom with laundry appears to be acceptable. Tile floor, pink wainscoting tile, drywall above. Threshold into the bathroom laundry area is chipped should be repaired or replaced.</p> <p>Second-floor bathrooms appear to be acceptable. All appear well maintained. Minor re-grouting required it will be noted in photos below. Bathrooms have mosaic tile on the floor and for wainscoting and a shower area with solid surface sinks.</p>
Bathrooms	Full, Quarter
Bathroom Photos

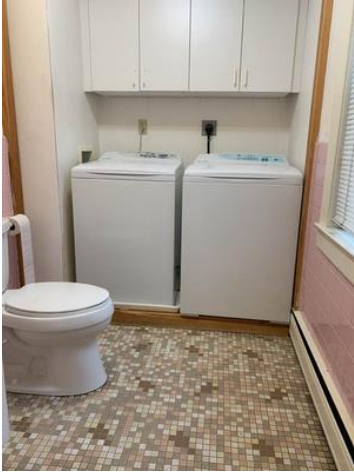
Laundry Assessment	<p>Laundry appears to be in acceptable condition. There has been no indication from staff as to any issues with the laundry. Top loading washer and electric dryer.</p>
Laundry Photos	<div data-bbox="771 1144 1122 1612">

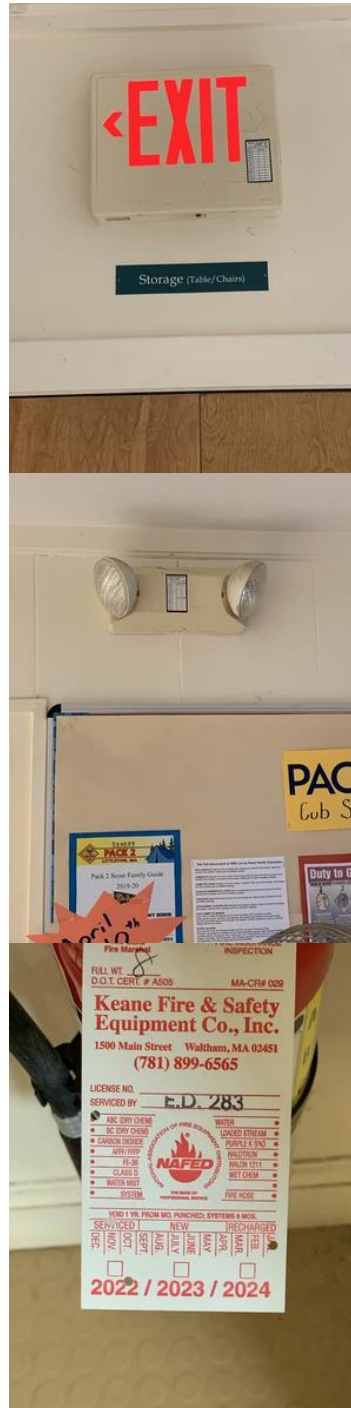
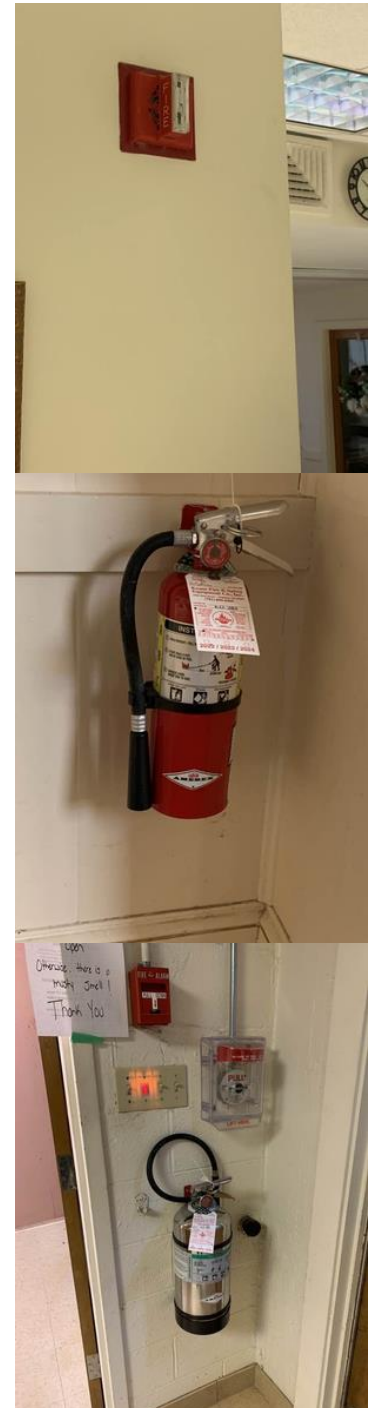
<p>Fire Alarm Box</p>	<p>Fire alarm panel is located on the lower level in the storeroom beneath the rectory.</p> <p>Appears to be an acceptable condition. Appears to be hardwired and not a cellular system.</p>

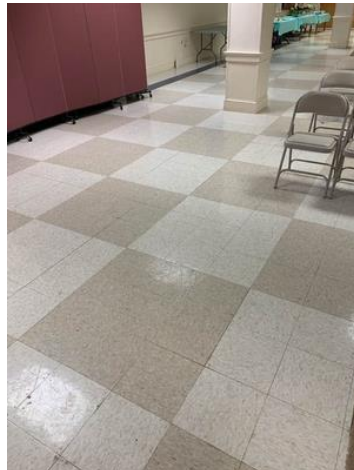
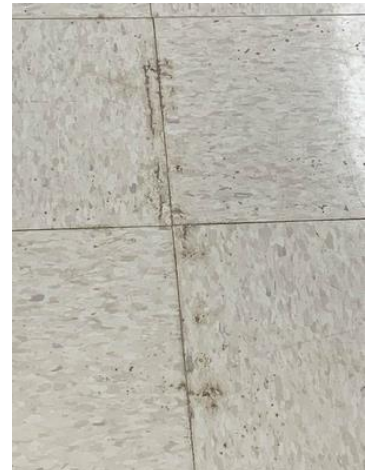
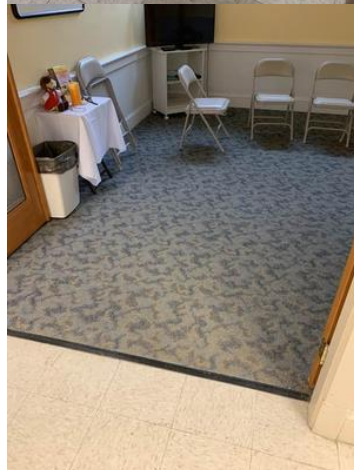
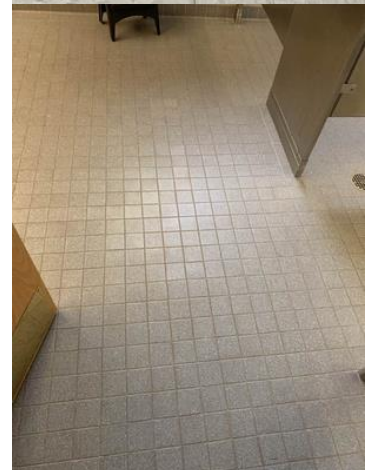
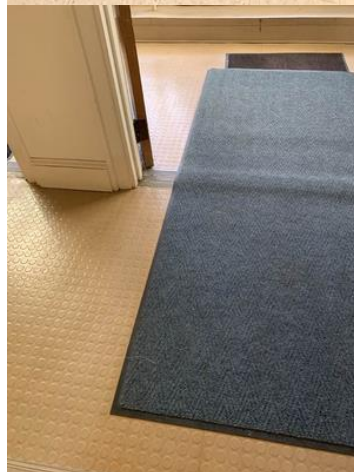
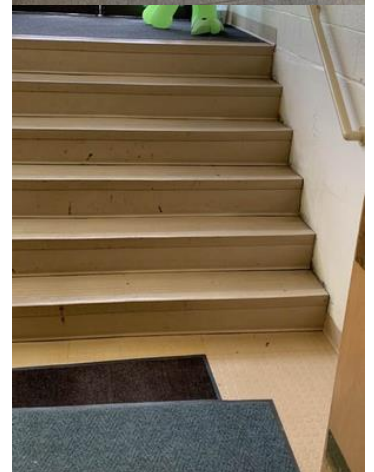
Floor Photo

Floors Assessment	<p>Floors of parish hall appear to be acceptable. Some refinishing will be required in the one-to-five-year period depending upon traffic and wear. Note photos below. Primary floor surfaces consist of VCT flooring, ceramic tile, wall-to-wall carpeting, and unpainted slab on grade as noted in the electrical room and boiler room.</p> <p>This level is used as a large gathering space that includes the kitchen as well as classrooms on one side. All classrooms appear to be in acceptable condition, well-maintained and cared for.</p>

<p>Lower level beneath the rectory appears to be in acceptable condition. Note photos in sections below.</p> <p>The carpet at the lower level, pass through area, beneath the rectory has staining that appears to be from moisture. Should confirm that this is remaining dry and have it cleaned.</p> <p>Seam in the meeting room on the lower level by the garage, carpet seam in the meeting room outside of the garage is starting to fray. This may have to be repaired or the carpeting replaced to avoid tripping hazard in the next 1 to 5 years depending upon traffic and wear.</p> <p>Church floors are a combination of ceramic tile and wood, appears to be prefinished hardwood flooring as well as Terrazzo. All flooring surfaces appear to be in acceptable condition and well-maintained.</p> <p>Rectory first floor floors are a combination of mosaic tile in the bathrooms wall-to-wall carpeting and some hall areas, original hardwood in some office and other areas should be refinished in 1 to 5 years depending upon traffic and wear, new prefinished or prefinished hardwood flooring and ceramic tile.</p> <p>Note some first-floor carpet seams are separating. Carpeting should be replaced to prevent tripping hazard.</p> <p>Second floor floors are combination of mosaic tile, original hardwood, room carpeting, and newer prefinished hardwood in the hallway area. All floors appear to be acceptable.</p>

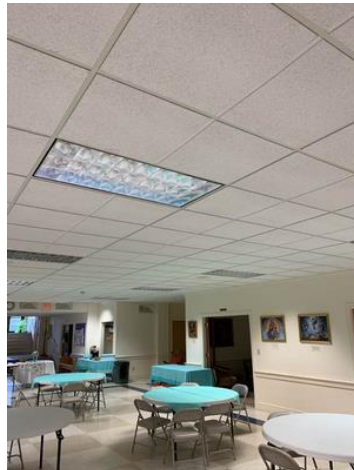
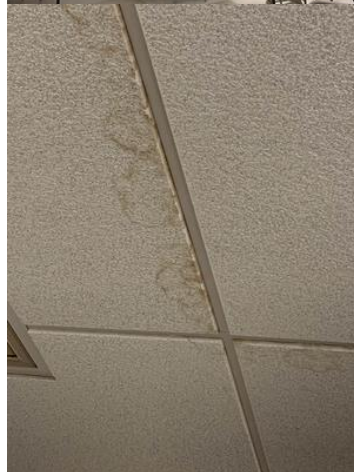
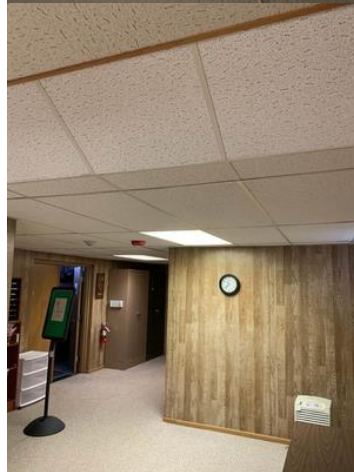
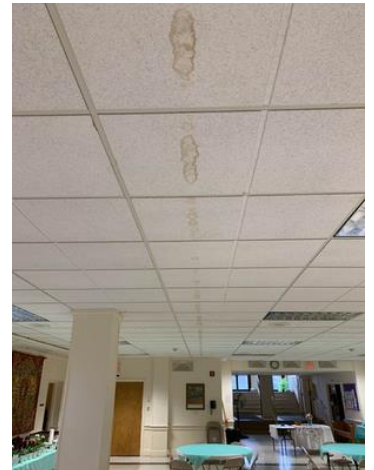
Ceiling Photo

Ceiling Assessment	<p>Ceilings throughout the lower level are suspended tile. All appear to be acceptable except for tiles that appear to be stained by condensation dripping from the steam or condensate lines. Note photos below.</p> <p>Ceilings in the lower level beneath the rectory appear to be acceptable. It's a combination of large, suspended ceiling tiles with integrated lighting and acoustic tile on strapping.</p> <p>Some acoustic tile has let go from strapping above as noted in photo below the repair could be attempted or eventually replace ceiling in 5 to 10 years depending upon how it ages.</p>

Ceiling in the church crying room may need to be replaced in the 5 to 10 year. Depending upon wear and how it performs. It appears to have some sags in it currently.

Ceiling of the chapel off the altar had been damaged from what appears to be a prior leak. Have been told that leak has been remediated, ceiling will eventually have to be repaired. It is possible that the acoustic tile won't be matched and perhaps a ceiling of blueboard and plaster veneer will be quoted.

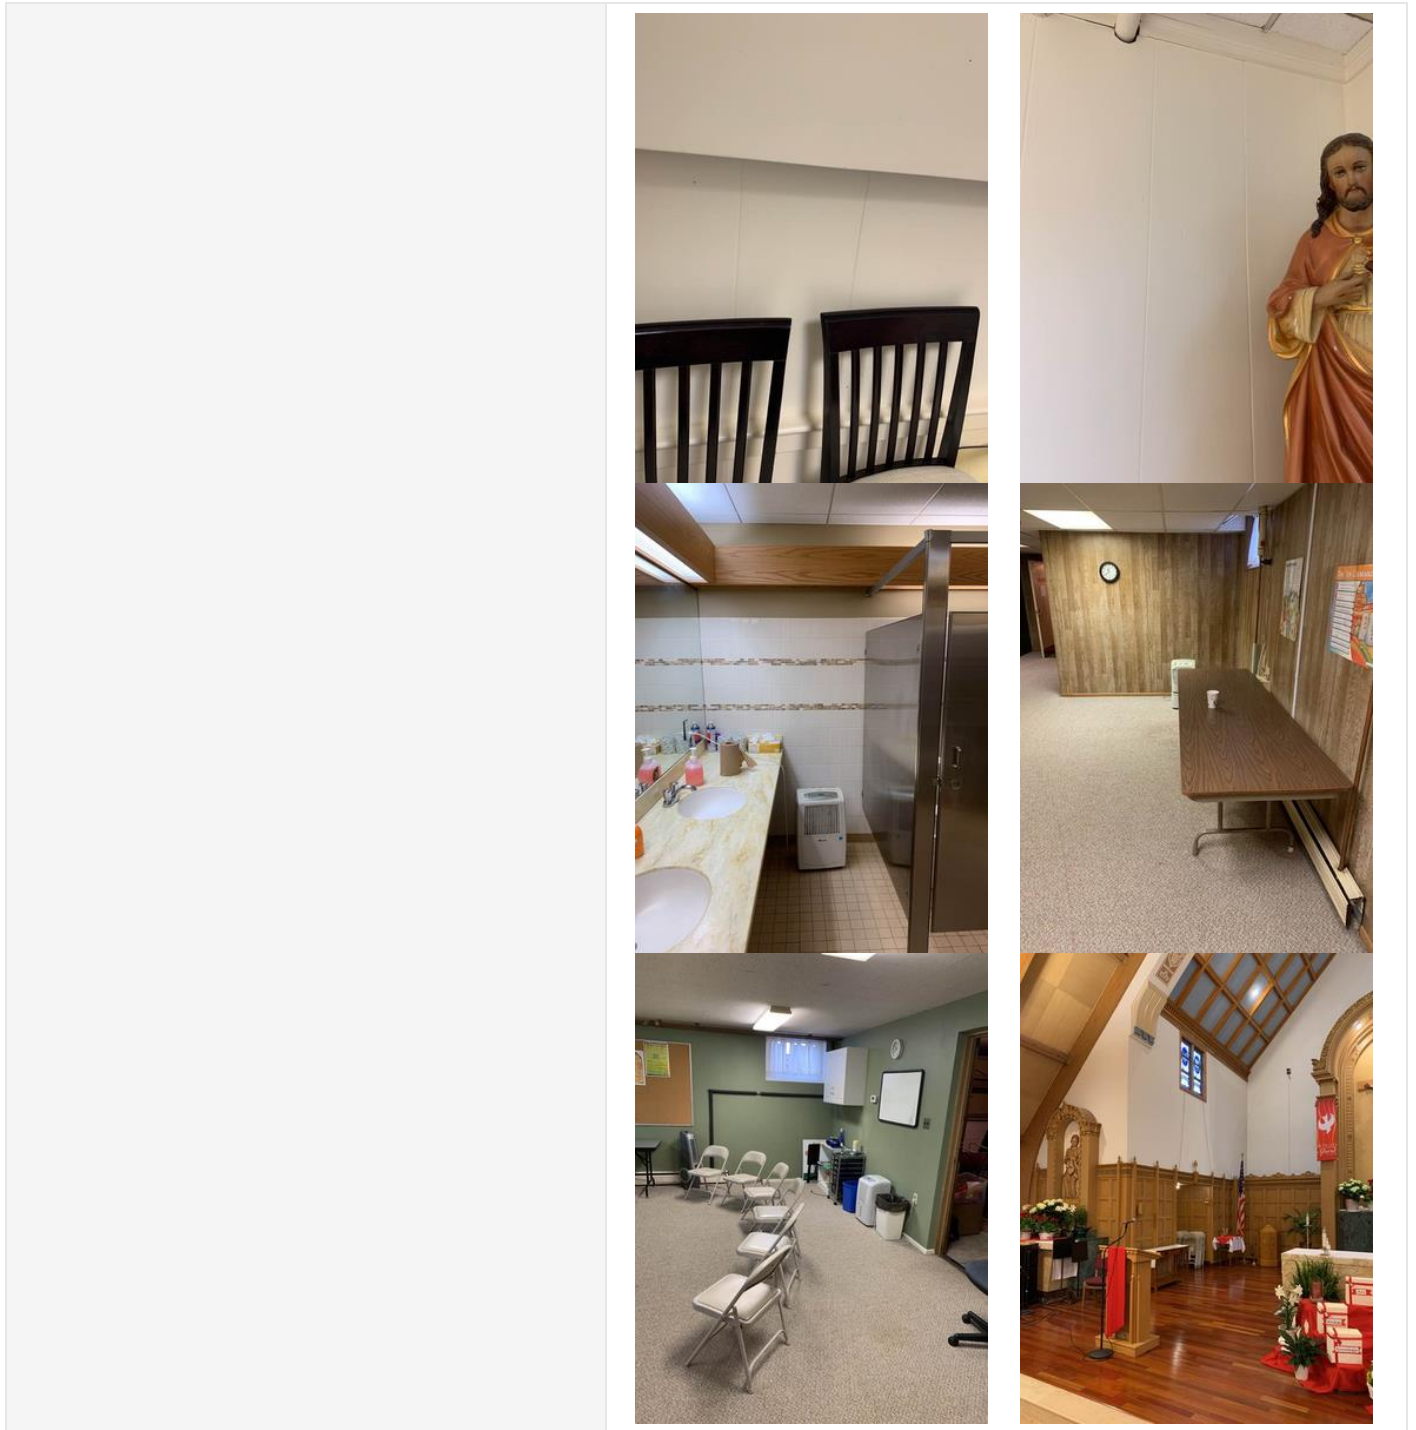
Lower-level walls appear to be acceptable and are a combination of painted wood paneling, drywall, and tile as a tall wainscoting in the bathrooms. Would recommend touchup painting of trim, one to five-year period. This is strictly for aesthetics and it's possible the trim could be washed, and painting could be put off.

Wash or paint

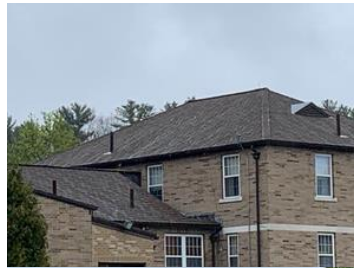
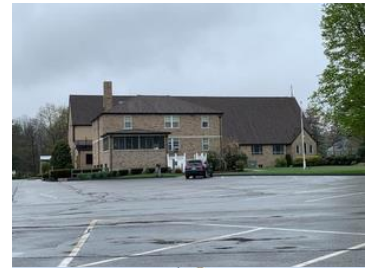
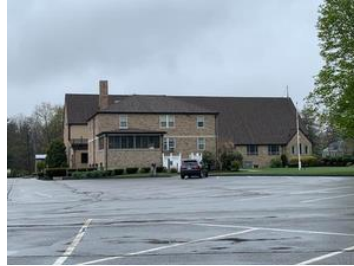
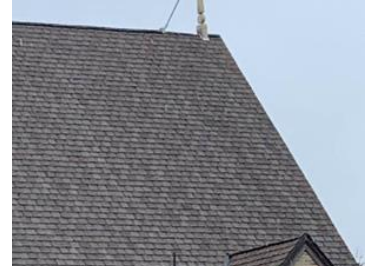
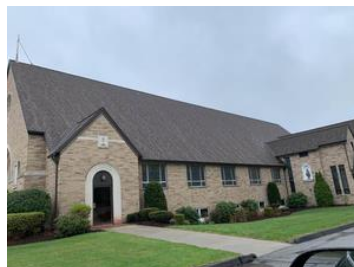
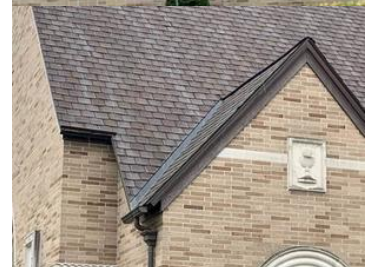
Roof Assessment	<p>Roof appears to be acceptable. There are no missing shingles in field visible from grade. Shallow pitches covered with rubber. Would recommend inspection by roofing contractor for annual maintenance.</p>
Roof Coverage	Architectural, Rubber
Roof Photo

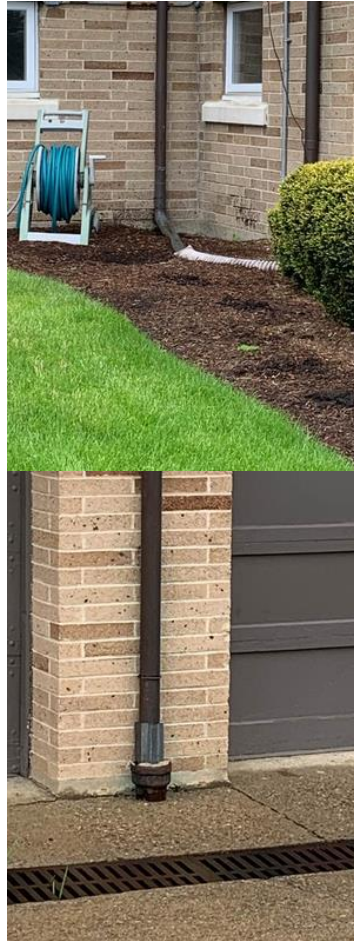
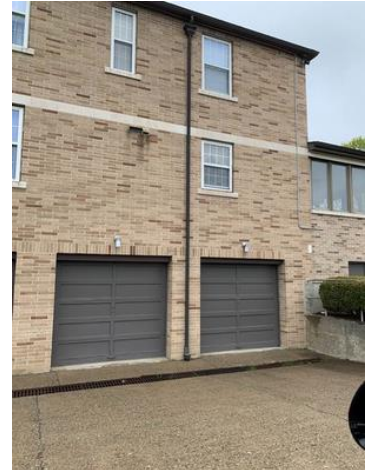
Drainage appears to be in acceptable condition. No staining on the exterior elevations. Appears to be a combination of aluminum gutters and downspouts with some copper downspouts and what appears to be galvanized metal.

Storm heads at the top of the downspouts. Would recommend inspection of gutter system as there is some areas that need to be addressed and will be noted in photos below.

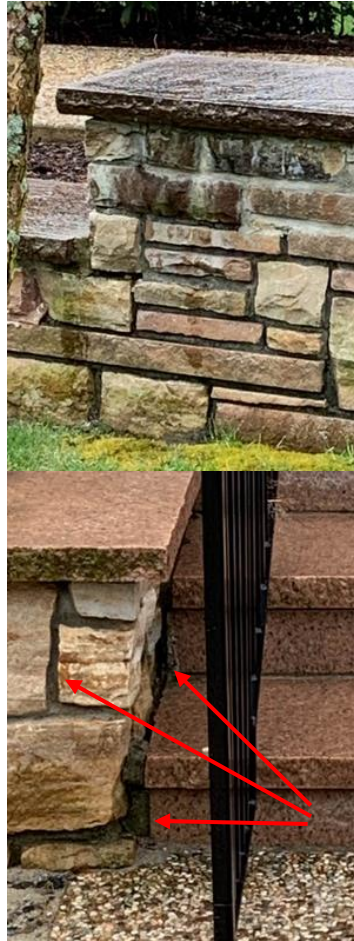
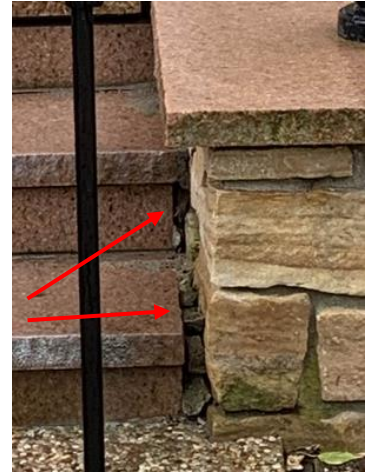
Front elevation appears to be in acceptable condition with minor repair required. Note photos below.

The retaining wall of the ramp should be addressed soon for the degradation from water penetration and freeze/thaw cycle will compound damage and repair cost. Note photos below.

Budget for masonry repair of ramp, 1- 18 months, \$15,000

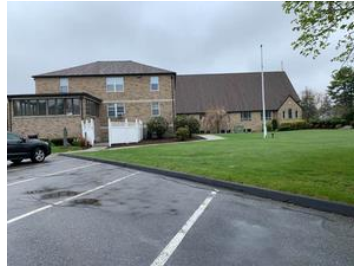
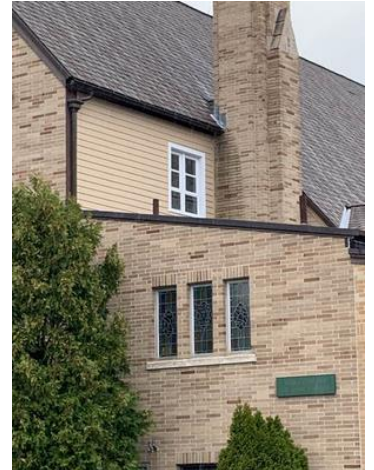
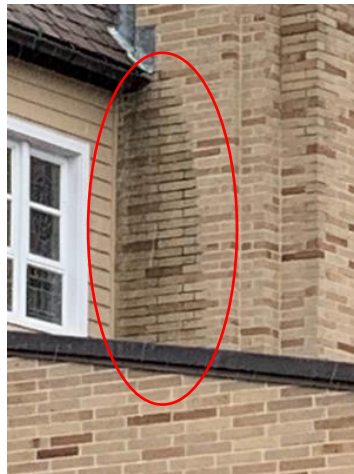
Side Photos

Exterior Left Side Wall Assessment	Exterior left elevation appears to be acceptable. There is minor repair required note photos below.

Repointing required
