Church Building Updates

INNOVATIVE INSULATED CONCRETE FORMS USED ST. MATTHEW CHURCH - NEW CHURCH BELLEVUE, NEBRASKA

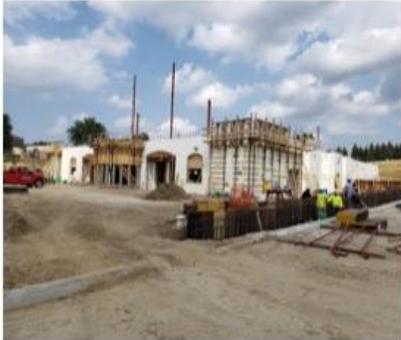
Walk-out Lower Level

Matthew's Elementary School on South 36th Street in Bellevue, Nebraska. The structure is designed to work with the natural site contours and provide lower level "walk-out" on the west side of the building for ease of accessibility to the Fellowship Hall and Parish Offices.

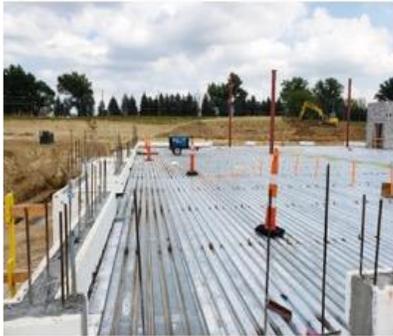
Insulated Concrete Form Exterior Walls

Construction started in the Spring of 2019 and is scheduled to be substantially complete by May 15, 2020. JJA suggested the use of a non-conventional construction process to save construction costs and improve energy efficiency. In lieu of the typical concrete block and metal studs, the St. Matthew Building Committee agreed to use Insulated Concrete Forms (ICF) for the exterior walls. The ICF Blocks are a stackable insulated form with 2 5/8" rigid insulation on each side with ties at 8" o.c. which supports vertical and horizontal reinforcing. After the ICF blocks have been stacked, concrete is placed in the center of the forms. This provides a resilient wall with a R-value of 26. Drywall can then be screwed directly to the ICF ties, which alleviates the need for additional furring. Masonry ties are available from the ICF manufacturer that allow for the installation of brick veneer. An EIFS system does not require added insulation. The finish coat can be directly applied to the ICF Blocks. Previous utility studies have shown substantial saving for both heating and cooling. This was another benefit St. Matthew considered before deciding to agree to use this system.

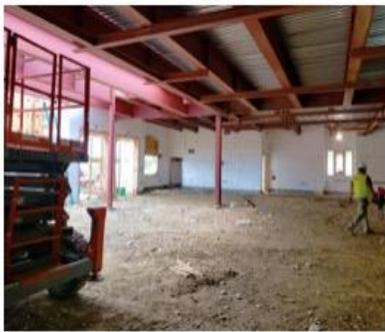
Main Floor Structural System

The interior framing is comprised of structural steel, metal deck, metal studs, and large glued-laminated roof trusses. These trusses provide the traditional church atmosphere, which was a priority for this congregation.
